Tameside MBC

Section 19 Investigation Report

Micklehurst Road, Mossley Flood Event

June 2018

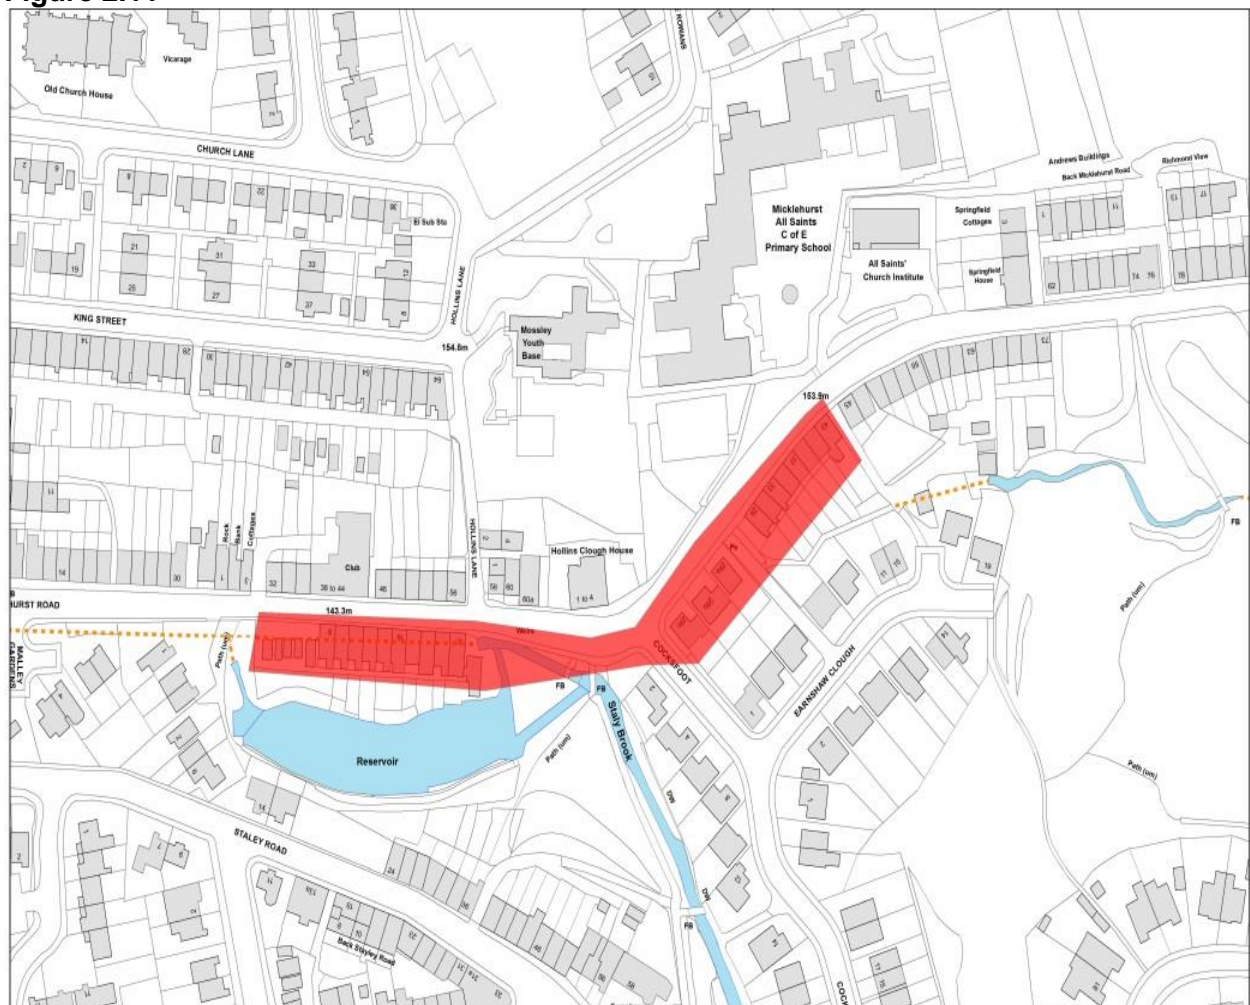
Following extensive rainfall, a culvert collapse occurred on the 11th September 2017 at the side / rear of 29 Micklehurst Road, Mossley. The events constituted flooding in and around a number of properties and the highway. The impact of the flood event also affected the culvert downstream creating a void beneath a hardstanding area. To minimise risk, a temporary road closure was in force between numbers 9 and 43 Micklehurst Road.

Figure 2.11 identifies the general area affected on the 11th September 2017.

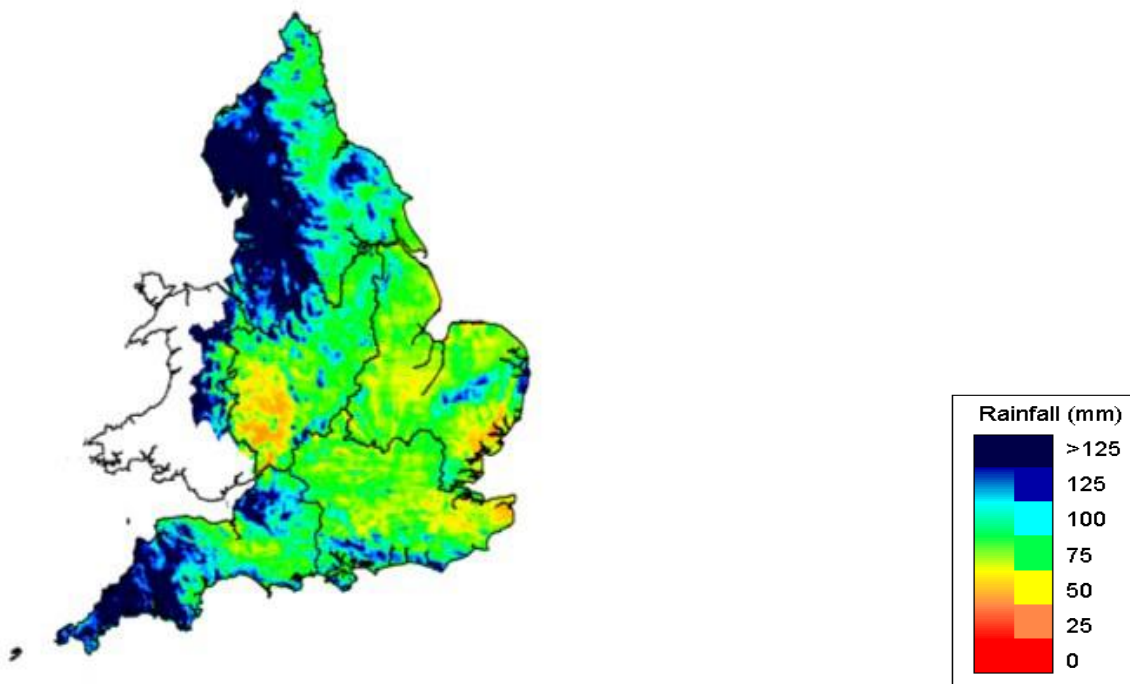
Rainfall data for September 2017

September monthly rainfall totals were highest across parts of north-west and south-west England at 150 to 230mm.

At a regional scale, September rainfall totals were above average 147% in both north-east and north-west England. September rainfall was classed as notably high in north-west England and above normal elsewhere. The monthly rainfall total for England was 133% of the 1961-90 LTA for September (136% of the 1981-2010 LTA).

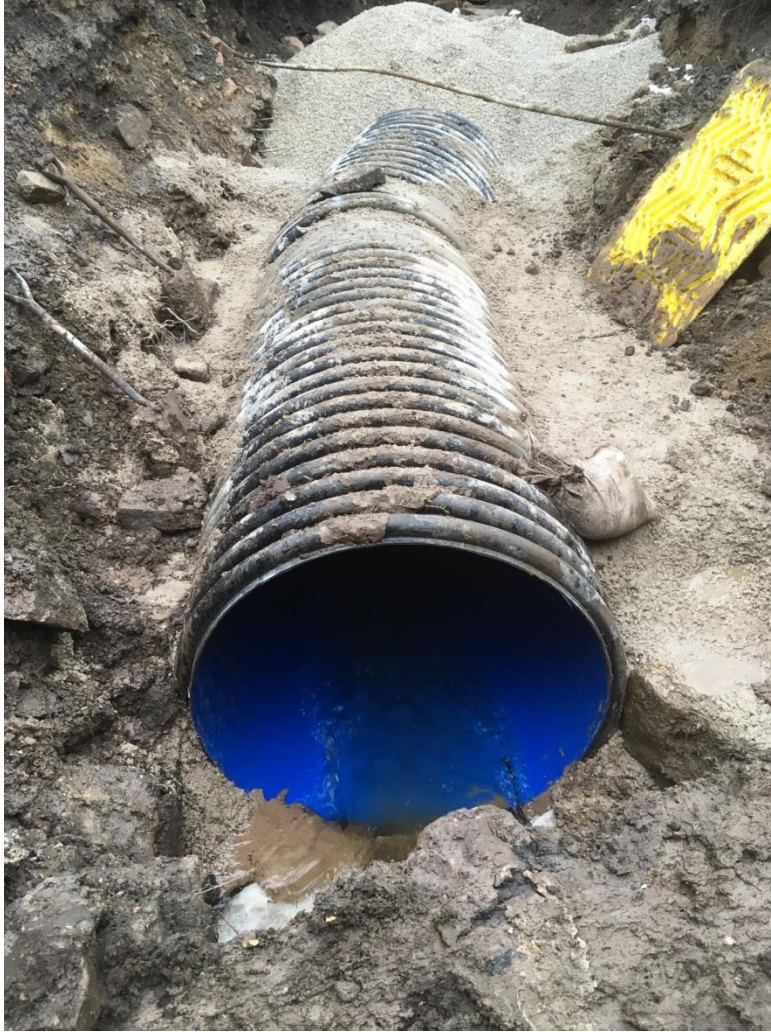
New HDPE Culvert during construction

Tameside MBC Engineers undertook excavations (approximately two metres deep) on a suspected blockage adjacent to 29 Micklehurst Road. Once exposed, it provided evidence of a full collapse. Debris found included various items such as tyres, bricks, garden accessories and a pallet. At the point of collapse, the culvert had a deviation in the line which contributed to constraints of the culvert putting hydraulic pressure on the structural walls.

Whilst rectifying the issues found at number 29, a further problem became apparent at the rear of number 33 - surcharging of water and a further collapse. The damage extended to over three metres in length. It was deemed un-repairable and new construction was required to restore the integrity of water flow.

Restoration of the culvert to the rear of number 33 consisted of removal of debris and the old culvert and installing a new 1,200mm diameter pipe High Density Polyethylene (HDPE) twin wall culvert, approximately nine metres in length. Two new 1,800mm diameter access chambers were also installed.

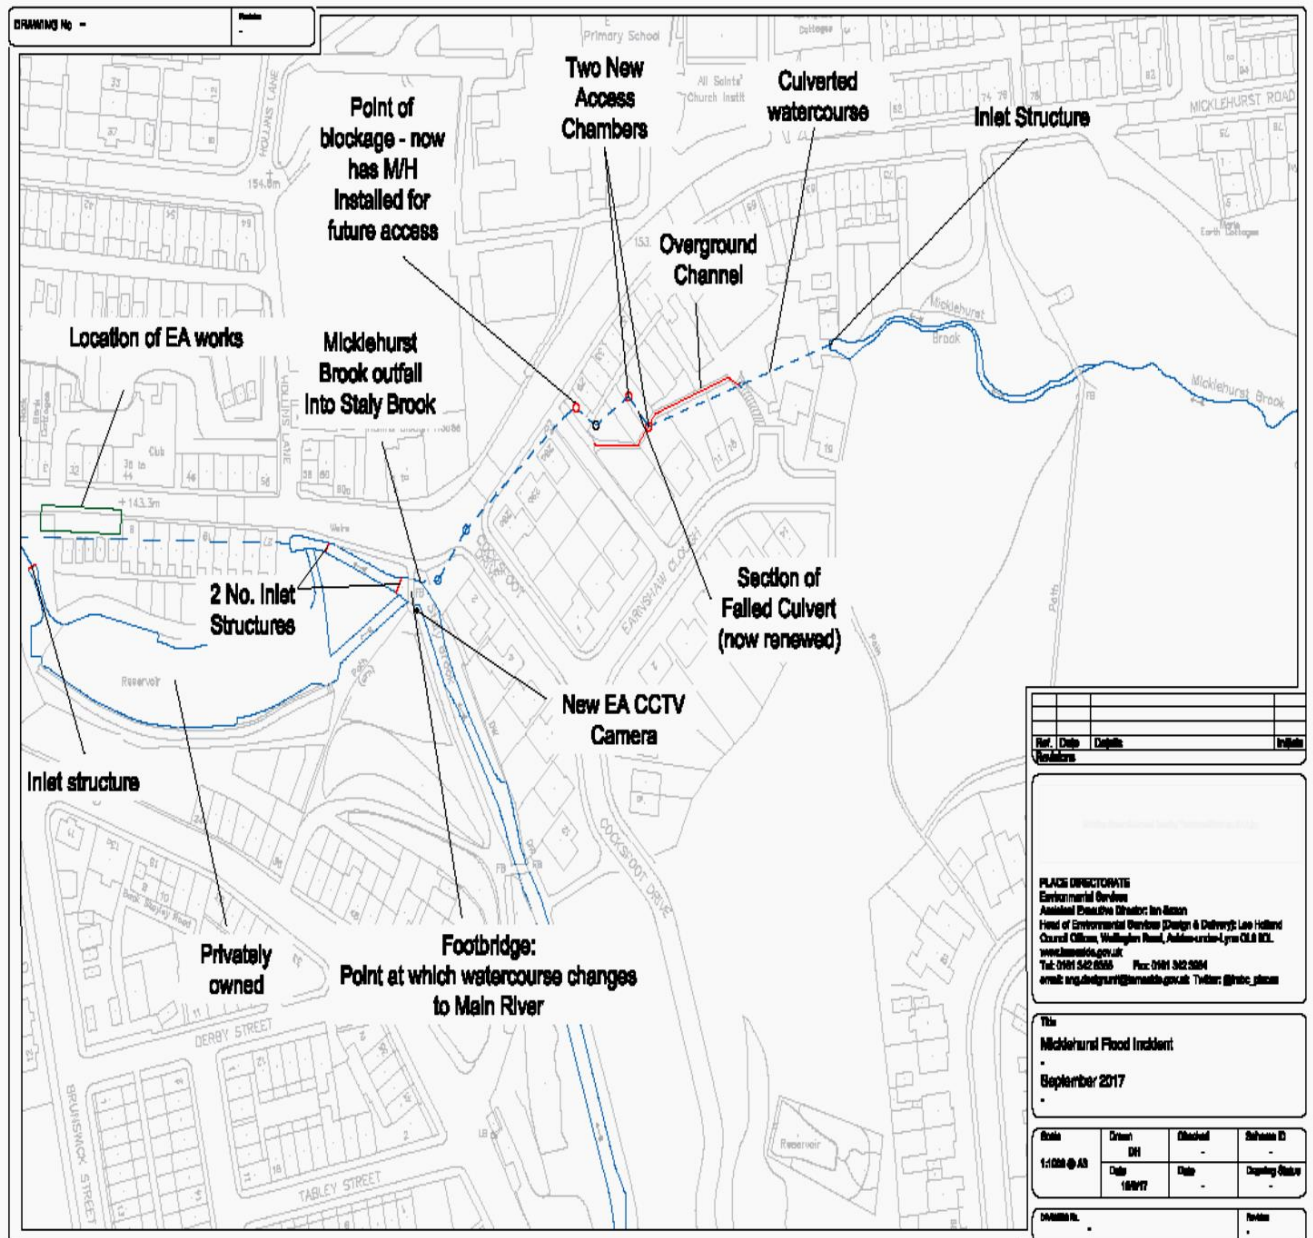
Plan 2 – Detail of Features at Micklehurst Road, Mossley

During these works, re-profiling of an over ground channel was undertaken. This channel directs any surcharge flows in the area between the rear gardens of properties on Micklehurst Road and Earnshaw Clough. This flow is returned to the culvert at the rear of number 33 Micklehurst Road – see plan below;
