CAT BACKGROUND AND PROCESS

The Council has recently conducted a condition survey of the property which has identified £136,023 of repair works. The full condition survey is found in Appendix 3.

STRUCTURAL INSPECTION REPORT
HOLLINGWORTH COMMUNITY CENTRE
5.5.26

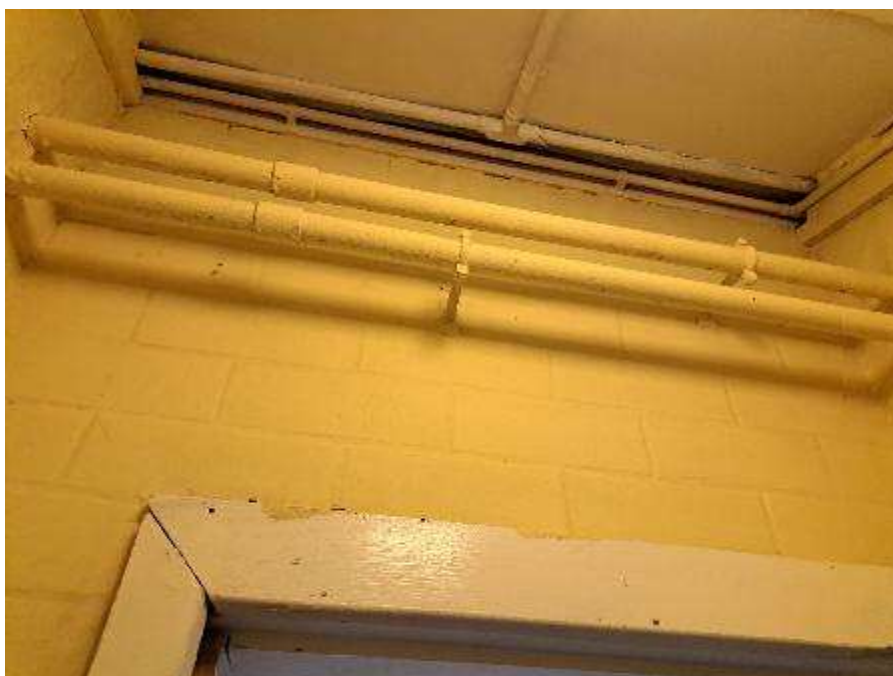
9. Damaged architrave

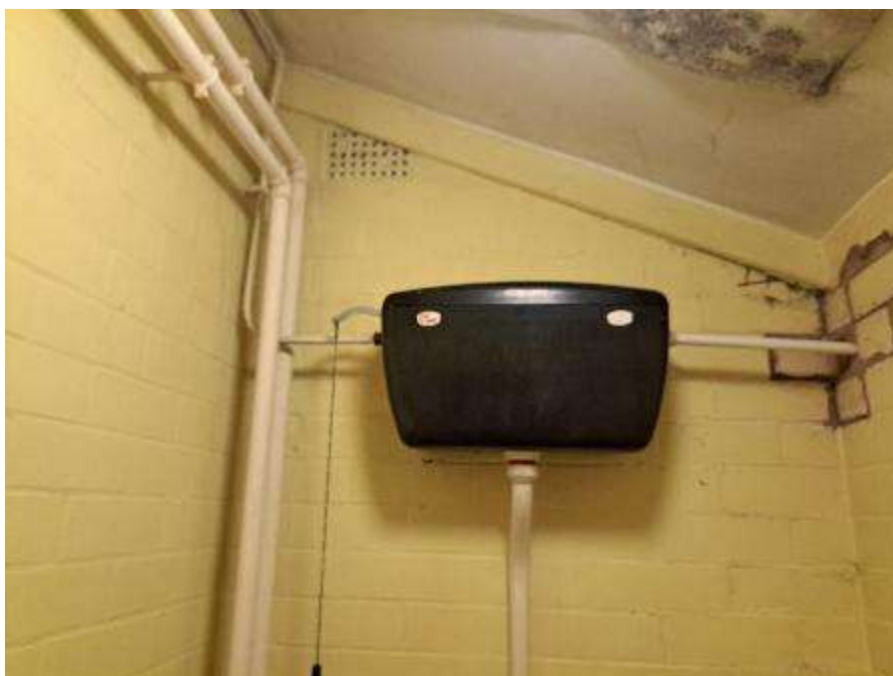
19. Damaged decoration to the WC and aged WC unit

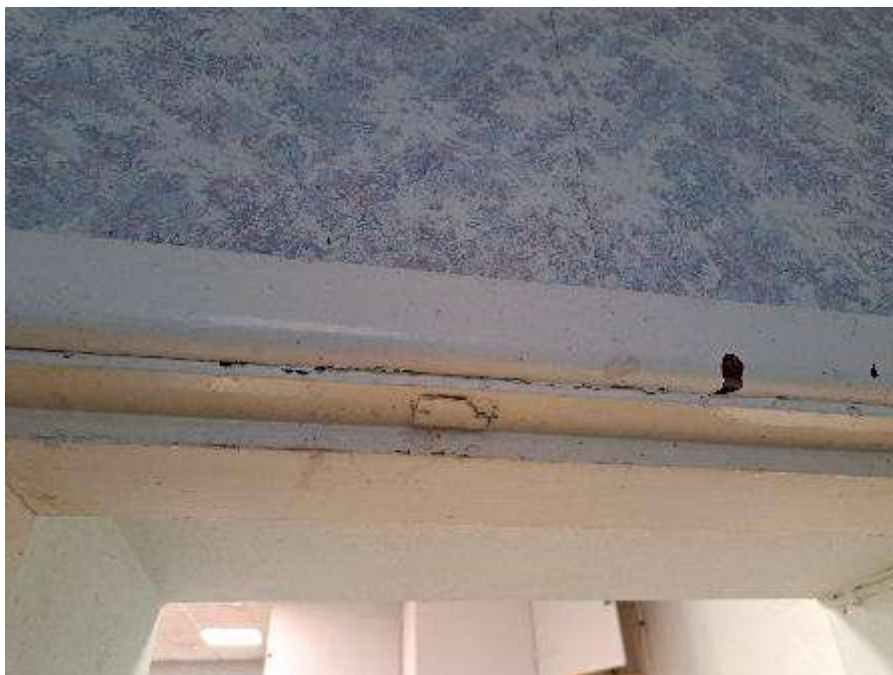
36. Damaged timber door

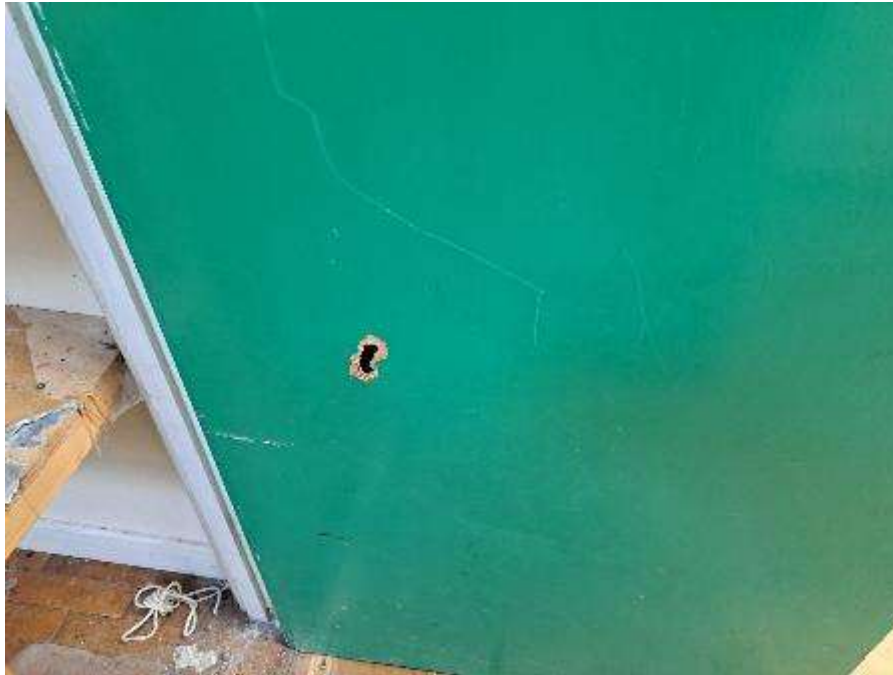
42. Damaged wall due to fixings

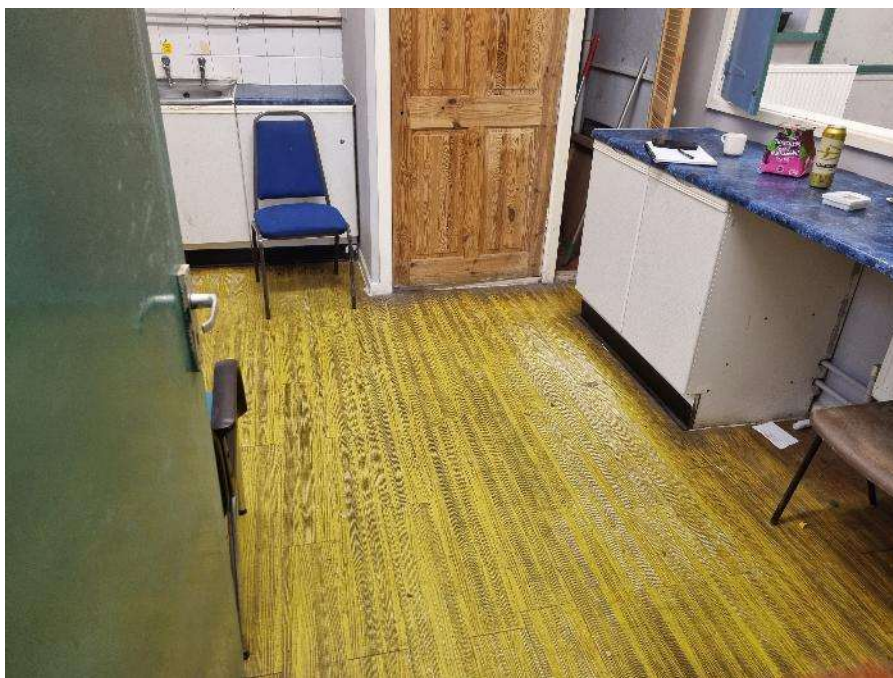
45. View of damaged floor

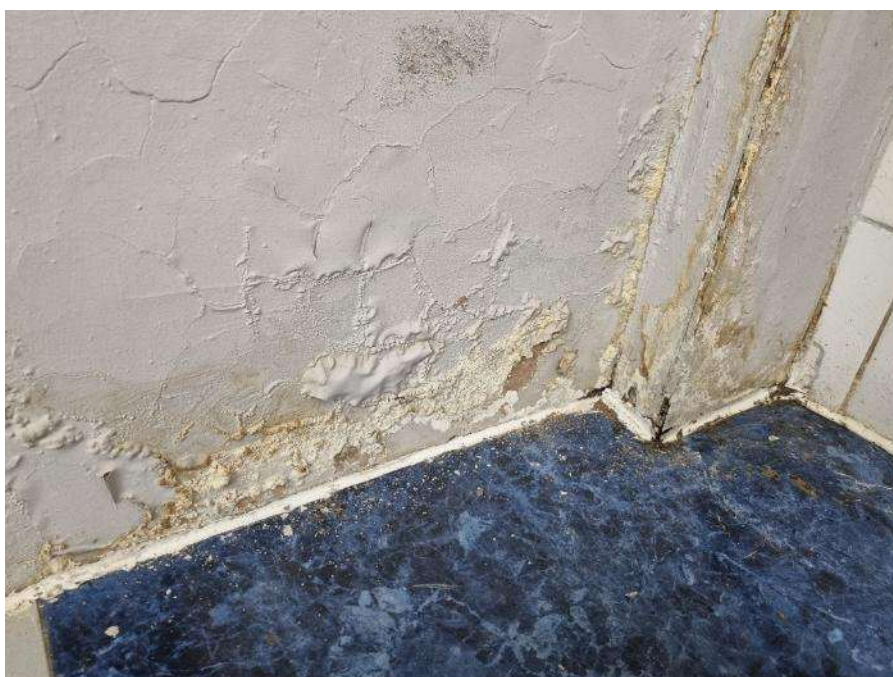
49. Cracking and damp noted to the walls

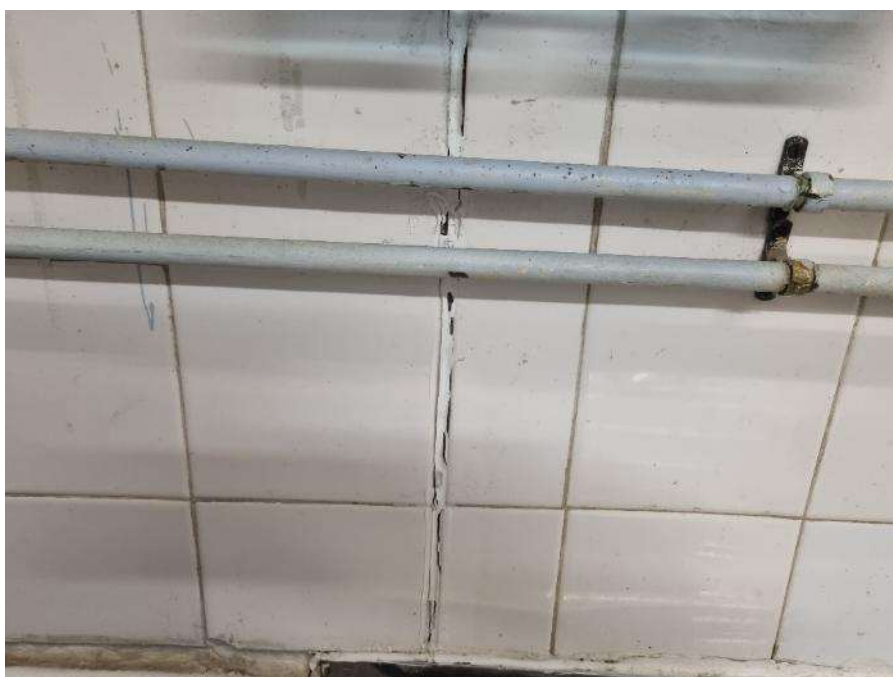
51. Cracking noted to the walls

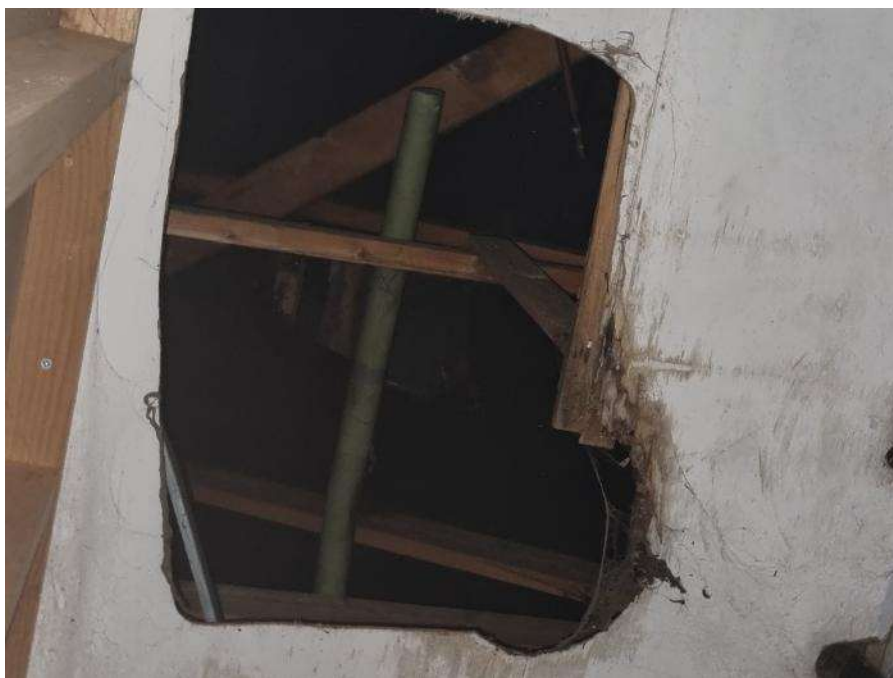
55. Poor condition of the ceiling

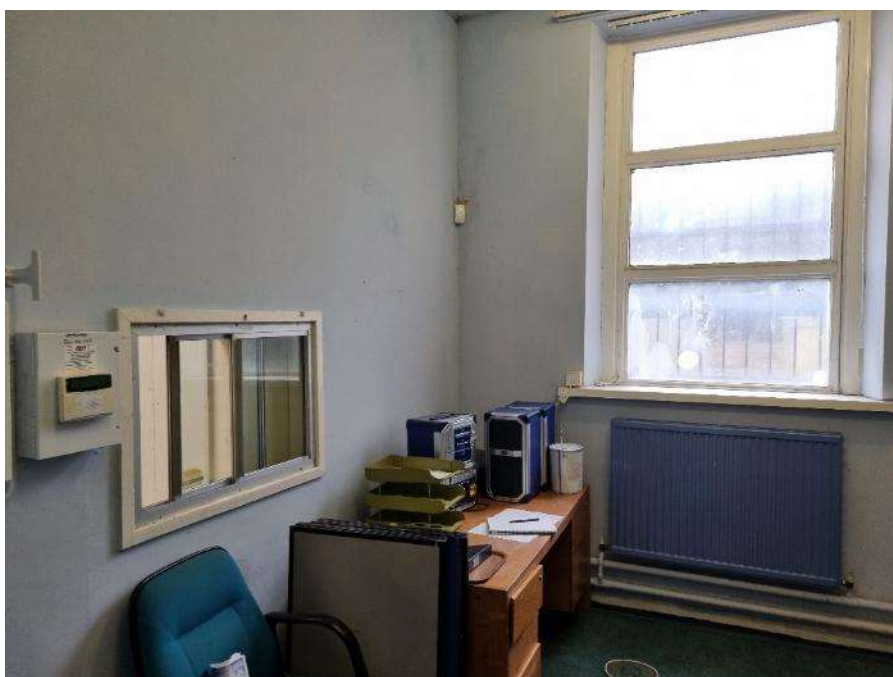
57. Carpet is in poor condition to the office.

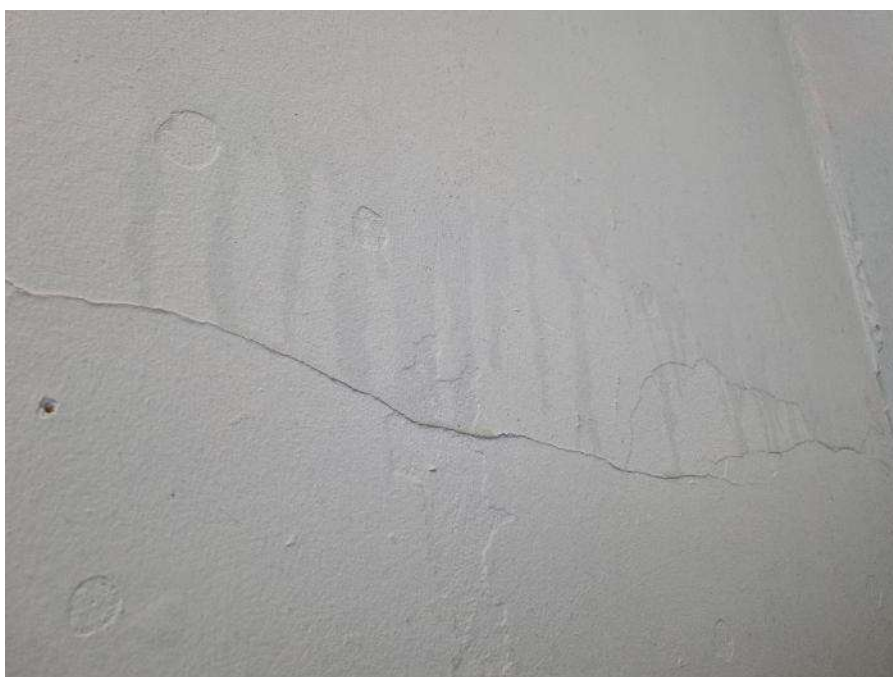
59. Ceiling is in poor condition

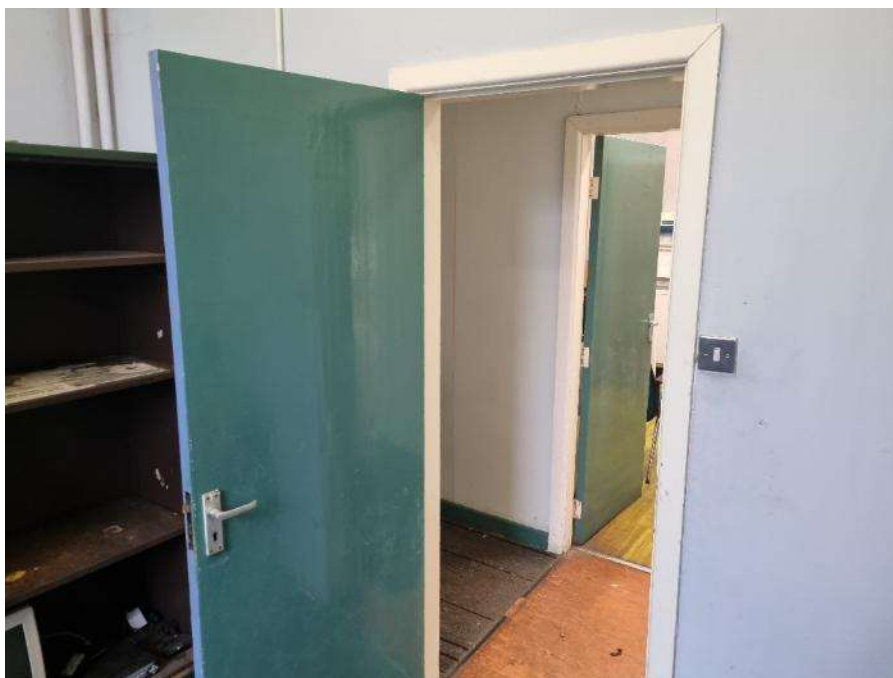
25.	Evidence of structural movement was observed to the north-facing gable elevation. The external stone wall was bowing towards the roof line. There was also stepped cracking throughout the property which would require further investigation.	Allow for a full structural survey to be carried out.	H

61. Cracking has been noted due to movement in the gable wall

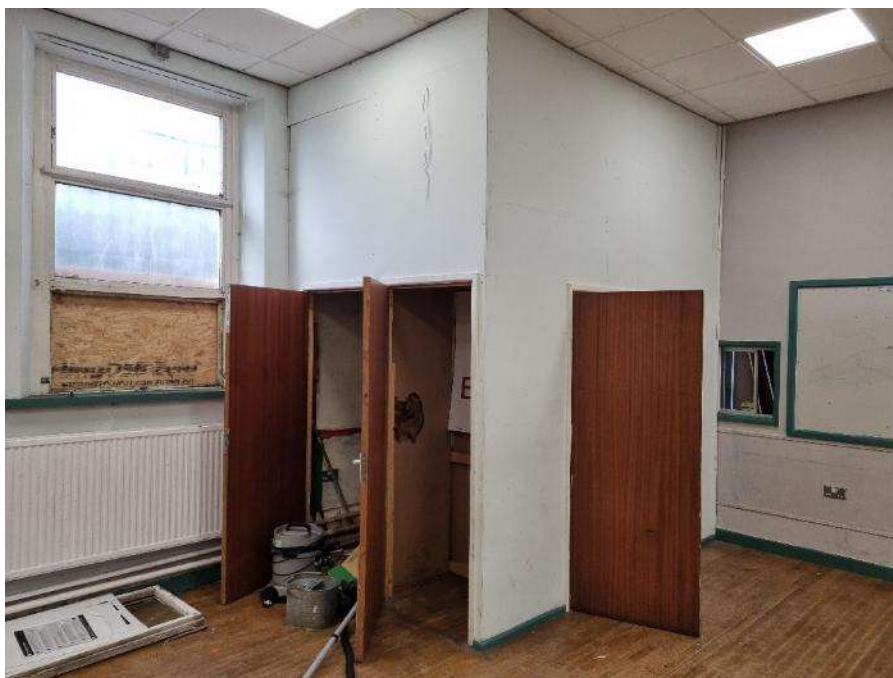
63. Window is in poor condition

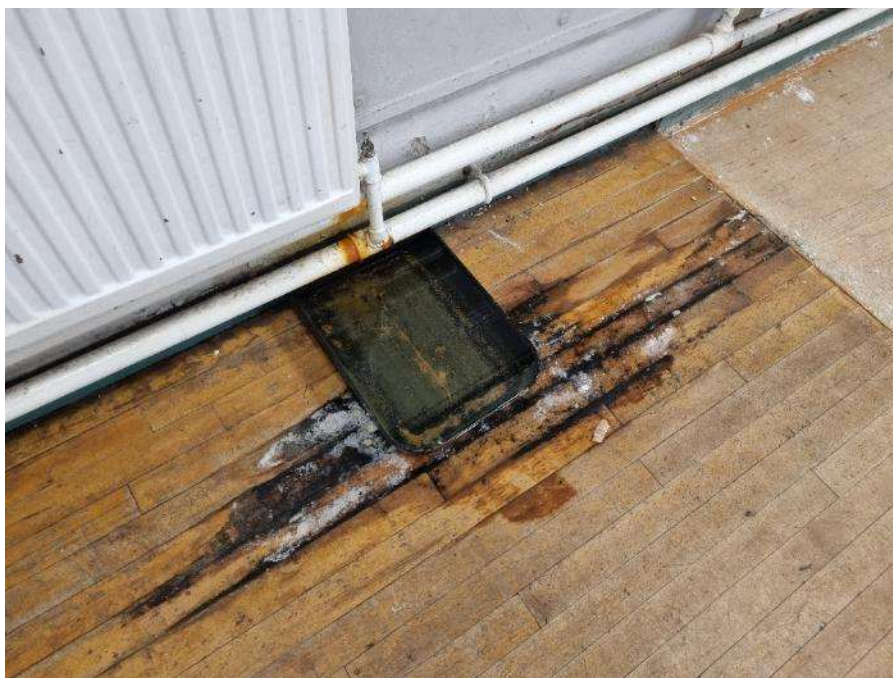
23.	The timber floor in the hall was soft underfoot and had warped due to assumed moisture; it was at risk of failure in sections. There were also signs of mycelium present through the main hall and adjacent rooms. Half of the hall has been previously replaced but still in poor condition.	Allow for a timber specialist to conduct an intrusive survey to confirm the presence of dry rot and any recommendations on remedial works.	H

75. Floor is in poor condition, soft underfoot and signs of mycelium

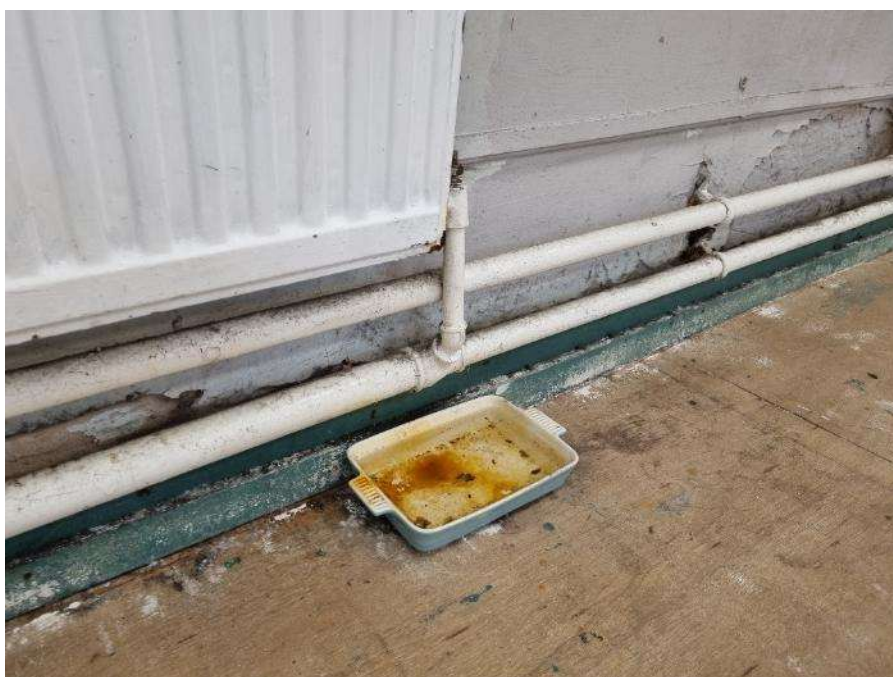
77. Floor is in poor condition due to pipe leaking below the radiator

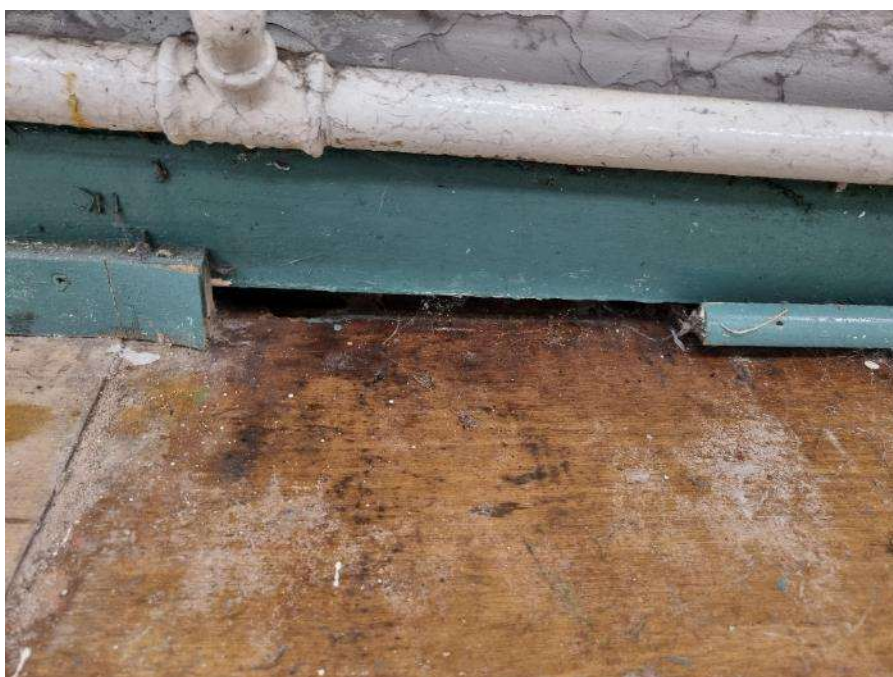
79. View of the defective plaster behind the radiator

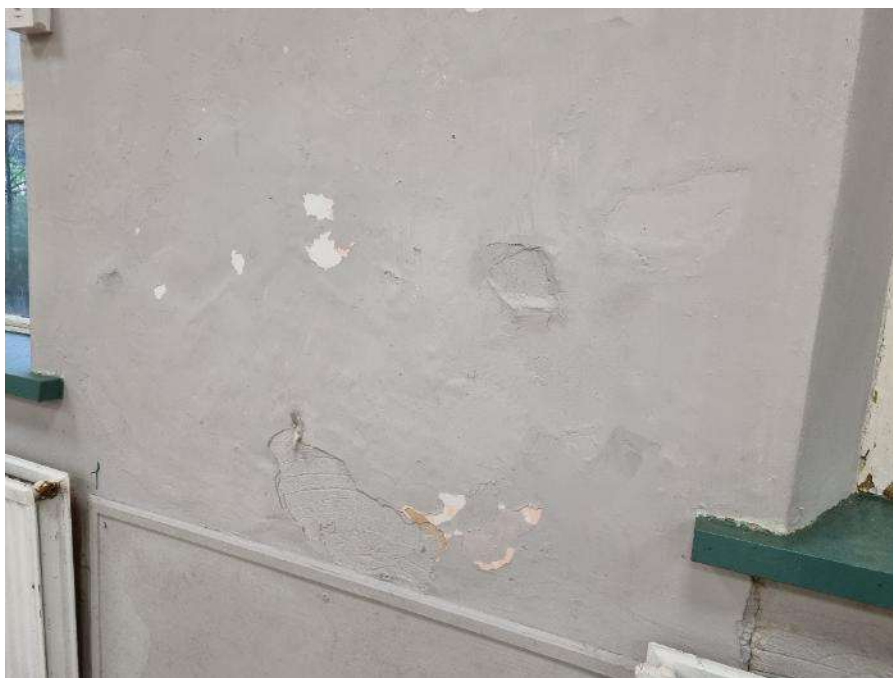
81. Defective plaster noted to below the window

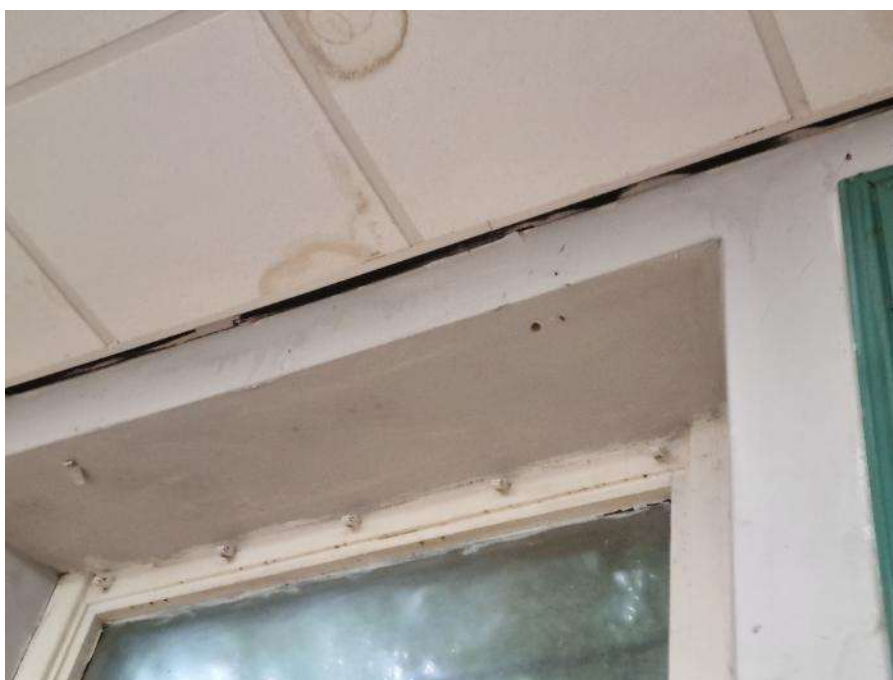
89. Sign of cracking noted to the wall

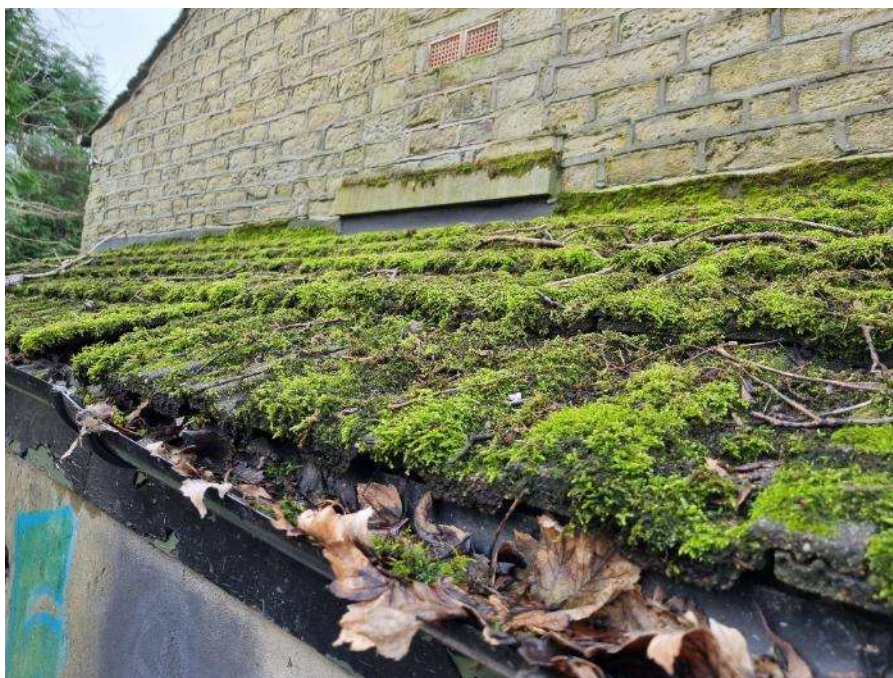
93. View of damaged roof

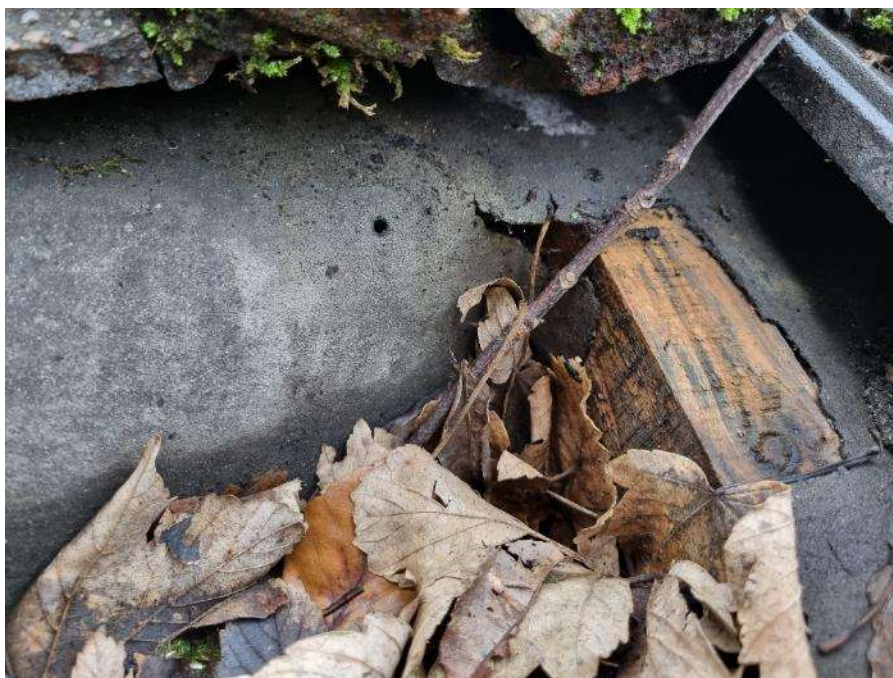
95. View of damaged roof

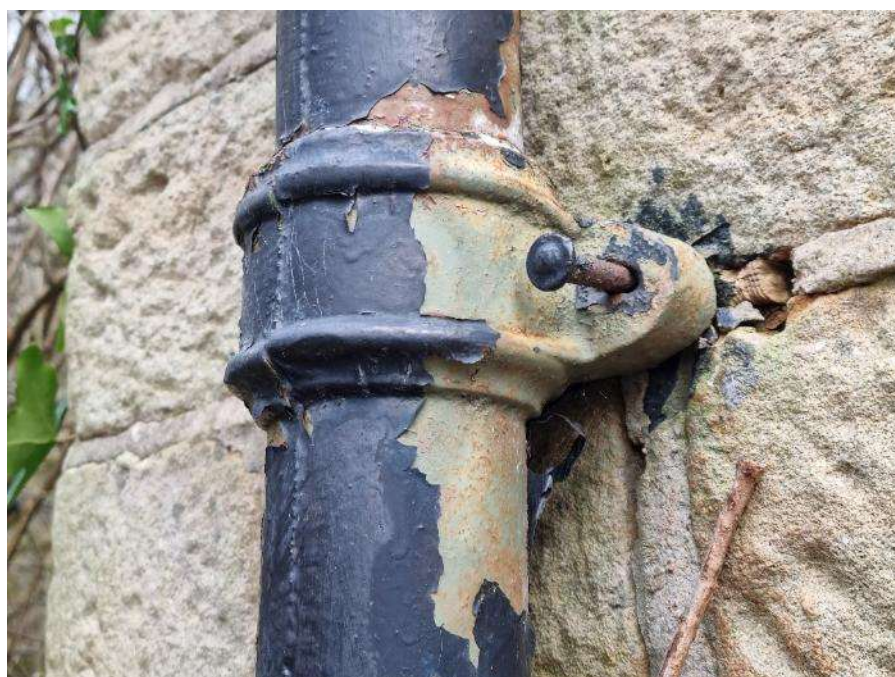
2.	The rainwater goods are in poor condition with defective sections and missing downpipes.	Allow for removal and replacement of all rainwater goods across the property.

3.	Timber fascias are in a poor and rotting condition throughout, owed to a lack of periodic maintenance. Isolated areas of damage are also vulnerable to ingress.	Allow to replace all timber fascias with new to match existing.

99. Poor condition of fascia's and rainwater

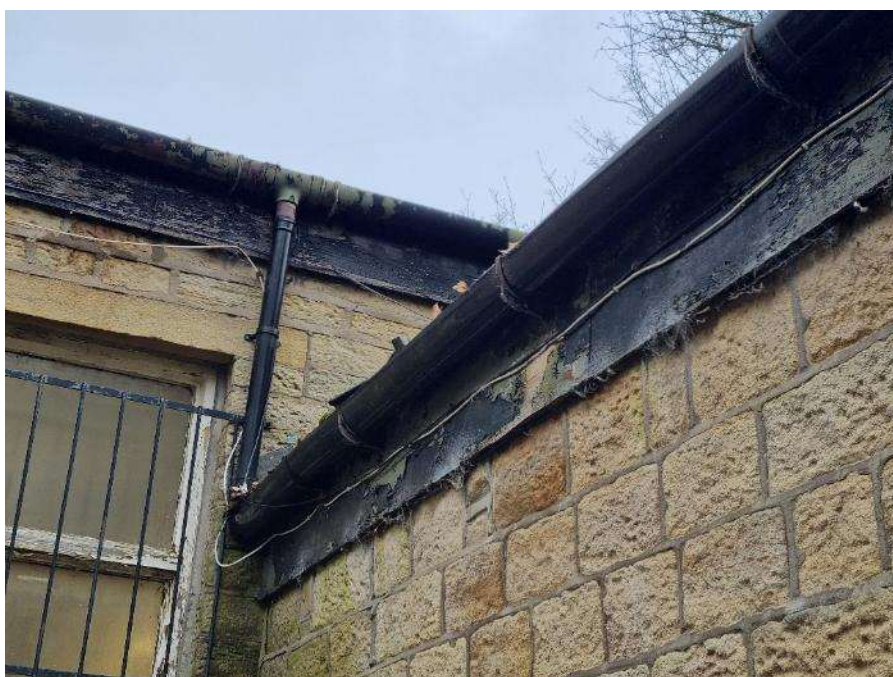
101. Fascias and guttering is in poor condition

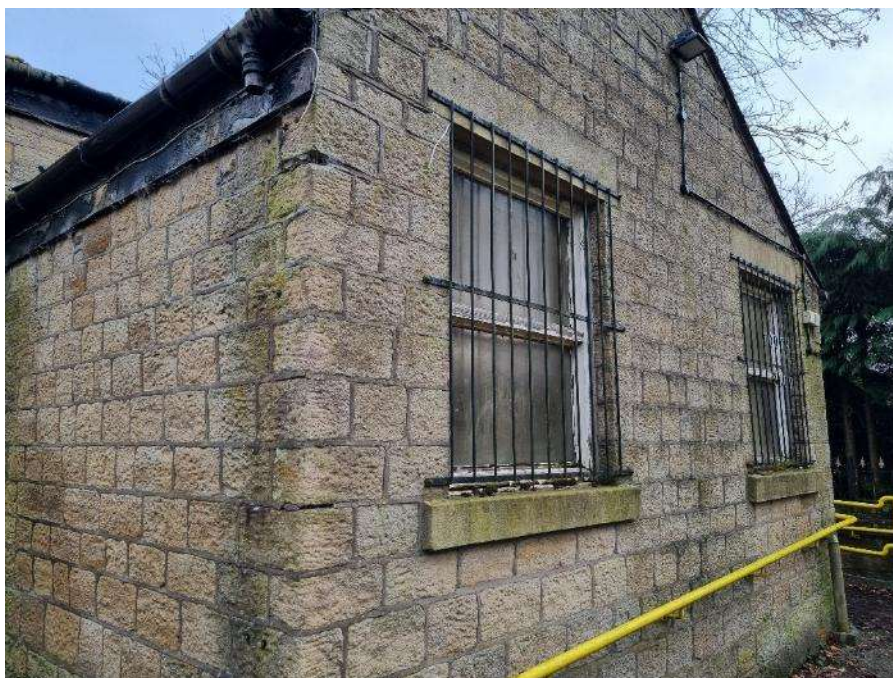
103. Fascias and guttering is in poor condition

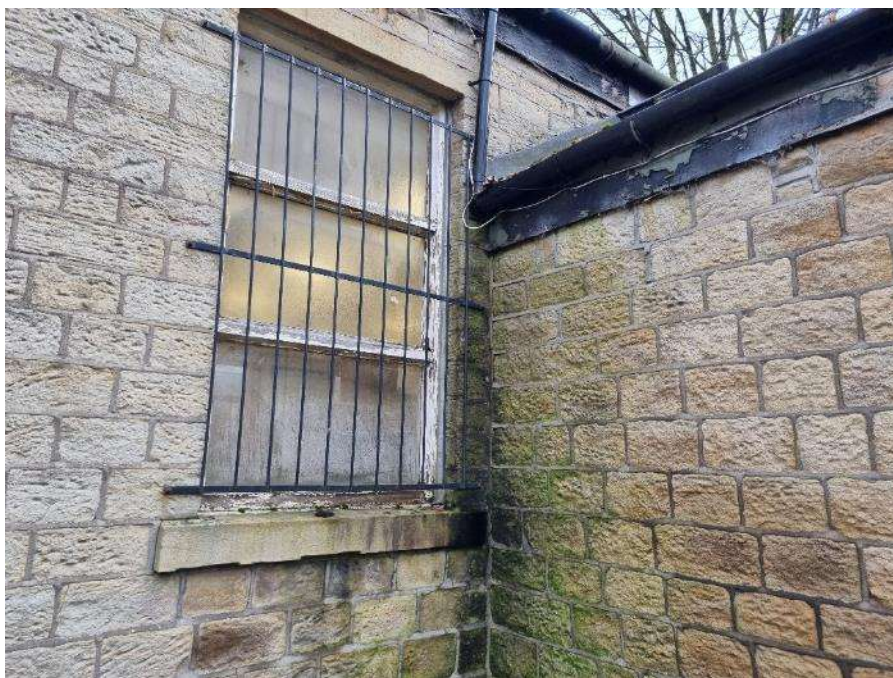
105. Missing downpipe and poor pointing.

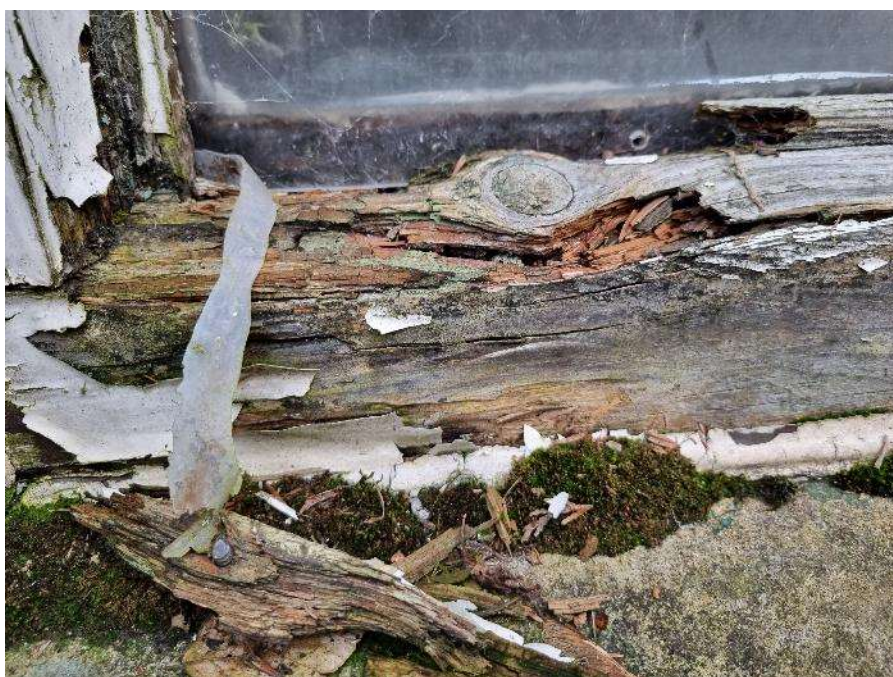
109. Window is in poor condition

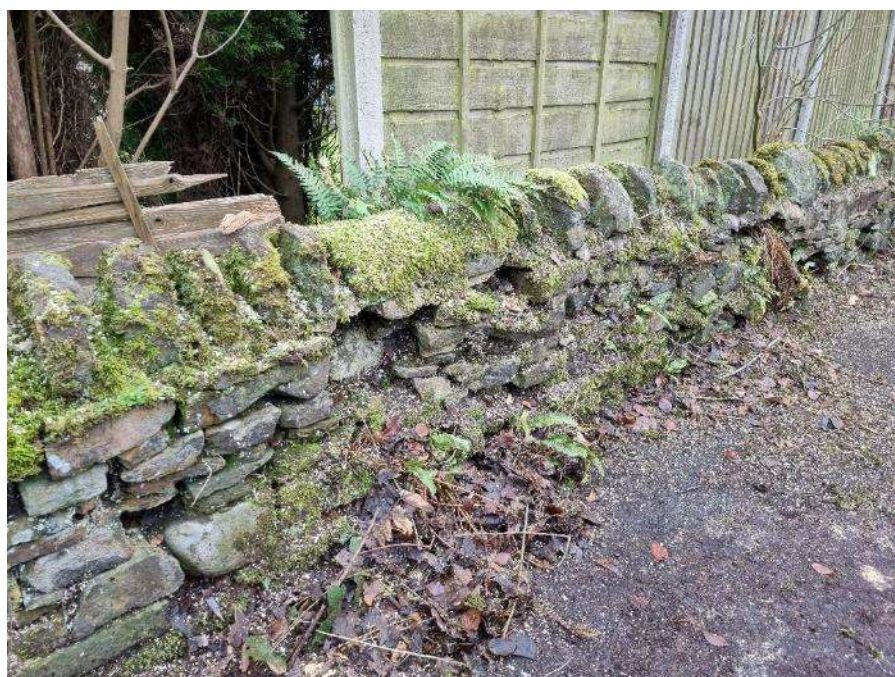
14.	Retaining walls at the external areas of the property are defective with missing stone and friable pointing.	Allow for isolated replacement of defective stone and pointing.	H

115. Boundary Wall is in poor condition

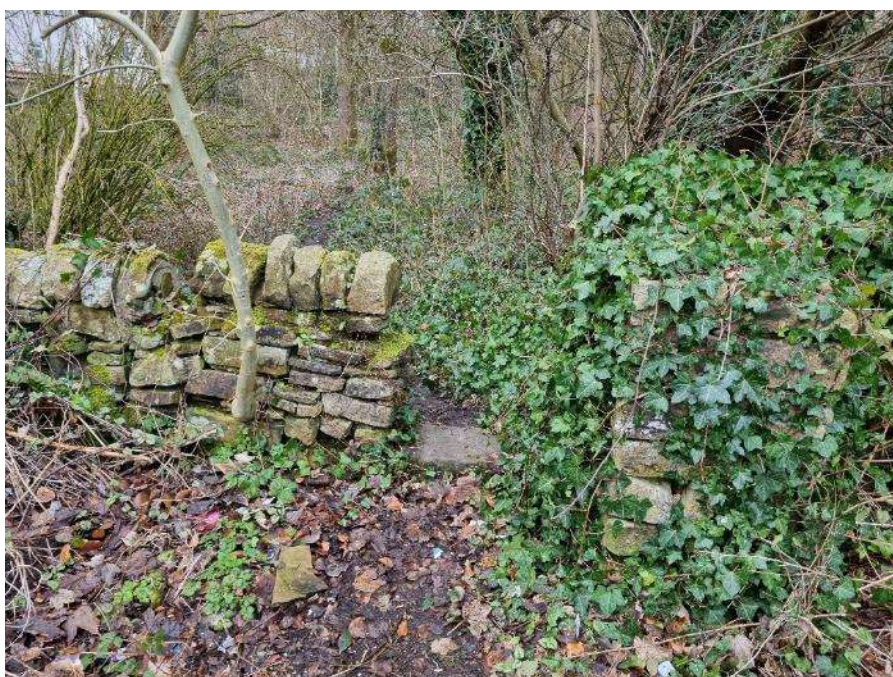
117. Boundary Wall is in poor condition

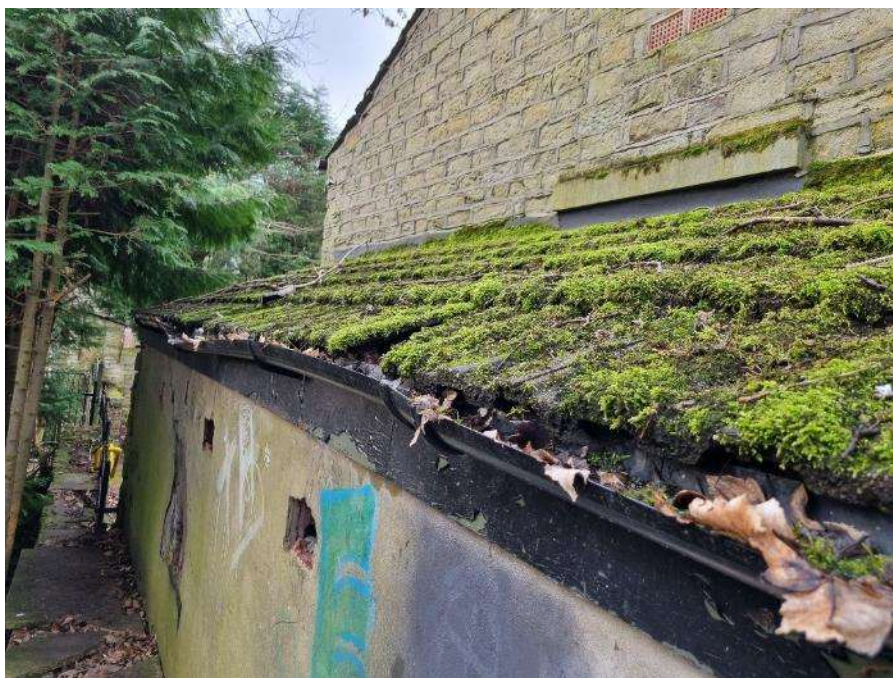
119. View of the south elevation

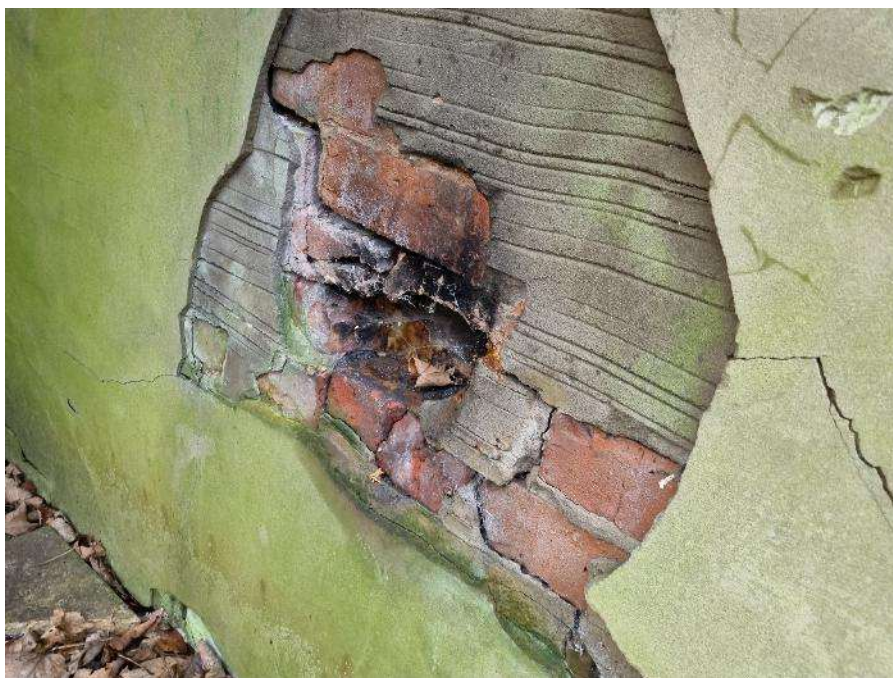
123. Holes within the render

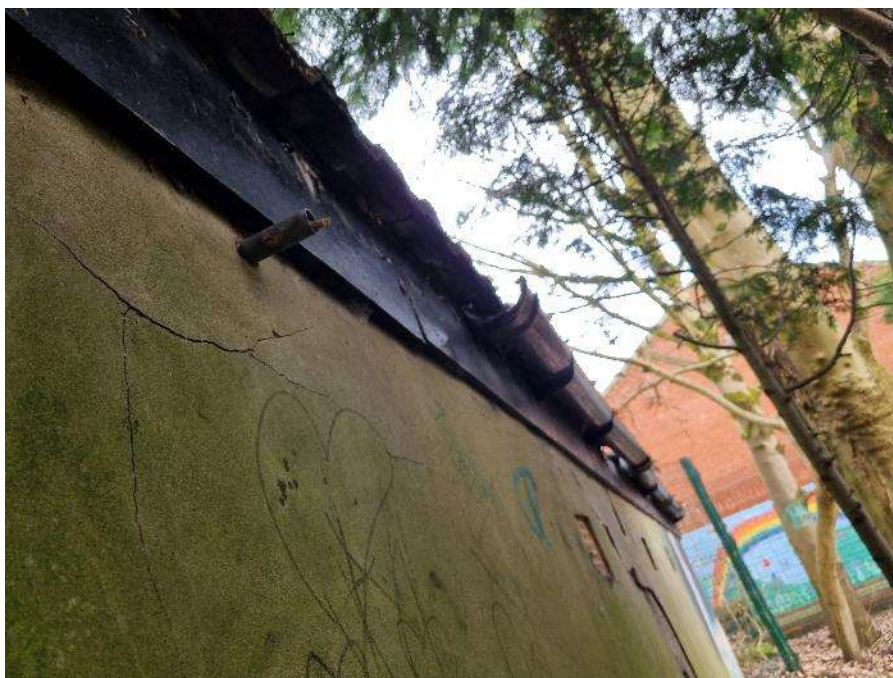
125. Damage to the render
