Hyde and Shepley

River Flood Defence Inspection

Final September 2010

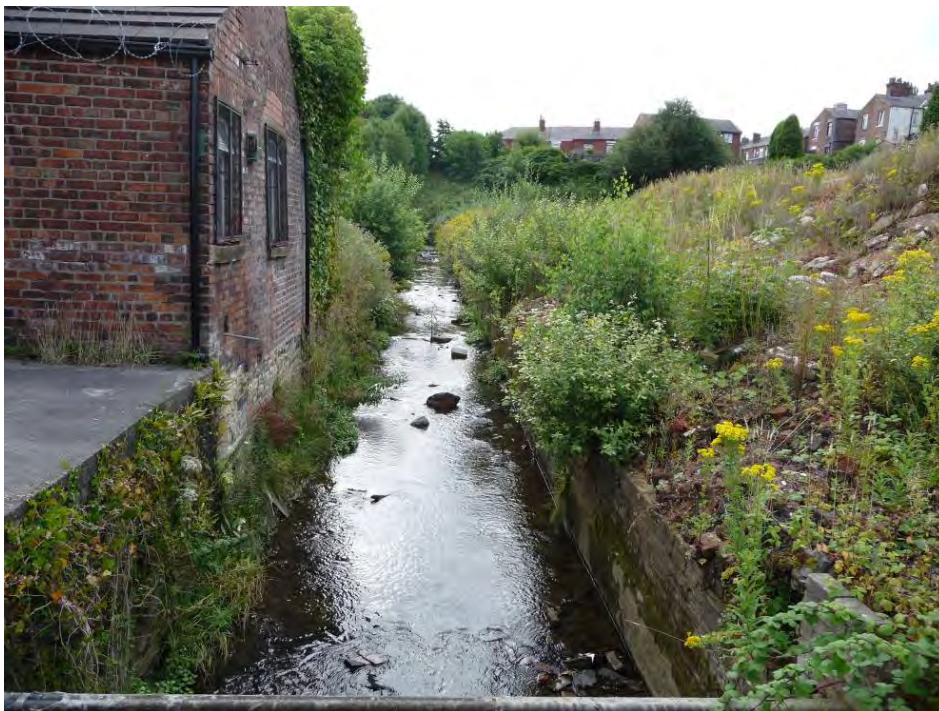
Chainage	Classification	Notes	Plate Number
Right Channel			
0 - 210	Masonry lined channel	Masonry / concrete vertical channel, approx 1.5m high x 3m wide. There are two vehicle access bridges crossing the channel, these reduce headroom to approx 1m.	2 - 7
Left Channel			
0 - 210	Masonry lined channel	As right channel	2 - 7

Plate 2 – View upstream along Godley Brook on derelict land adjacent to Morrison's

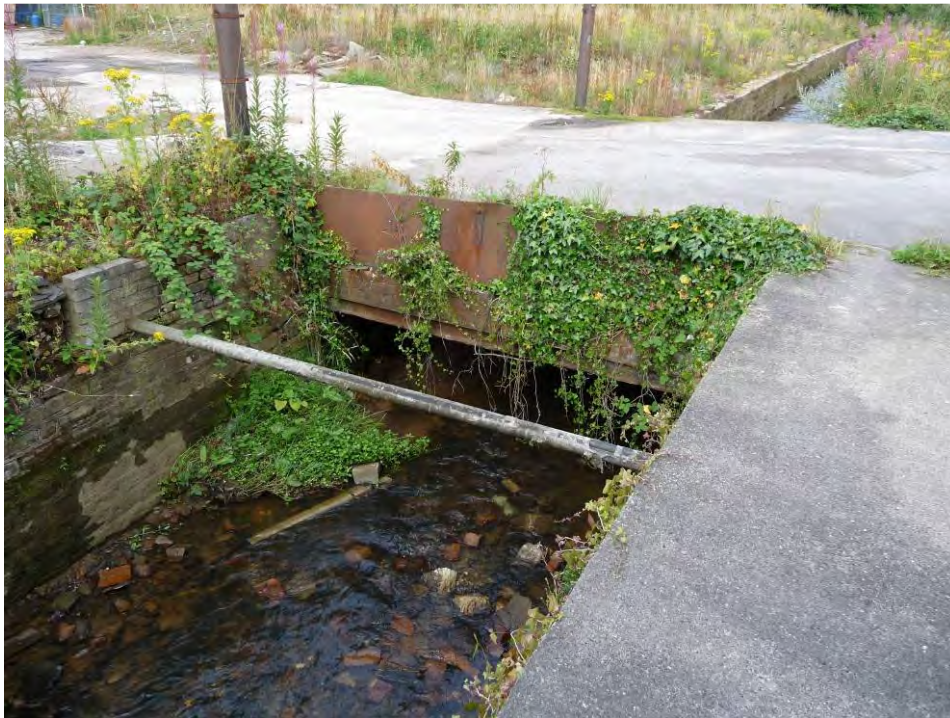
Plate 3 – Typical vehicle bridge over Godley Brook on derelict land

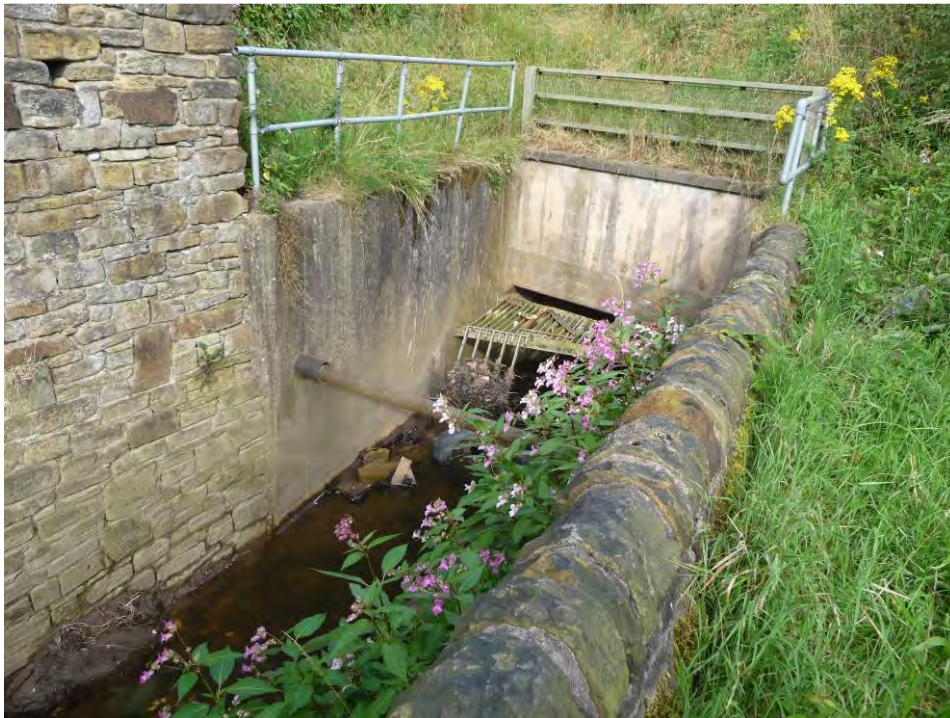
Plate 7 – Culvert inlet taking Godley Brook under M67

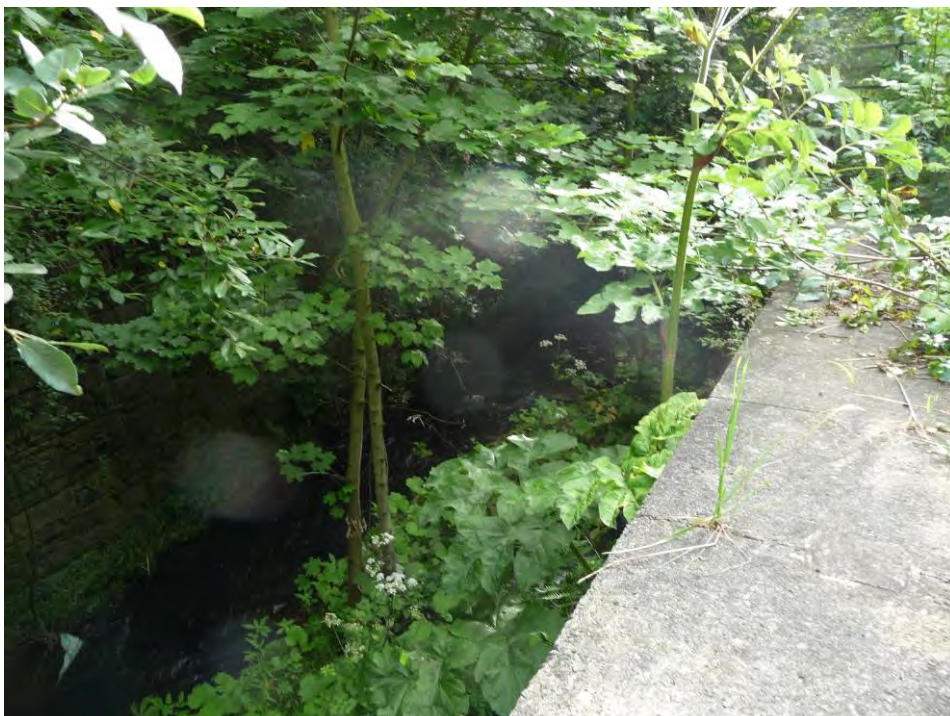
Chainage	Classification	Notes	Plate Number
Right Channel			
270 - 335	Masonry lined channel	Stone lined vertical channel, approx 1.5m high by 3m wide. Stone in good condition, no signs of instability.	14

Left Channel			
270 - 335	Masonry lined channel	As right channel	14

Plate 14 – View upstream of Godley Brook towards M67 culvert outlet

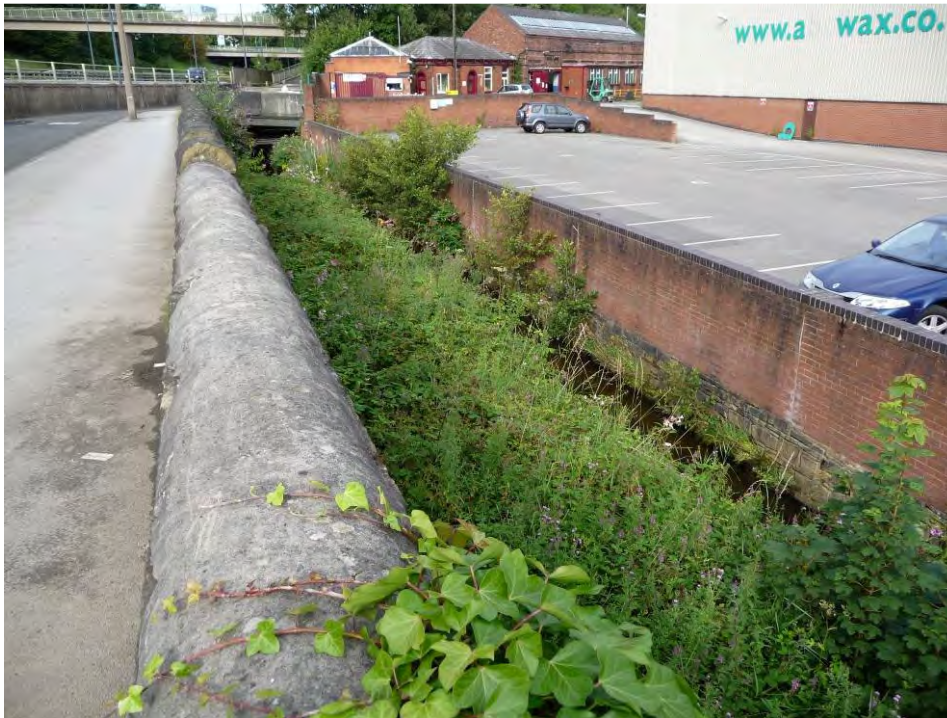
Chainage	Classification	Notes	Plate Number
Right Channel			
0 - 275	Raised defence	Combination of stone walling and brick walling approximately 1m high. Brick walling adjacent to factory at lower level than adjacent road and has drainage holes from the car park.	15 - 16
275 - 600	Masonry lined channel	Masonry lined channel, approx 1.5m deep by 4m wide, no close inspection due to lack of access Buildings form channel for part of length	
Left Channel			
0 - 100	Masonry lined channel	Stone vertical channel in good condition at base of M67 embankment, ties into stone channel from Godley Brook.	15
100 - 270	Raised defence	Stone walling along back of footpath tying into two bridges across Wilson Brook. Approximately 1m high, good condition with minimal vegetation and no signs of instability.	15 - 16
270 - 515	Natural channel (heavily vegetated)	Bank covered with trees and bushes. No sign of instability due to erosion at base of bank or oversteep banks	17

Plate 15 – View downstream adjacent to industrial estate

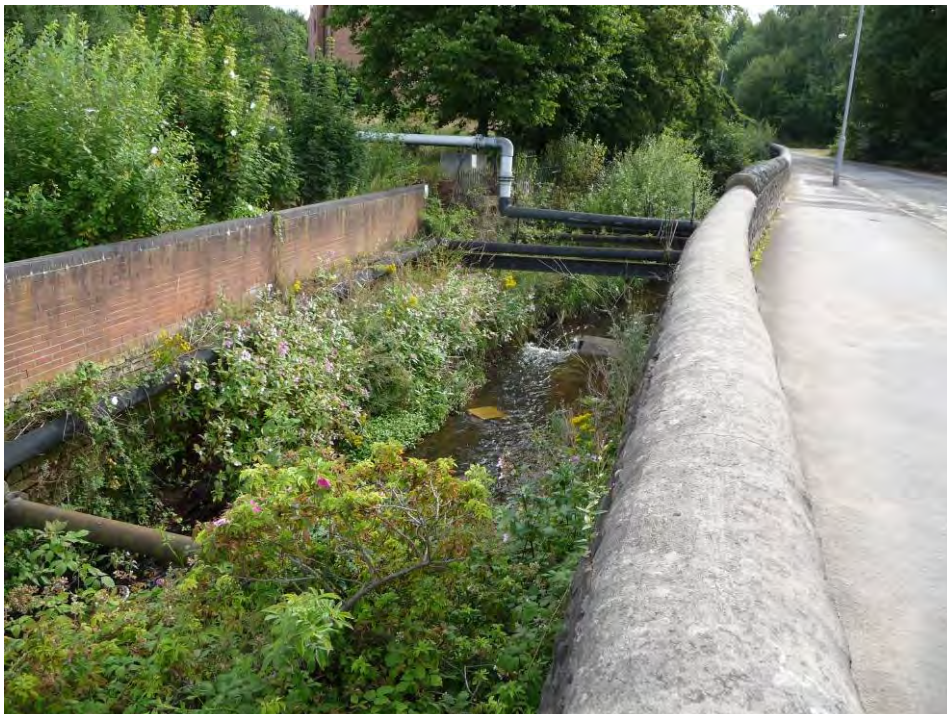
Plate 16 – View upstream adjacent to industrial estate

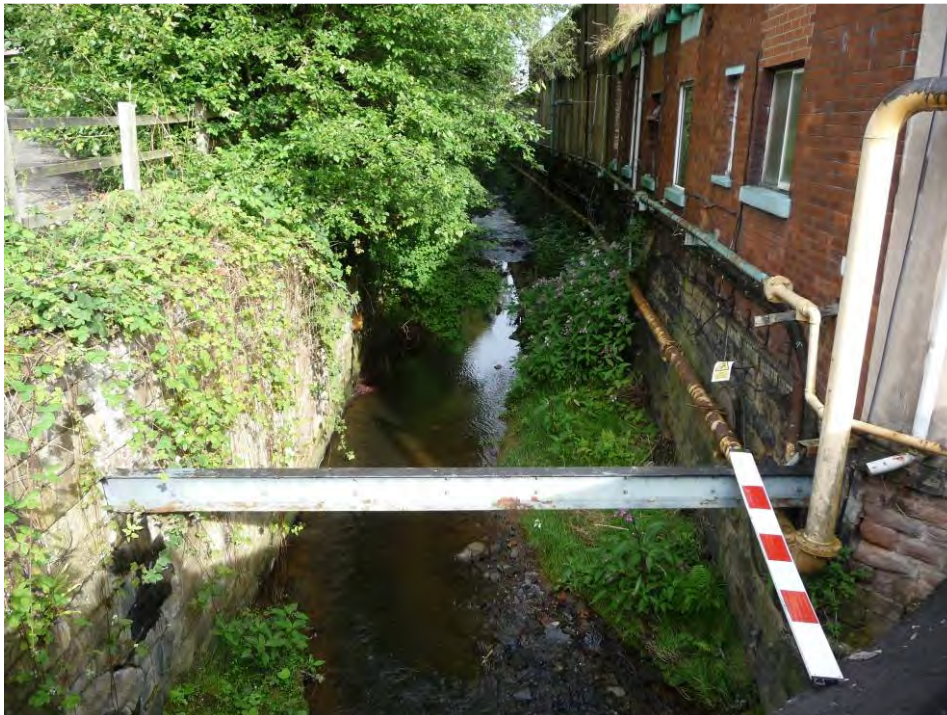
515 - 600	Masonry lined channel	Masonry lined channel, approx 1.5m deep by 4m wide, no close inspection due to lack of access	17
-----------	-----------------------	---	----

Plate 17 – View downstream along Wilson Brook from road bridge into Industrial estate

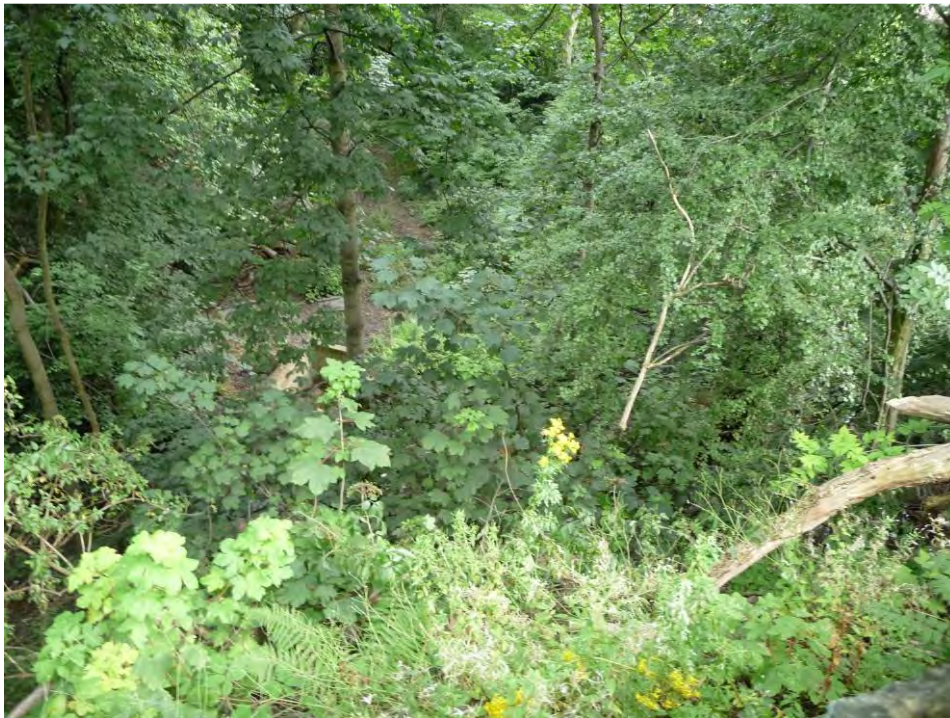
Chainage	Classification	Notes	Plate Number
Right Channel			
930 - 1015	Natural channel (heavily vegetated)	Deep natural channel, greater than 5m deep, with dense covering of trees. No signs of erosion or bank instability where view of bank possible	21
Left Channel			
930 - 1015	Natural channel (heavily vegetated)	As right channel	21

Plate 21 – View from Dukinfield Road of Wilson Brook on exit from culvert under Newton Street

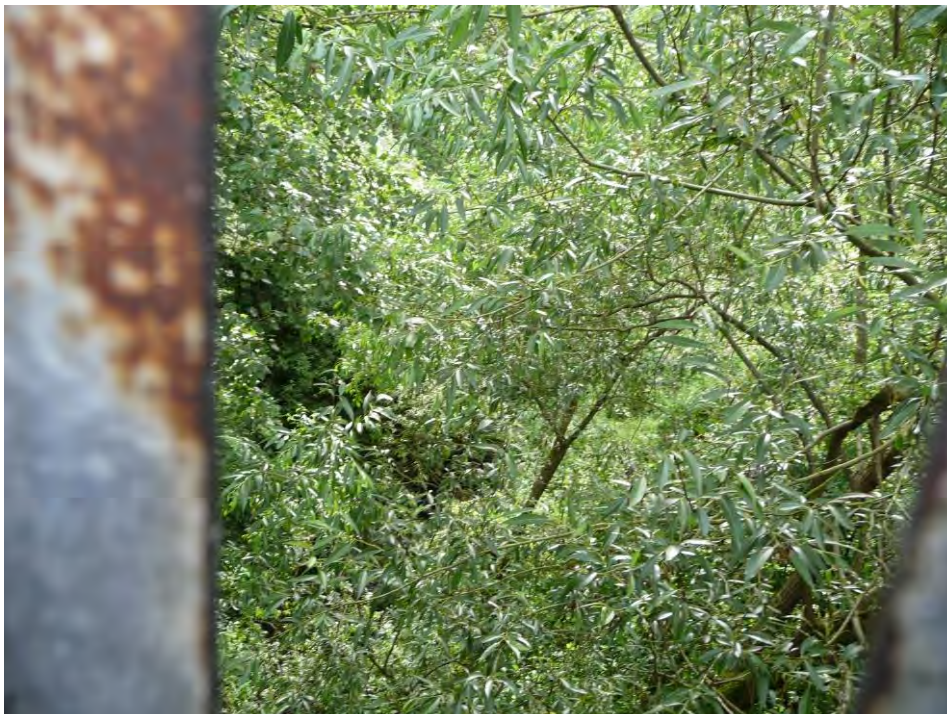
1225 - 1340	Natural channel (heavily vegetated)	Due to lack of access, this section was only inspected from Wellington Street. Deep natural channel, approximately 4 – 5m deep, with dense covering of trees and bushes. No signs of erosion or bank instability where view of bank possible.	24
Left Channel			
1225 - 1340	Natural channel (heavily vegetated)	As right channel	24

Plate 24 – View upstream along Wilson Brook from Wellington Street

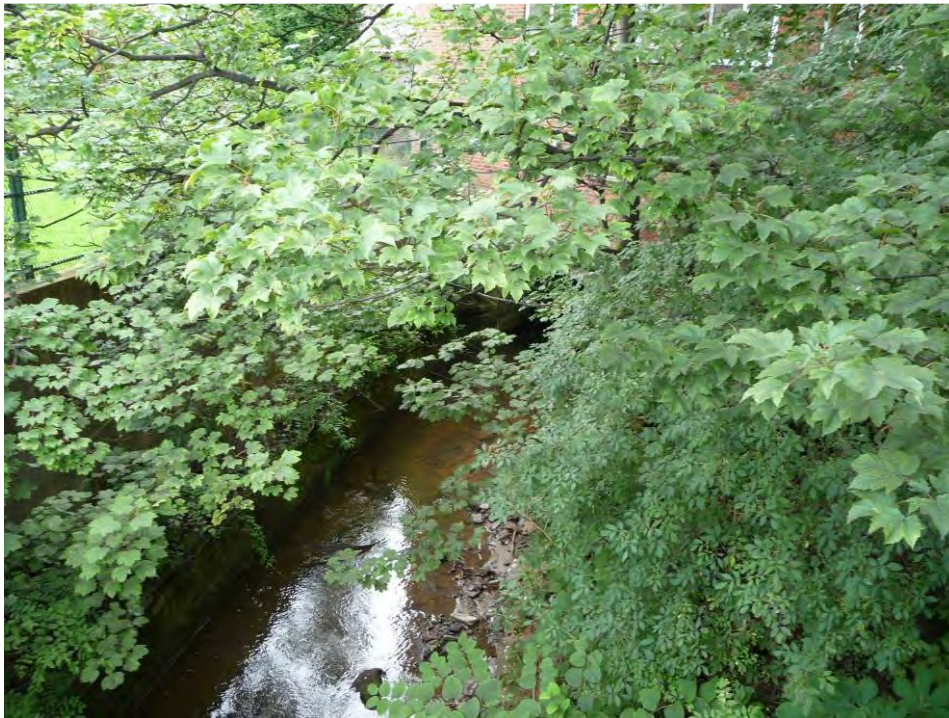
Chainage	Classification	Notes	Plate Number
Right Channel			
1535 - 1555	Masonry lined channel	Extremely short section of masonry lined channel between the exit of the culvert from Wellington Street and the culvert under Manchester Road. Bank level slightly below the surrounding road level. Vegetation growing in and at base of masonry, but no signs of instability.	29 - 30
Left Channel			
1535 - 1555	Masonry lined channel	Extremely short section of masonry lined channel between the exit of the culvert from Wellington Street and the culvert under Manchester Road. The back of footpath stone wall, approx 1.2m high, ties into bridge parapet at downstream end and building at upstream end. Vegetation growing in and at base of masonry, but no signs of instability.	29 - 30

Plate 29 – View upstream along Wilson Brook from Manchester Road

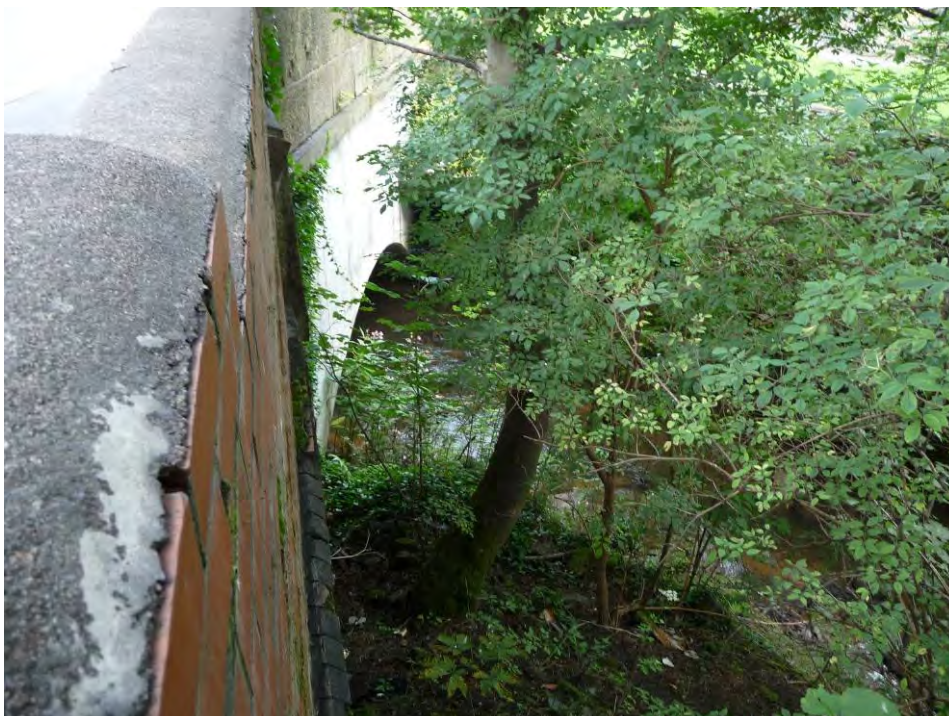
Plate 30 – View of upstream inlet of Wilson Brook under Manchester Road

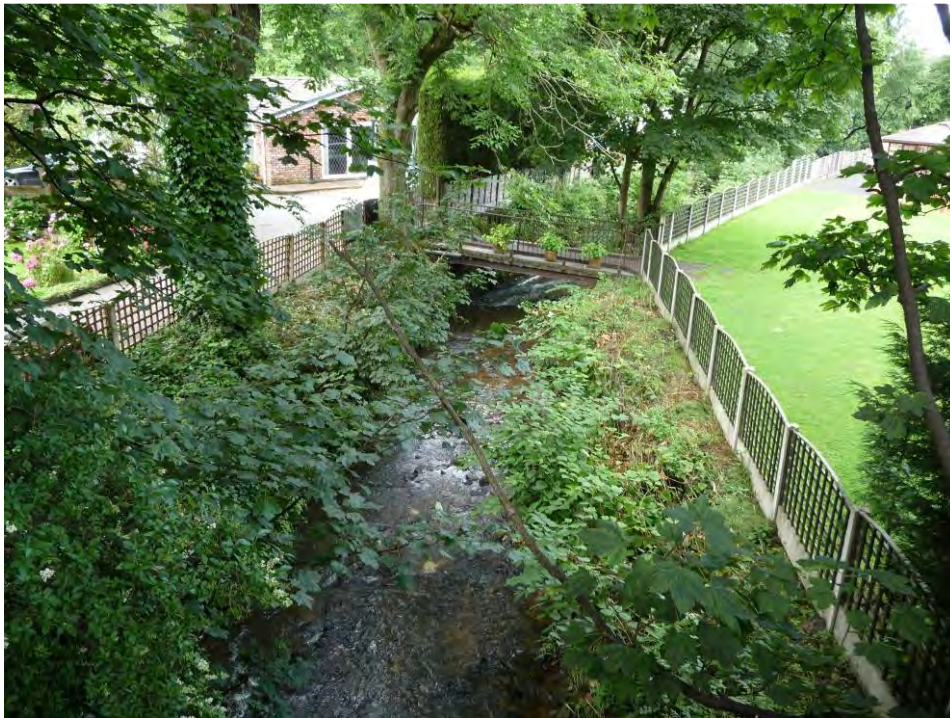
Chainage	Classification	Notes	Plate Number
Right Channel			
1575 - 1790	Natural channel (heavily vegetated)	Approx 3m wide with no raised defences, house gardens right up to bank crest	31 - 32
Left Channel			
1575 - 1790	Natural channel (heavily vegetated)	Approx 3m wide with no raised defences, house gardens right up to bank crest	31 - 32

Plate 31 – View downstream along Wilson Brook from Manchester Road

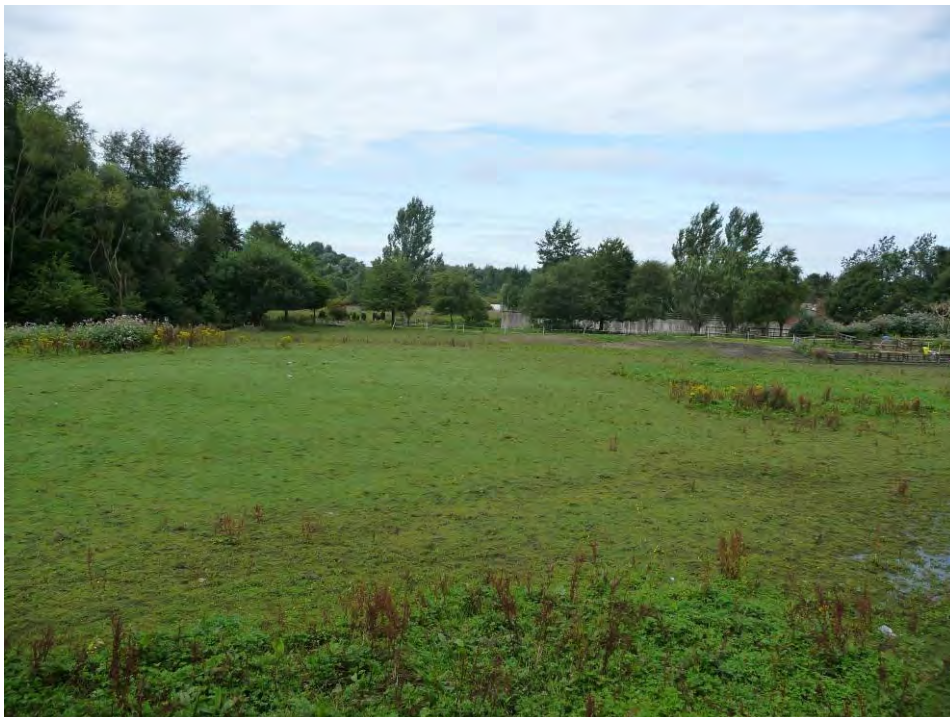
Chainage	Classification	Notes	Plate Number
Right Channel			
3645 - 3725	Natural channel (heavily vegetated)	Bank covered with trees and bushes. No sign of instability due to erosion at base of bank or oversteep banks	32
3725 - 4170	Natural channel (lightly vegetated)	Grass banks. No sign of instability due to erosion at base of bank or oversteep banks	34
4170 - 4500	Natural channel (heavily vegetated)	Bank covered with trees and bushes. No sign of instability due to erosion at base of bank or oversteep banks	27
Left Channel			
3645 - 3715	Natural channel (heavily vegetated)	Bank covered with trees and bushes. No sign of instability due to erosion at base of bank or oversteep banks	32

Plate 32 – View south along open fields on left bank of River Tame south of Manchester Road

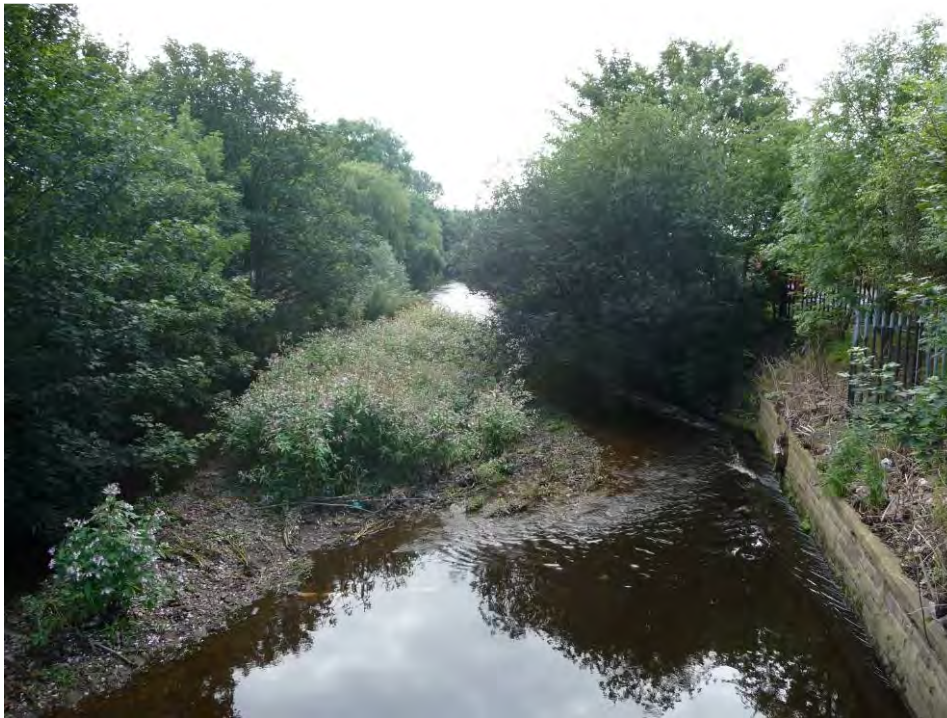
bank crest.	
660 - 1340	Natural channel (heavily vegetated)	Bank covered with trees and bushes. No sign of instability due to erosion at base of bank or oversteep banks	45
Left Channel			
625 - 680	Masonry lined channel)	Mixture of stone and brick vertical walling of varying height. Average condition, with excessive vegetation growth along this section of river, however, there are no structures supported on the bank crest.	46
680 - 1340	Natural channel (heavily vegetated)	Bank covered with trees and bushes. No sign of instability due to erosion at base of bank or oversteep banks	45

Plate 45 - View downstream from Shepley Road bridge

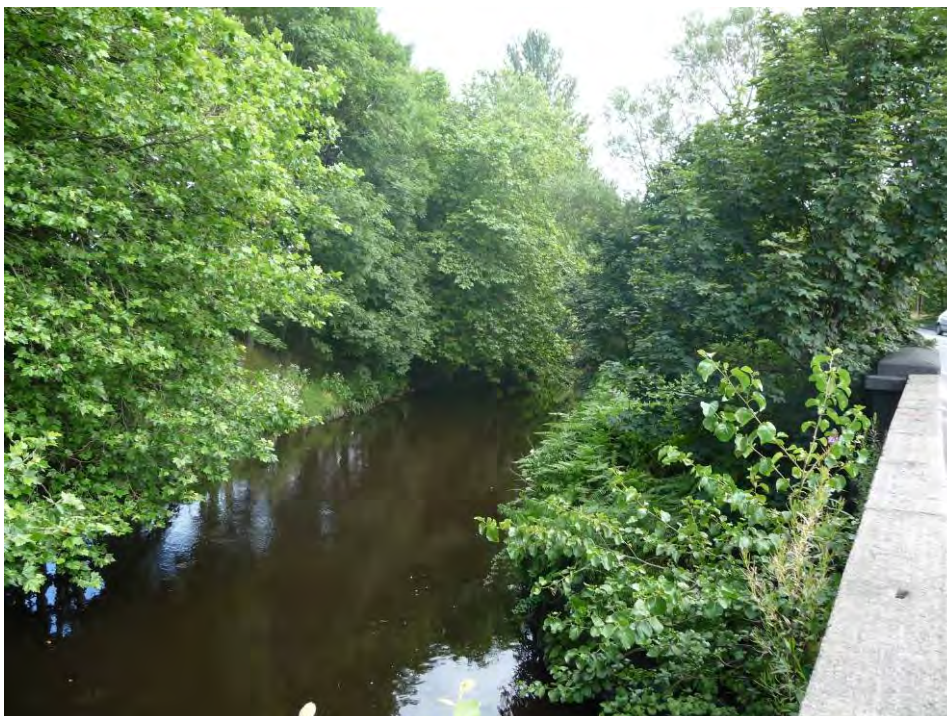
Chainage	Classification	Notes	Plate Number
Right Channel			
625 - 660	Masonry lined channel)	Mixture of stone and brick vertical walling of varying height. Average condition, with excessive vegetation growth along this section of river, however, there are no structures supported on the	46

Plate 46 – View upstream from Shepley Road bridge

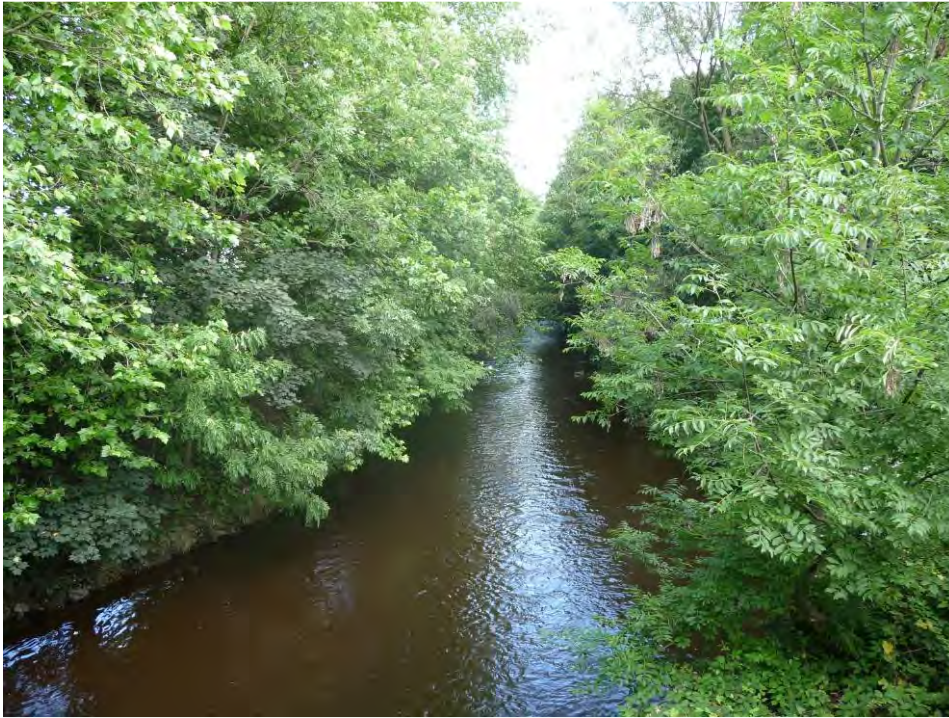
Chainage	Classification	Notes	Plate Number
Right Channel			
0 - 625	Natural channel (heavily vegetated)	Bank covered with trees and bushes. No sign of instability due to erosion at base of bank or oversteep banks	47
Left Channel			
0 - 515	Natural channel (heavily vegetated)	Bank covered with trees and bushes. No sign of instability due to erosion at base of bank or oversteep banks	47
515 - 625	Raised defence	Stone wall at back of footpath on Shepley Road, approx 1m high, tying into bridge parapet at downstream end. Stone wall continues up Shepley Road away from river. Good condition, no vegetation ingress and no signs of instability.	47

Plate 47 – View upstream from Shepley Road
