Tameside MBC

Section 19 Investigation Report

Micklehurst Road, Mossley Flood Event

June 2018

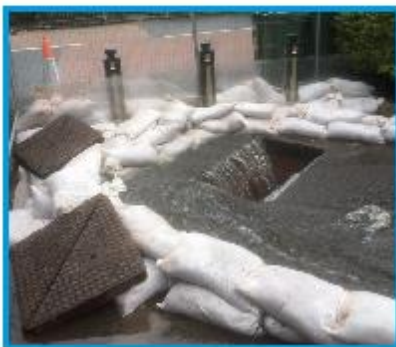
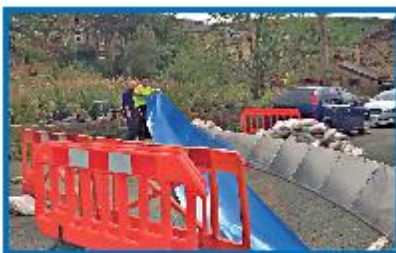
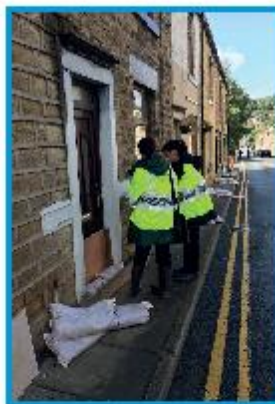
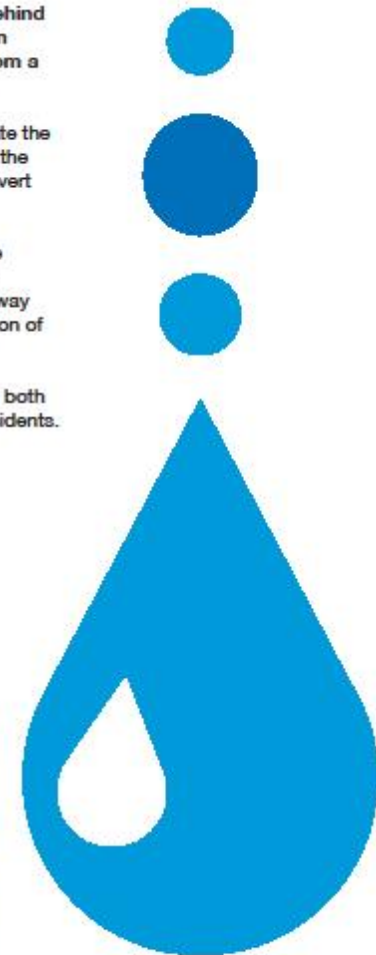
On Monday 11th September 2017, the Micklehurst Brook culvert located behind 29 Micklehurst Road became blocked. This was caused by heavy rainfall on the day and a collapsed culvert. This resulted in water being discharged from a manhole on Micklehurst Road and entering a number of properties.

400 sandbags were distributed to residents in properties directly affected by the flooding and the affected road was closed. To clear the blocked culvert, a high volume pump was deployed which cleared the debris and removed the water away from the collapsed area and back into the water course. Work to replace a section of the culvert that is damaged is ongoing.

A number of properties in the area have suffered internal flooding and staff from both Tameside Council and the Environment Agency remain in contact with these residents.

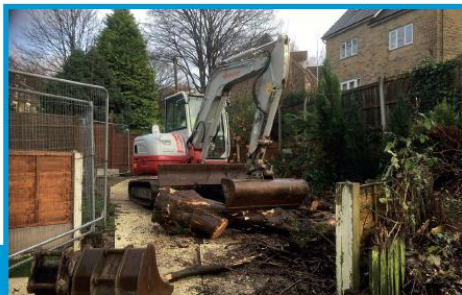
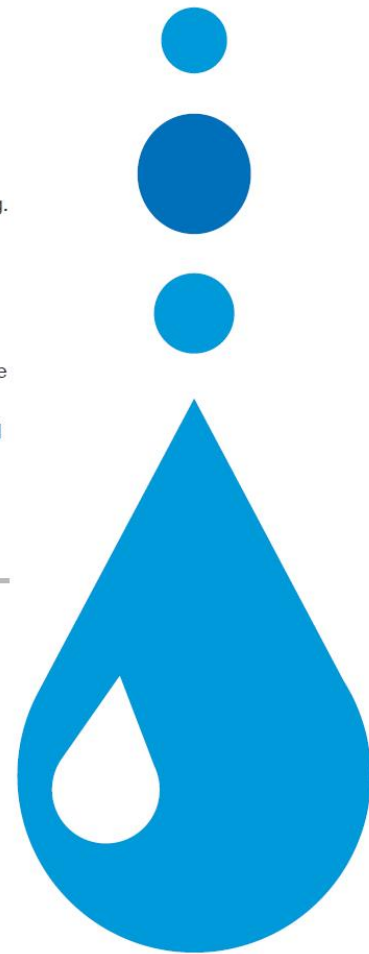
The area in front of garages where there is a large void will remain fenced off while the void is excavated and filled.

Galliford Black & Veatch have been contracted to carry out the repair works.

Pumps will be in operation from 8am to 6pm to pump out water, which will cause some noise disturbance, and pipes will be laid along the side of the road.
