CAT BACKGROUND AND PROCESS

The Council has recently conducted a condition survey of the property which has identified £136,023 of repair works. The full condition survey is found in Appendix 3.

STRUCTURAL INSPECTION REPORT
HOLLINGWORTH COMMUNITY CENTRE
5.5.26

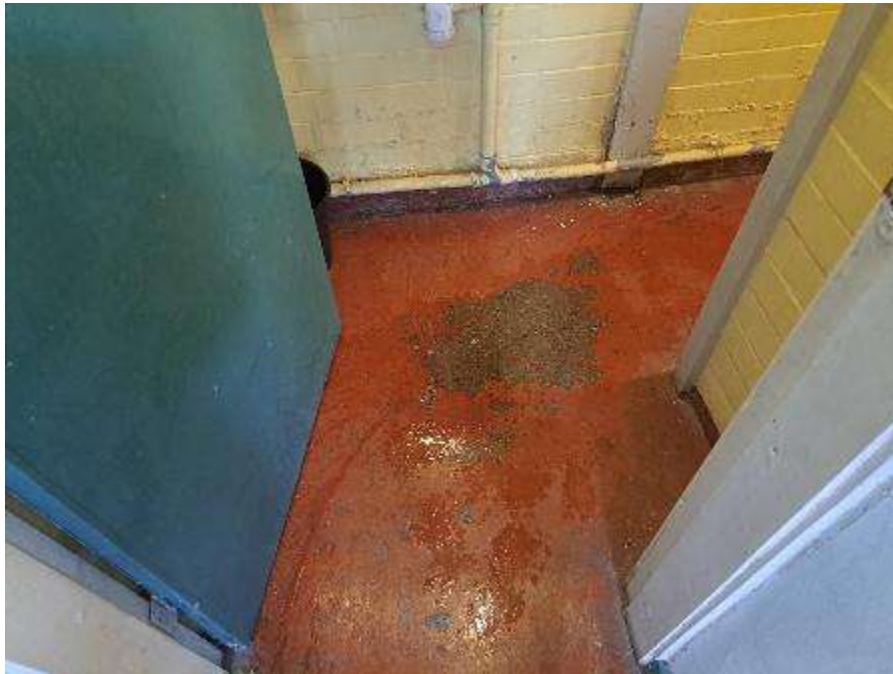
1. Damage to the concrete floor

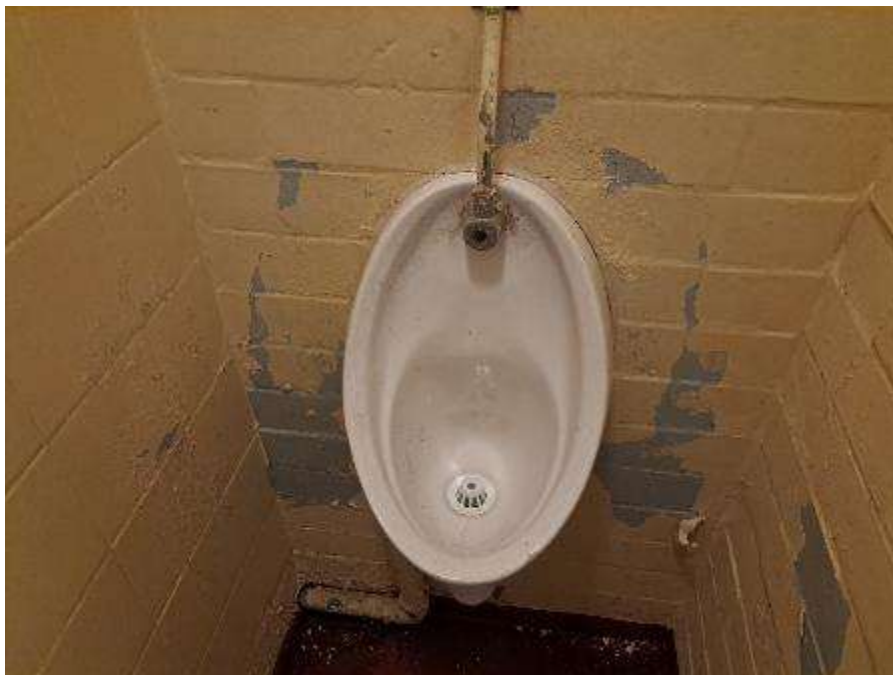
4. View of aged urinal and poor decoration

22.	The male and female WC units were in aged condition; fixings were rusted and were potentially reaching the end of their lifecycle.	Allow for a full strip out and replacement of all sanitaryware within the property.	M

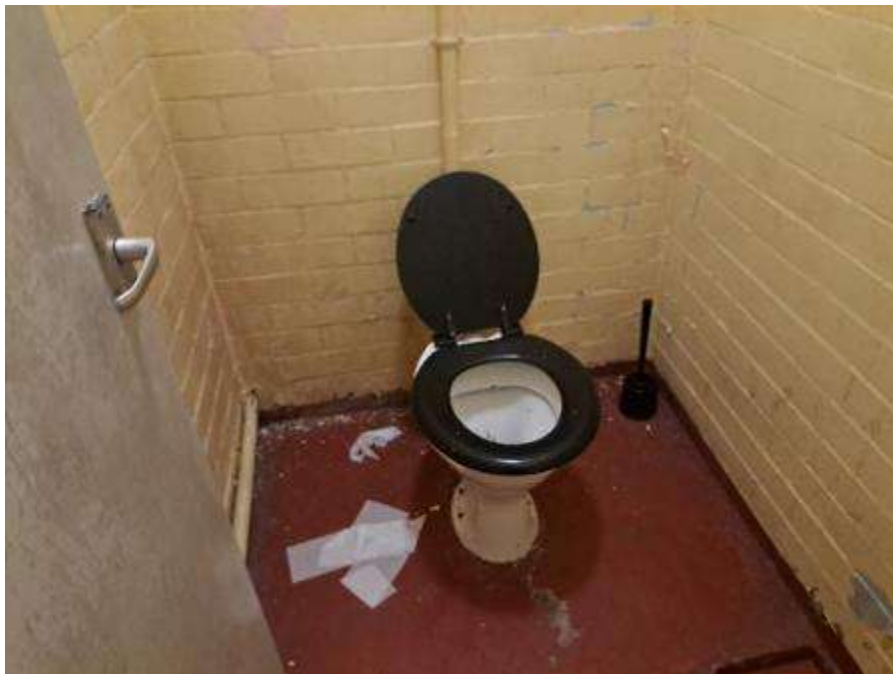
6. Damaged and aged WC

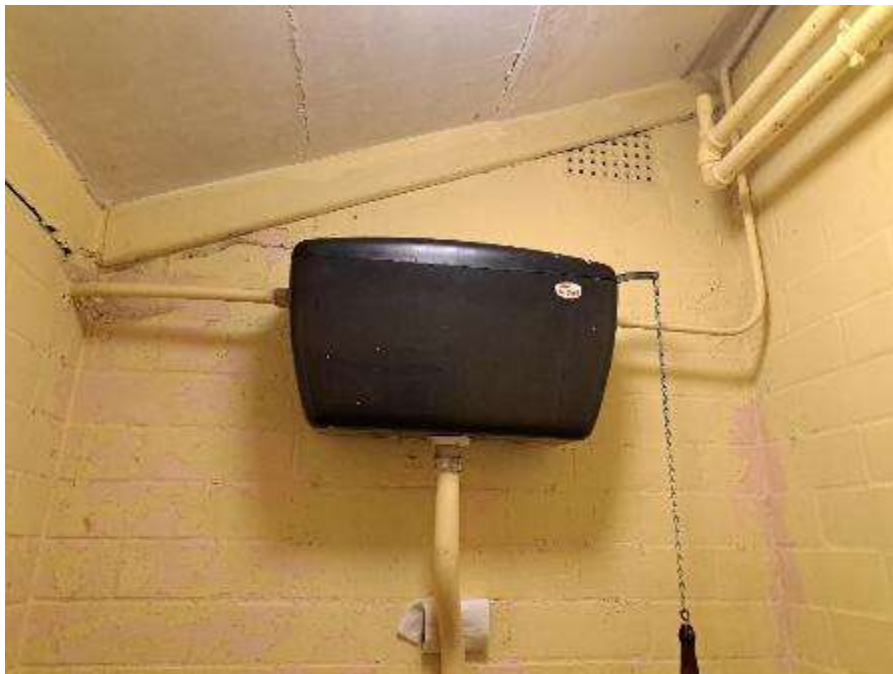
8. View of blocked air vent and aged WC

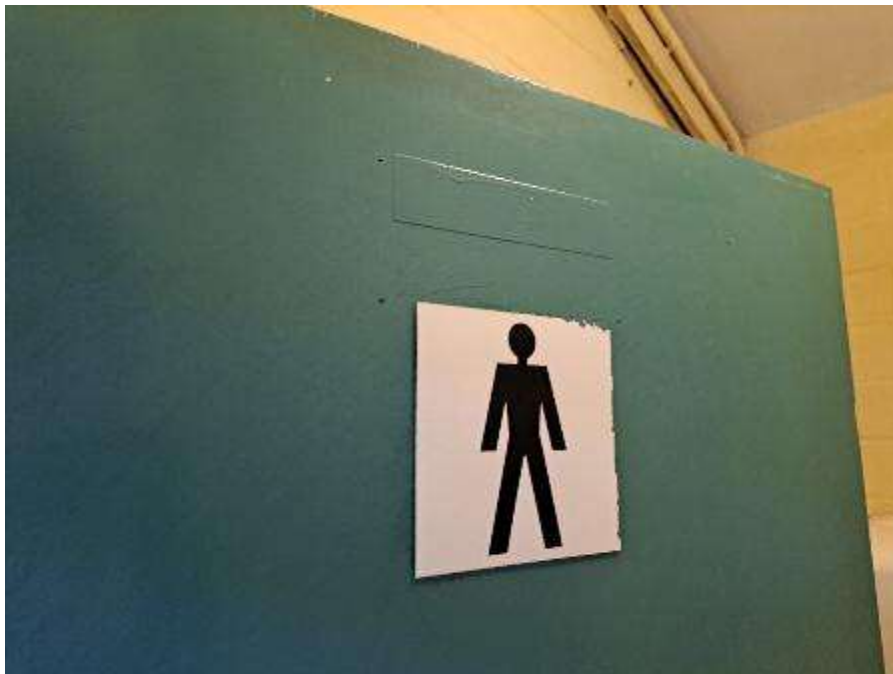
12. Penetration holes to the timber door

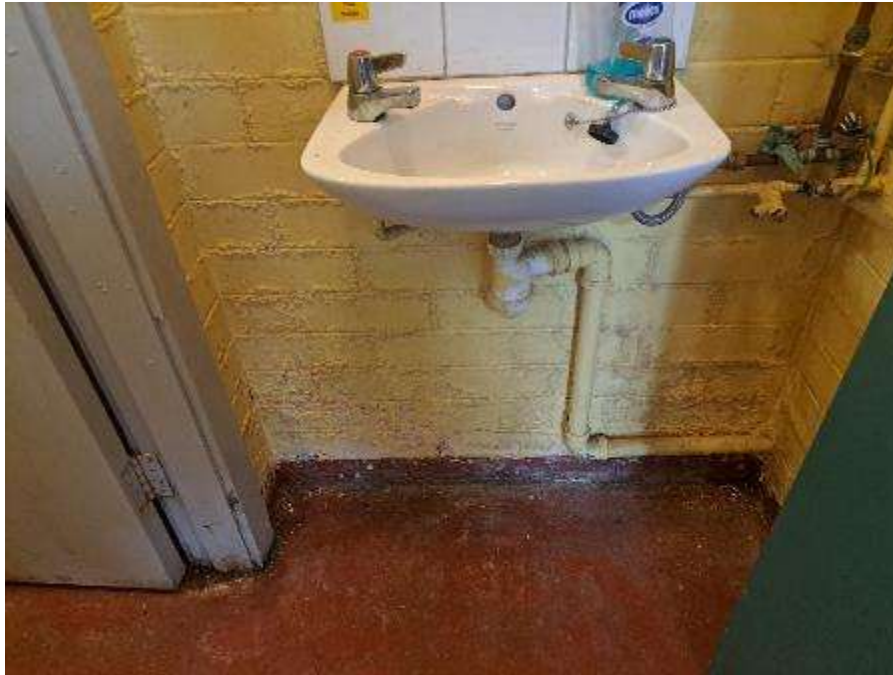
13. Damp present under the Female WC sink

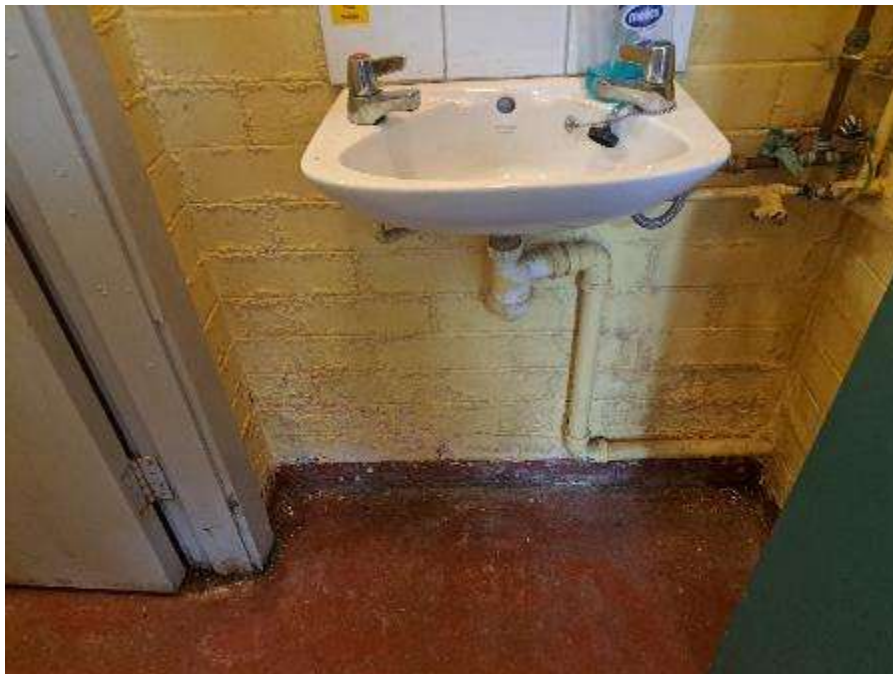
14. Dirty and aged sink unit

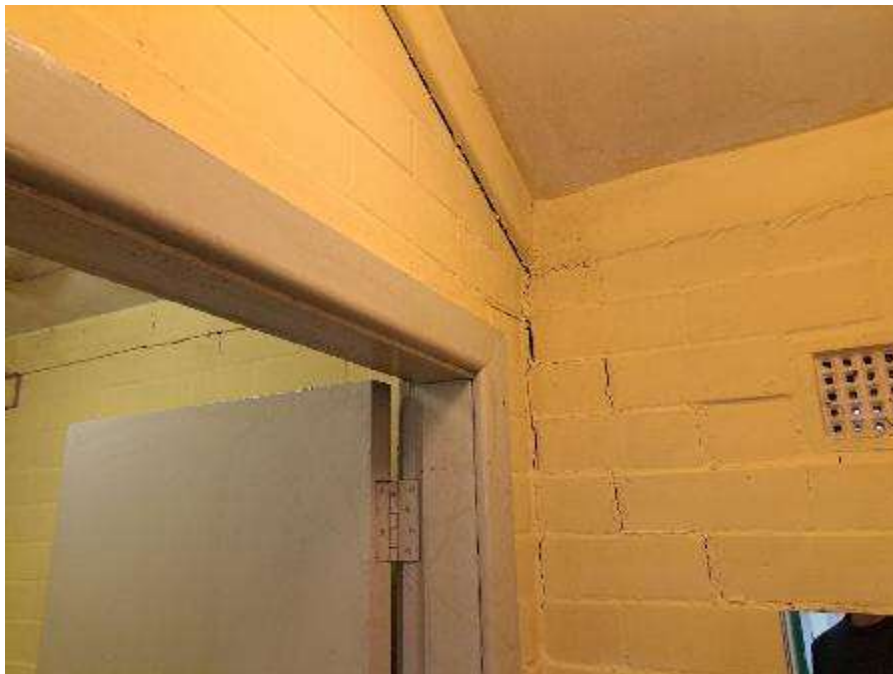
16. Cracking present at high level

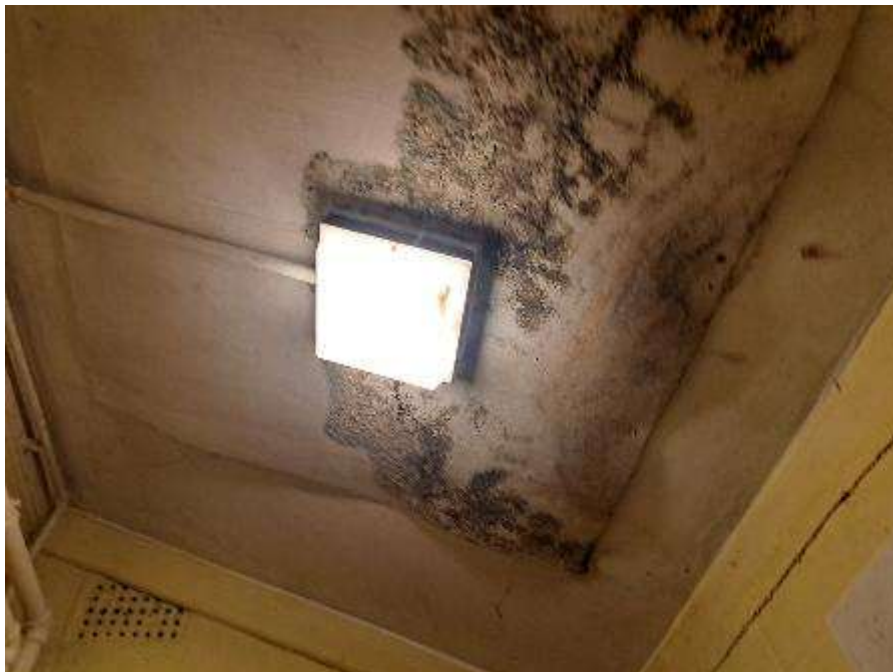
24. Damage to the ceiling due to the water ingress

20.	A result of the aforementioned roof and envelope defects, moisture staining and ingress affected finishes a present to a number of walls and ceilings.	Once the external defects have been resolved, allow for repairing, replacing and redecorating the affected fabric.	H

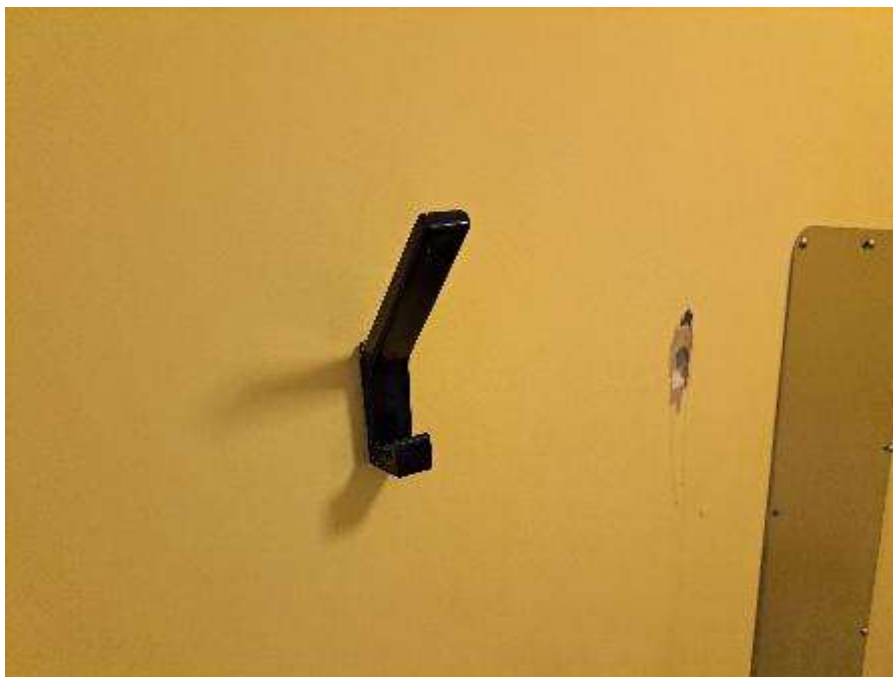
29. Damage from a previous coat hook

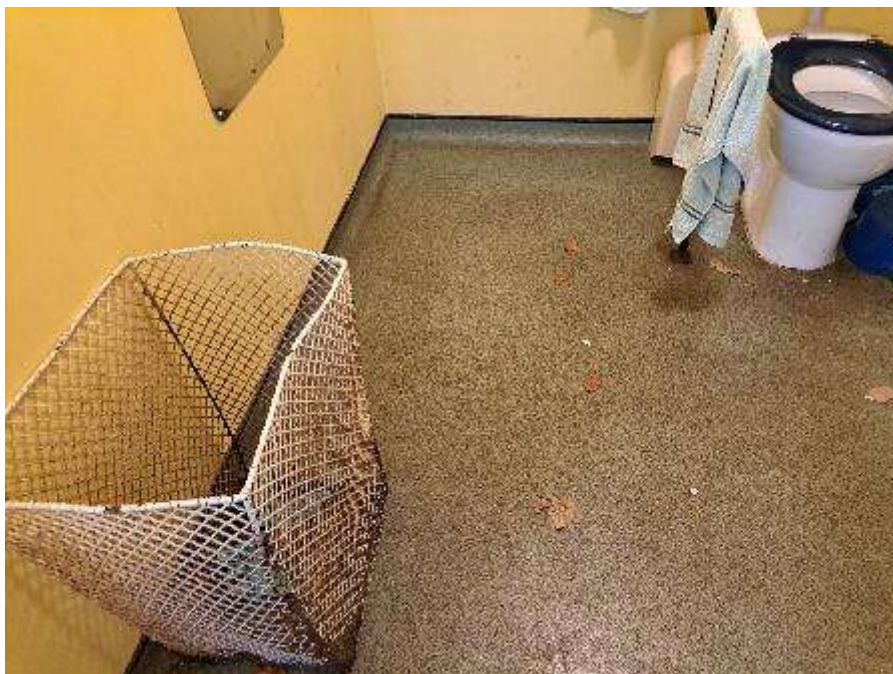
30. Rusted bin and debris

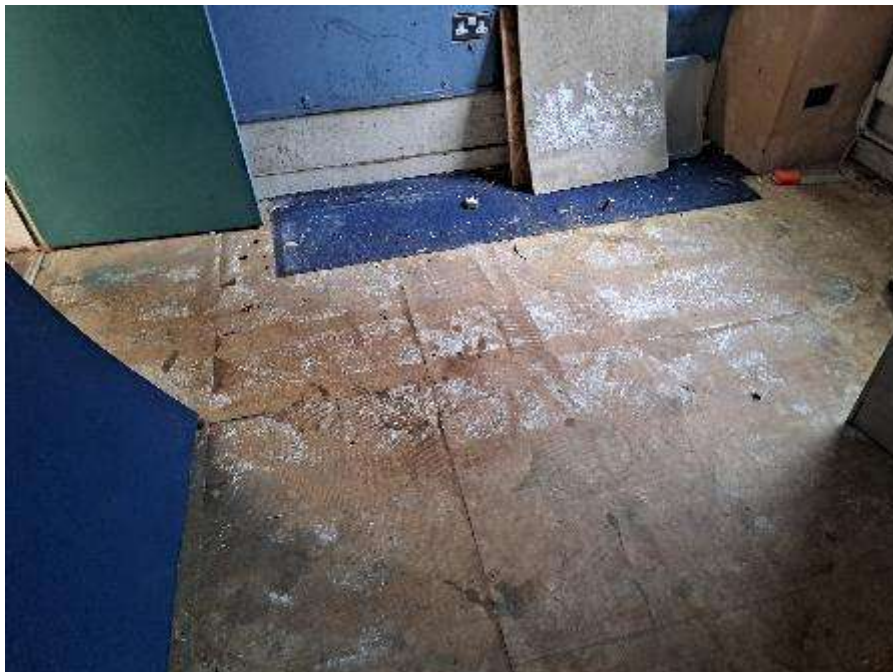
34. Damaged floor covering and fungi / mycelium spores

23.	The timber floor in the hall was soft underfoot and had warped due to assumed moisture; it was at risk of failure in sections. There were also signs of mycelium present through the main hall and adjacent rooms. Half of the hall has been previously replaced but still in poor condition.	Allow for a timber specialist to conduct an intrusive survey to confirm the presence of dry rot and any recommendations on remedial works.	H

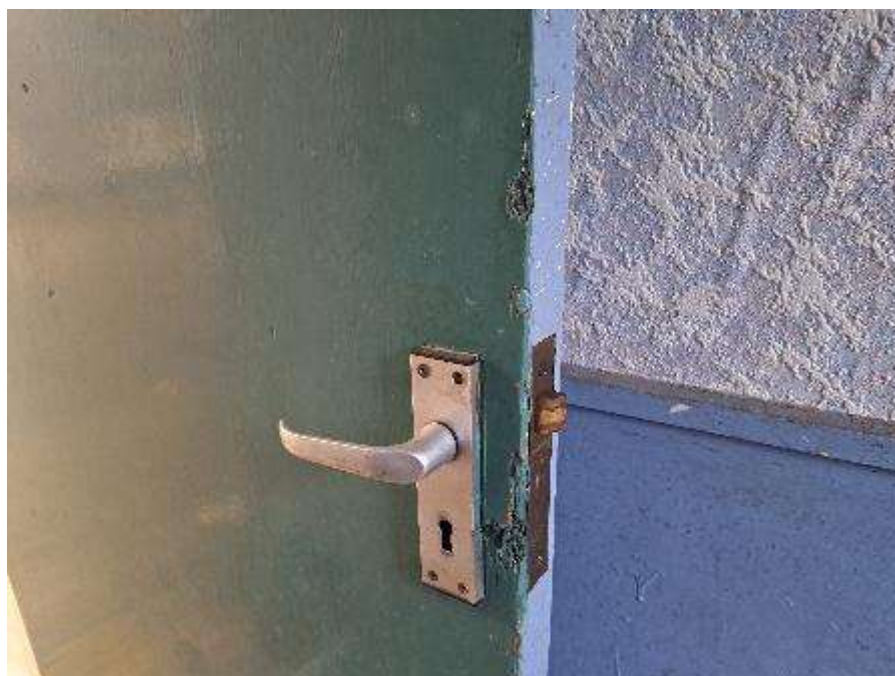
36. Damaged timber door

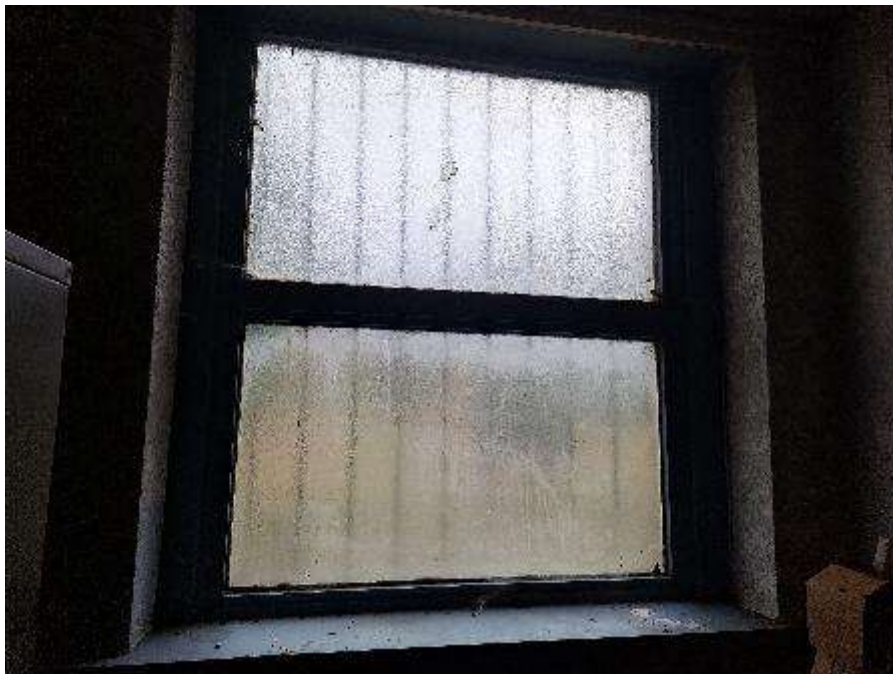
40. View of damaged timber window

6.	The timber windows were in poor condition throughout.	Replace the defective units with a modern equivalent.	H
7.	The smooth cast render to the south elevation is in poor condition with isolated areas of damage, cracking and saturation throughout.	Allow for the stripping and replacement of the render to the building.	H

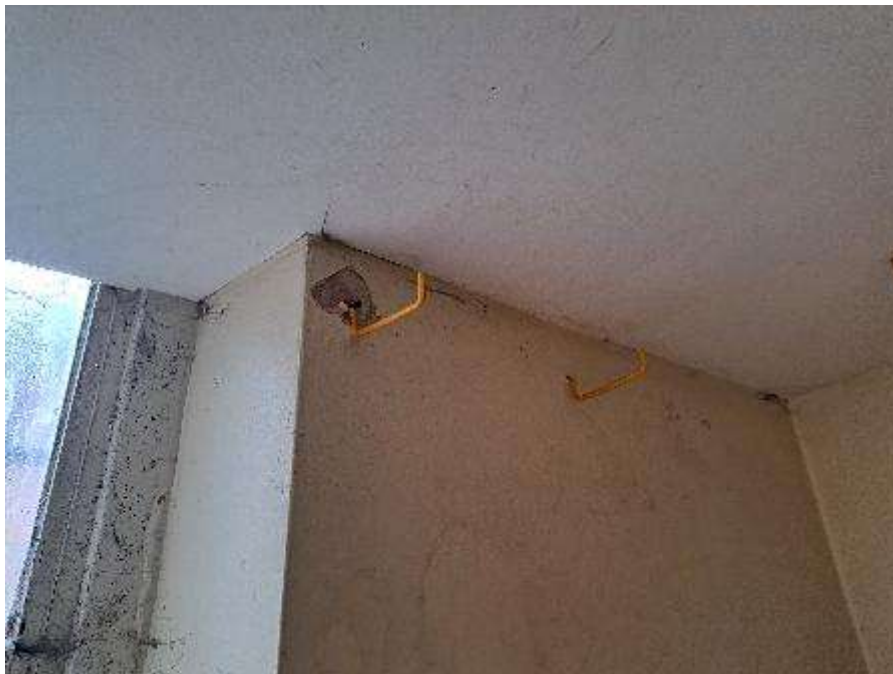
42. Damaged wall due to fixings

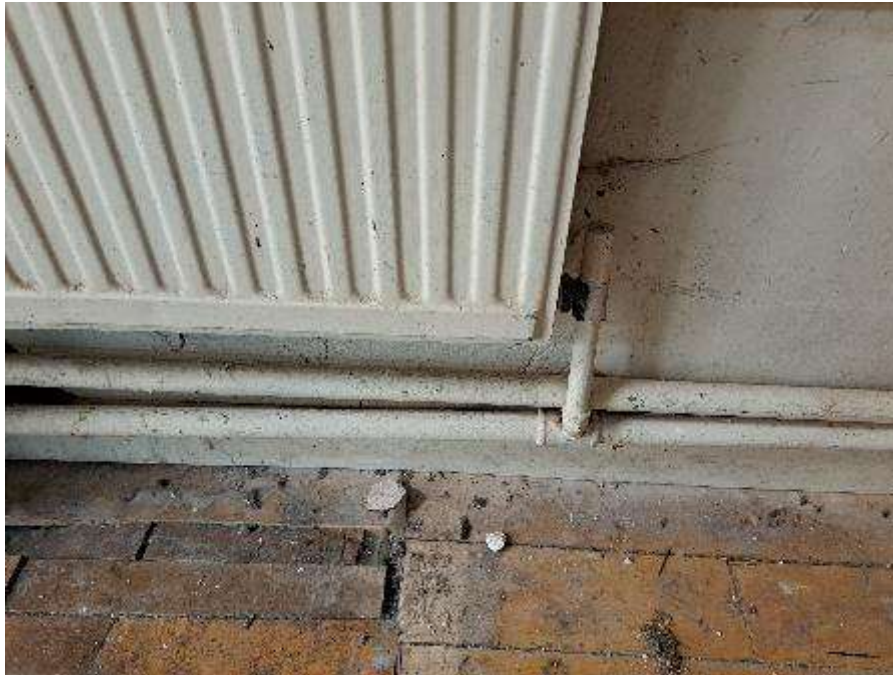
45. View of damaged floor

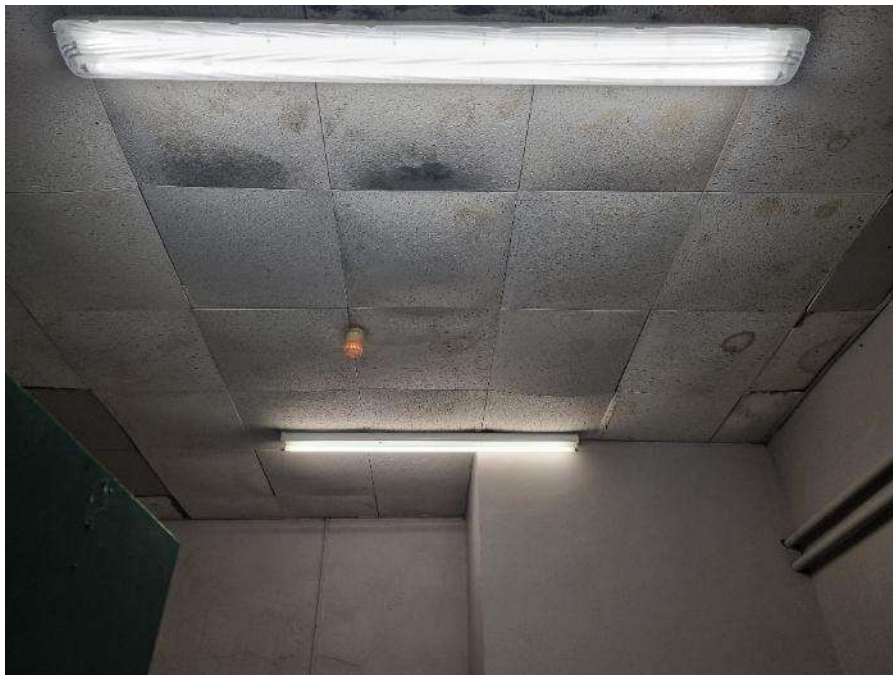
48. Suspended ceiling is in poor condition

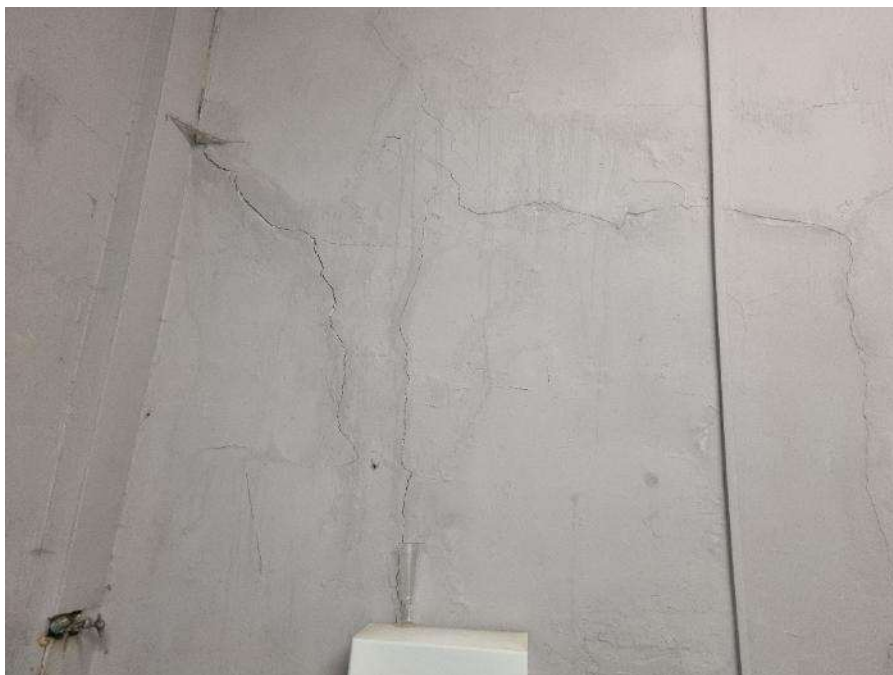
49. Cracking and damp noted to the walls

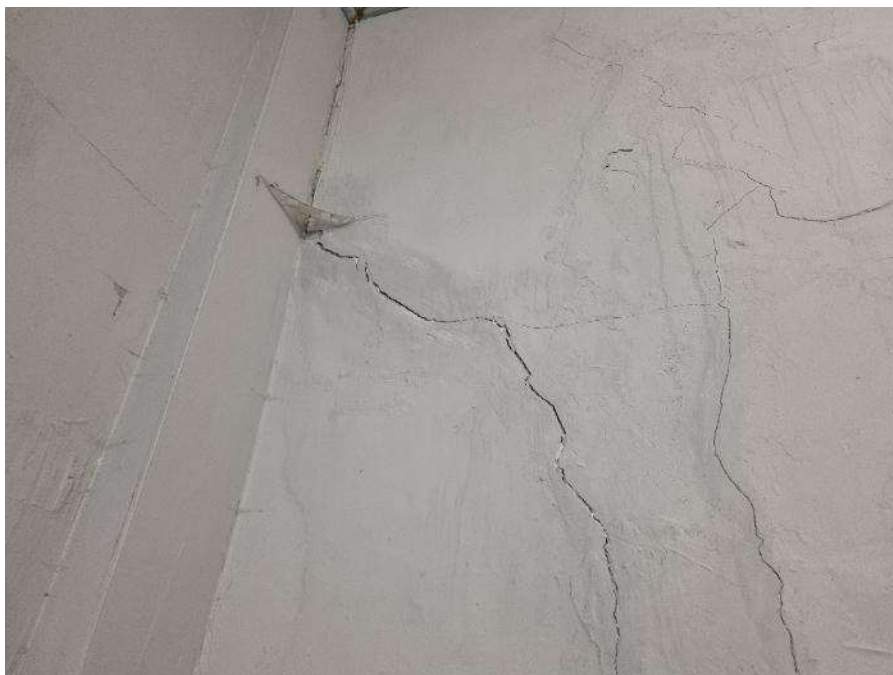
51. Cracking noted to the walls

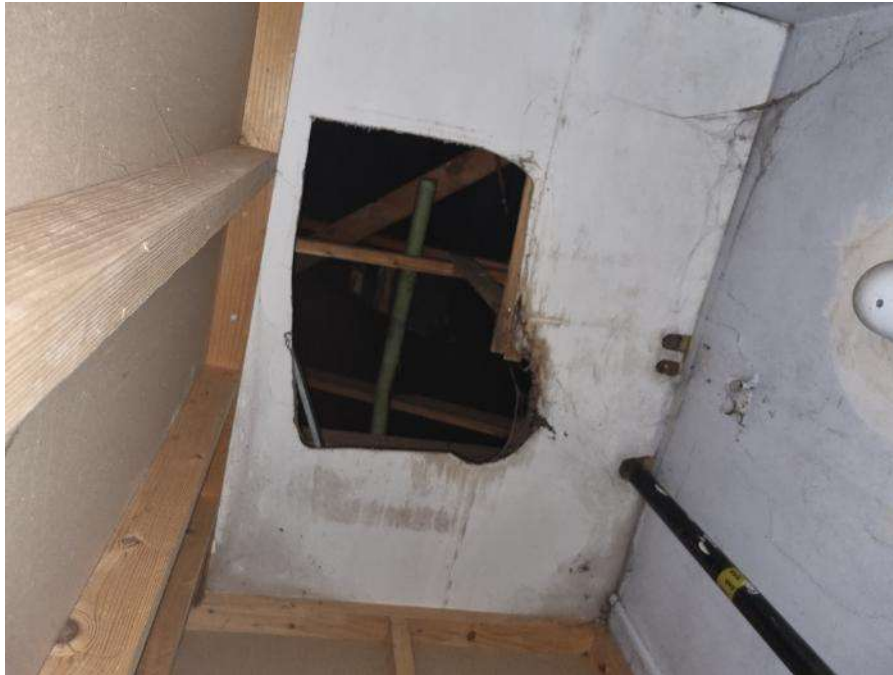
55. Poor condition of the ceiling

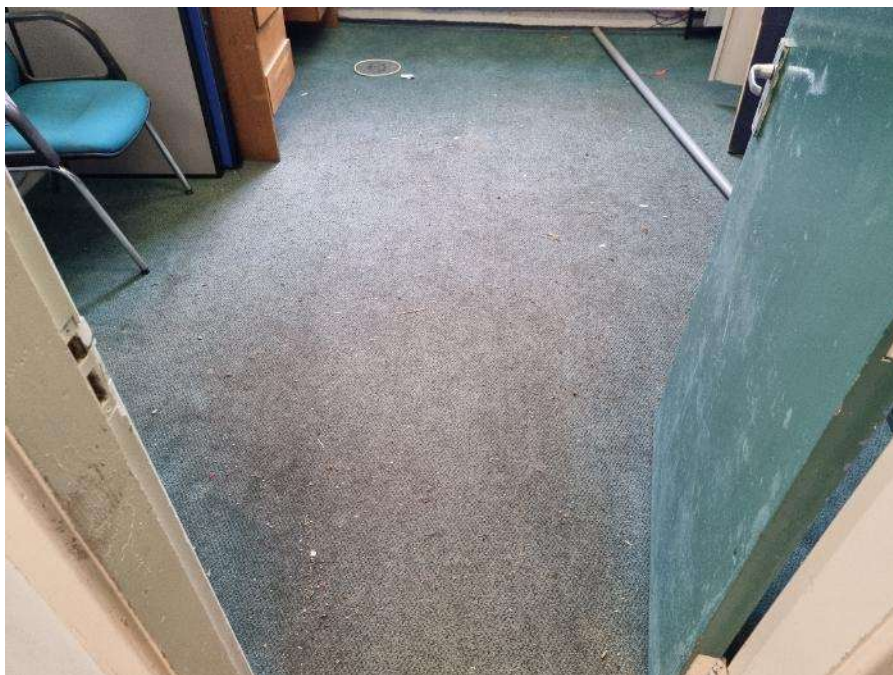
57. Carpet is in poor condition to the office.

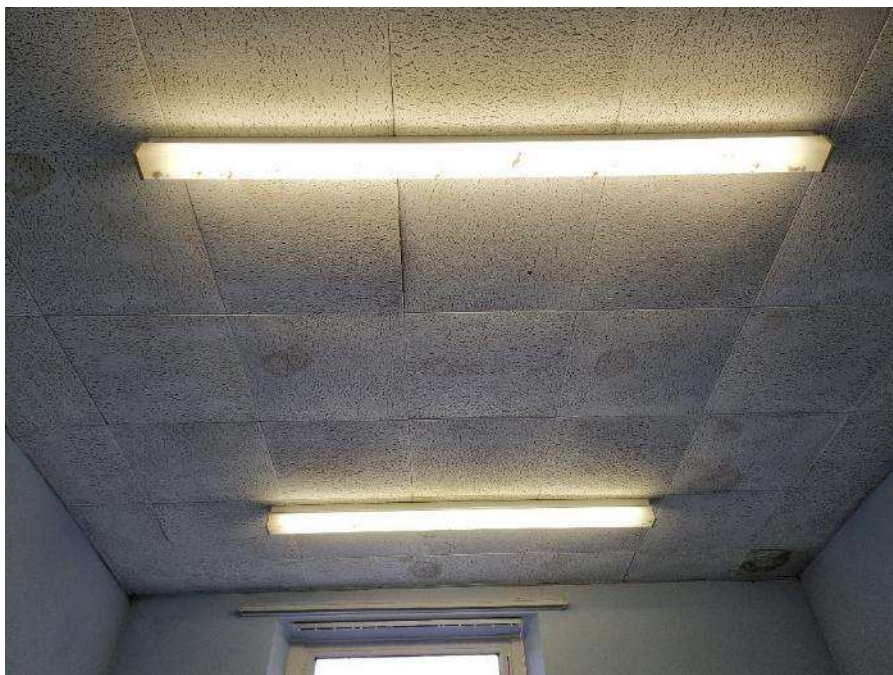
59. Ceiling is in poor condition

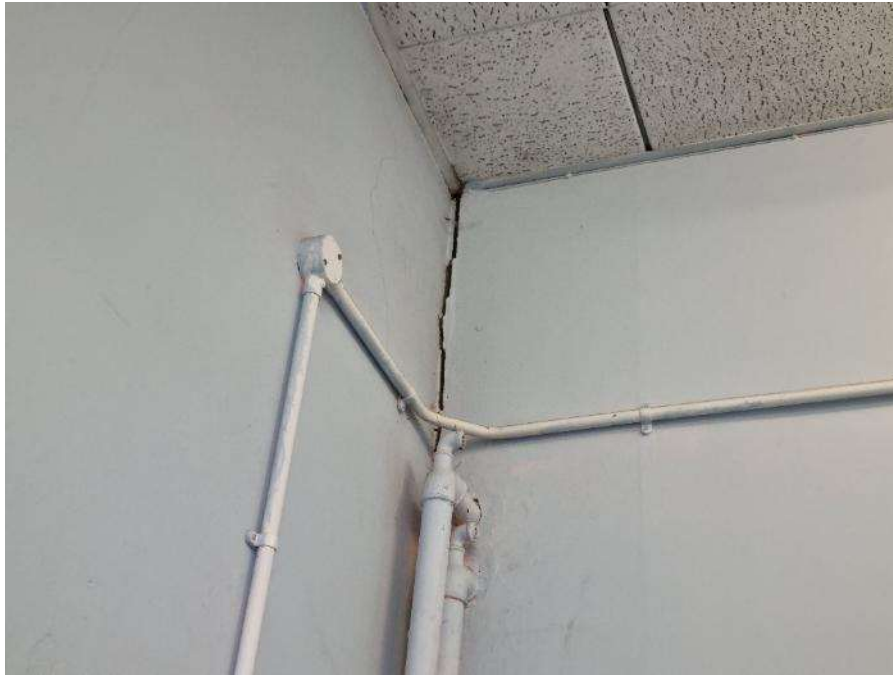
60. Minor hairline cracking noted.

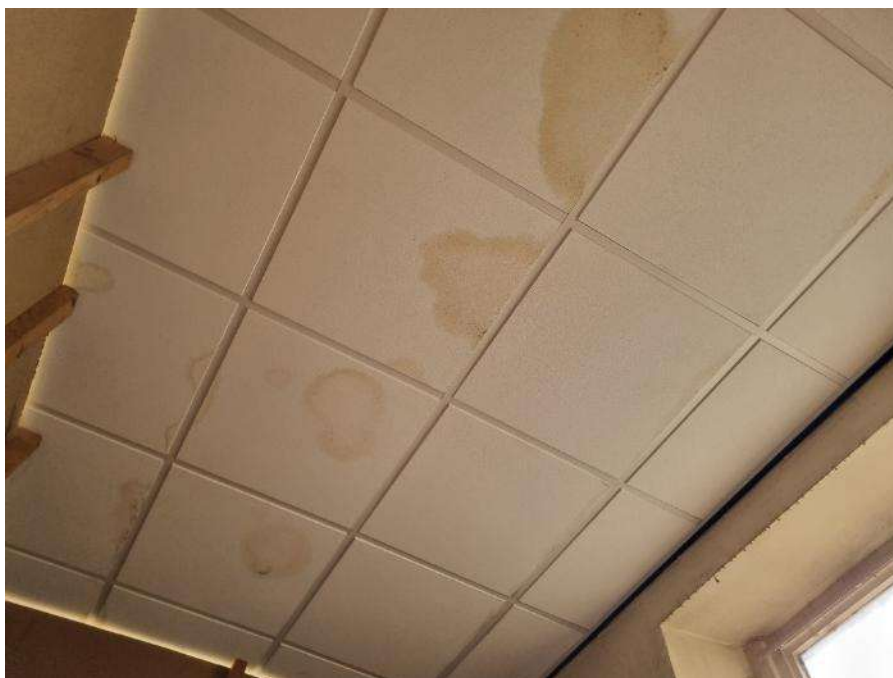
70. Ceiling is in poor condition

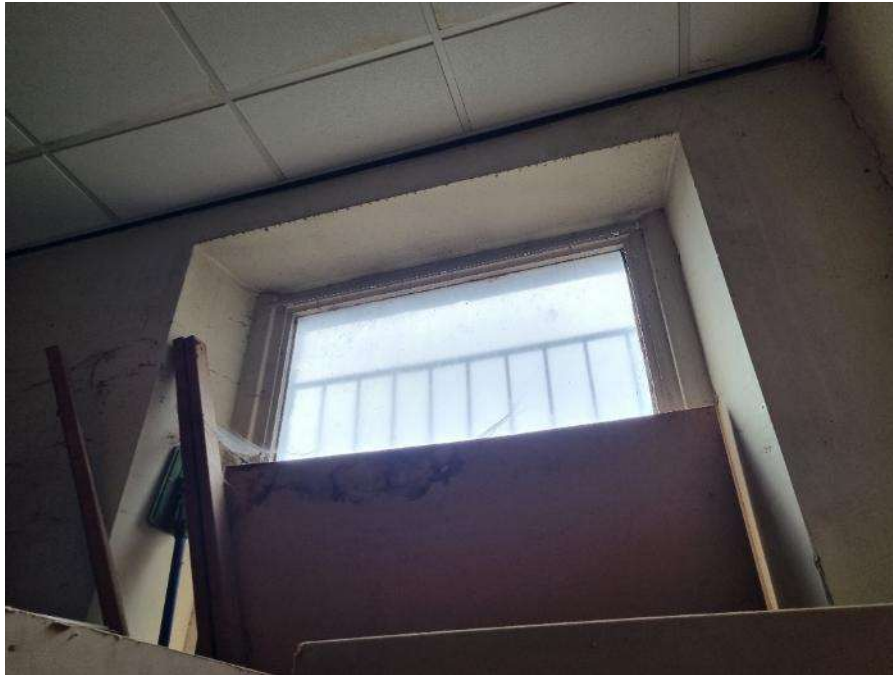
71. Windows are in poor condition.

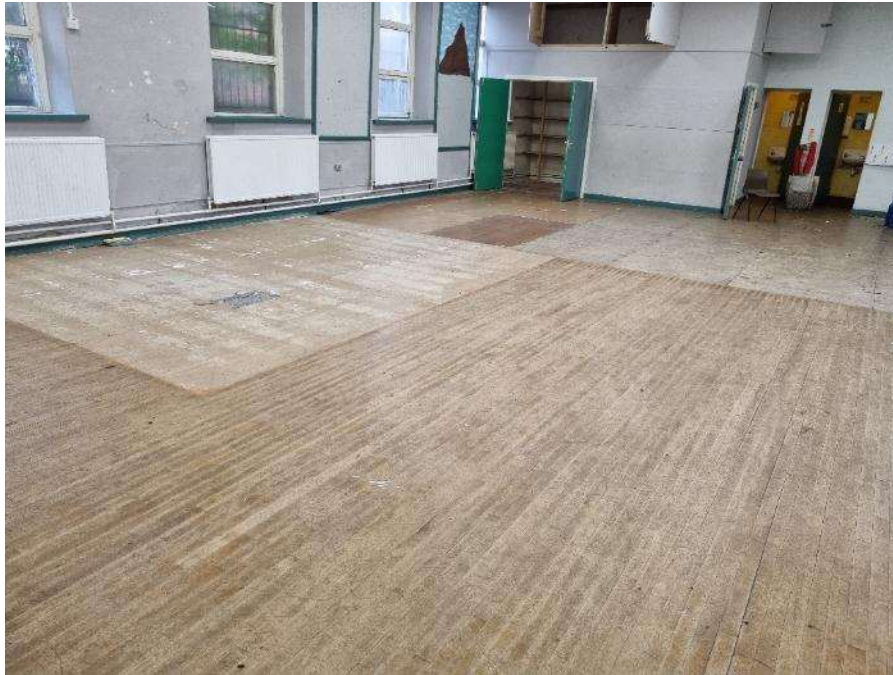
73. View of damaged floor within the hall.

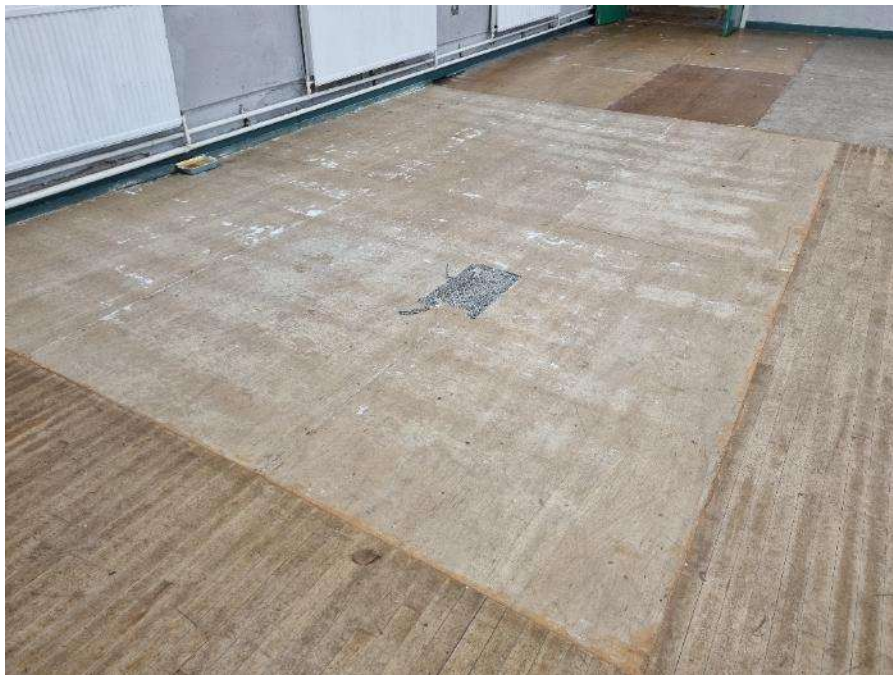
74. Floor is in poor condition, soft underfoot and signs of mycelium

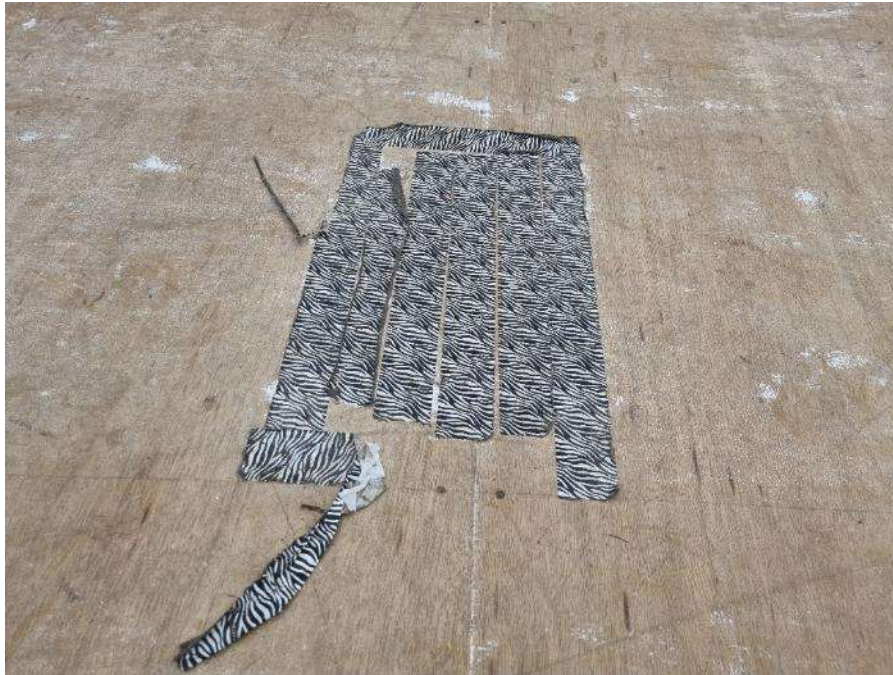
75. Floor is in poor condition, soft underfoot and signs of mycelium

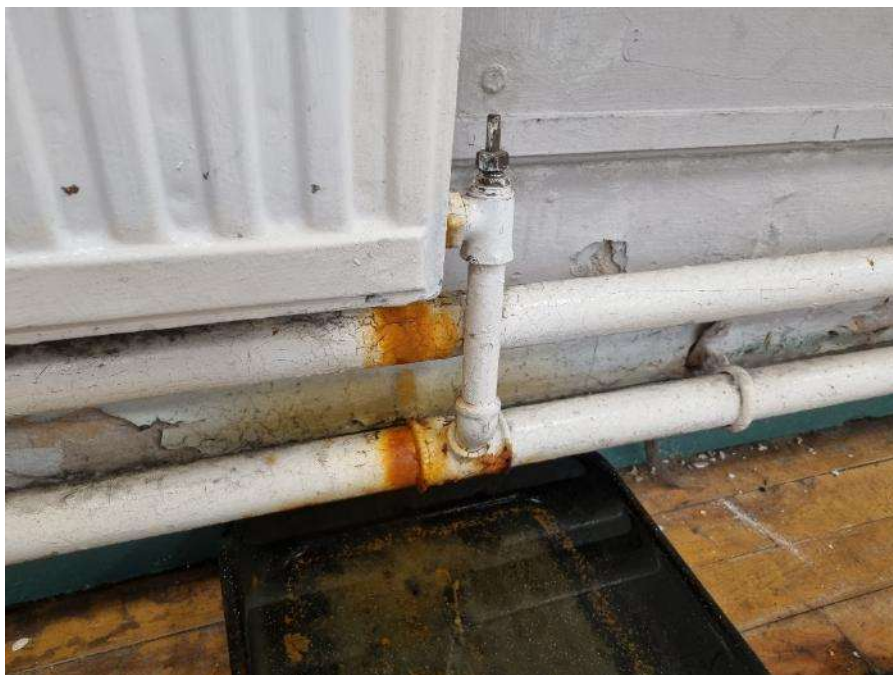
77. Floor is in poor condition due to pipe leaking below the radiator

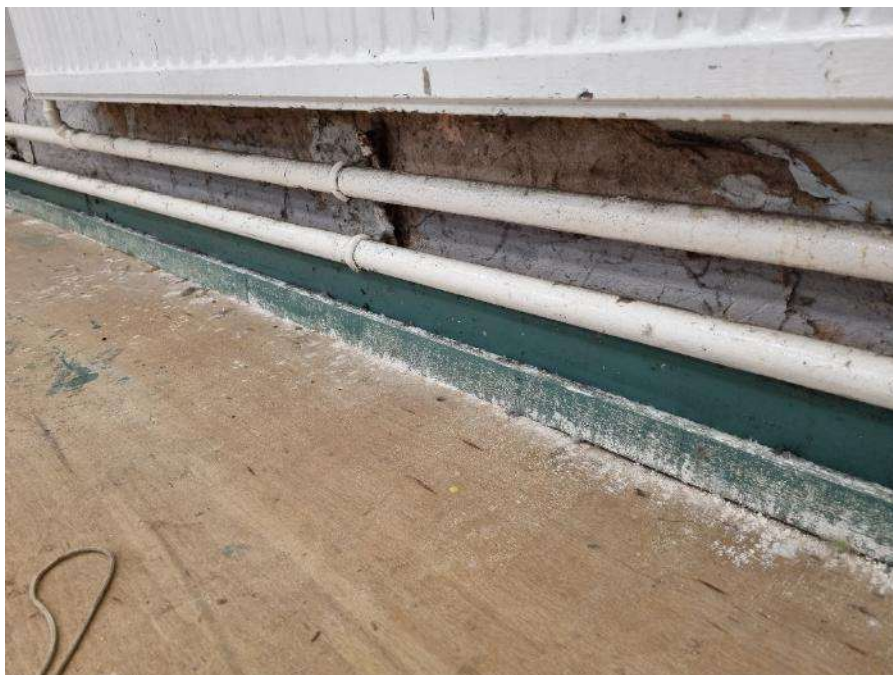
79. View of the defective plaster behind the radiator

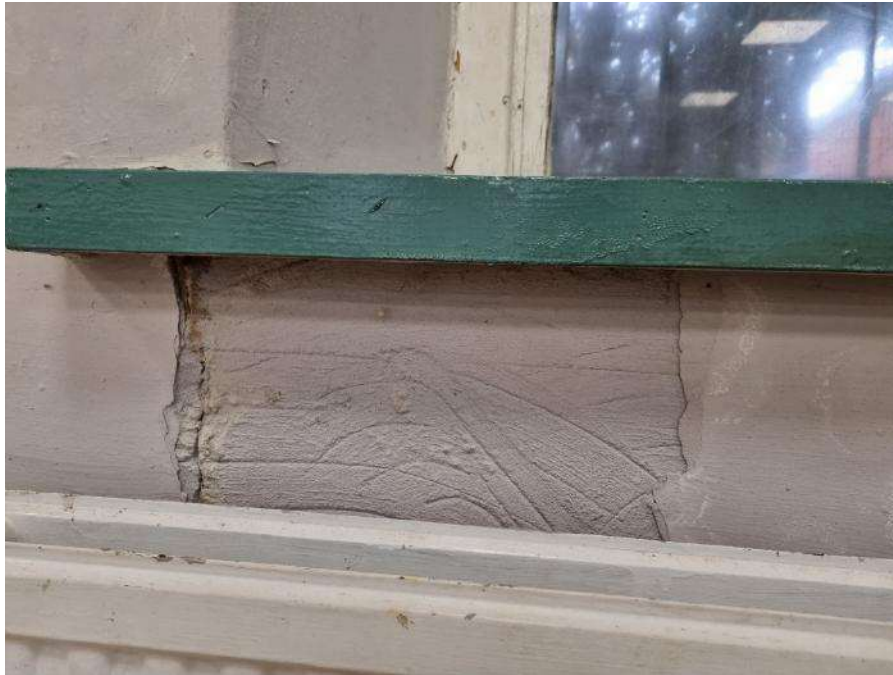
81. Defective plaster noted to below the window

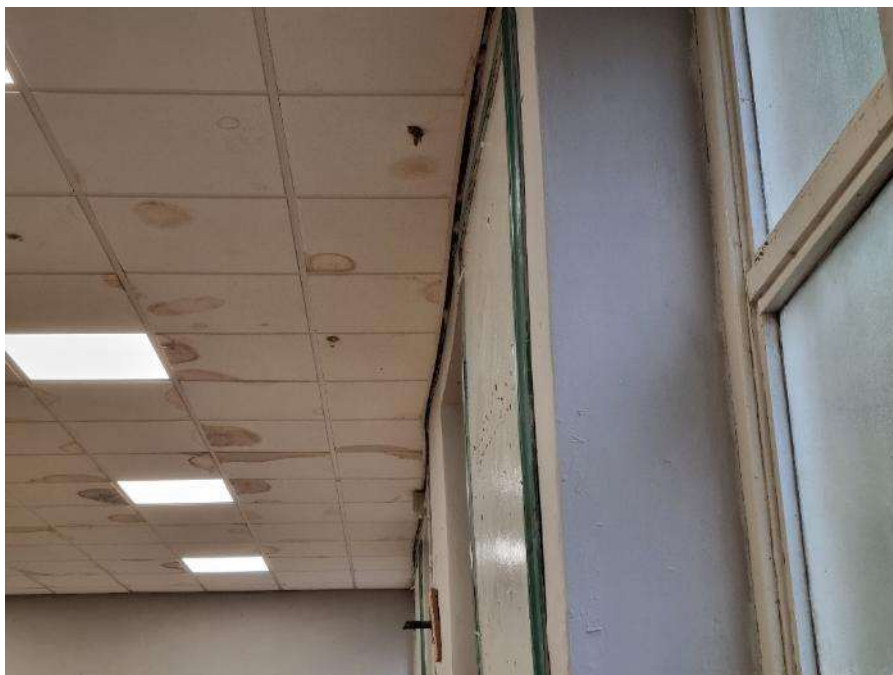
83. Walls are twisted and bulging in various areas

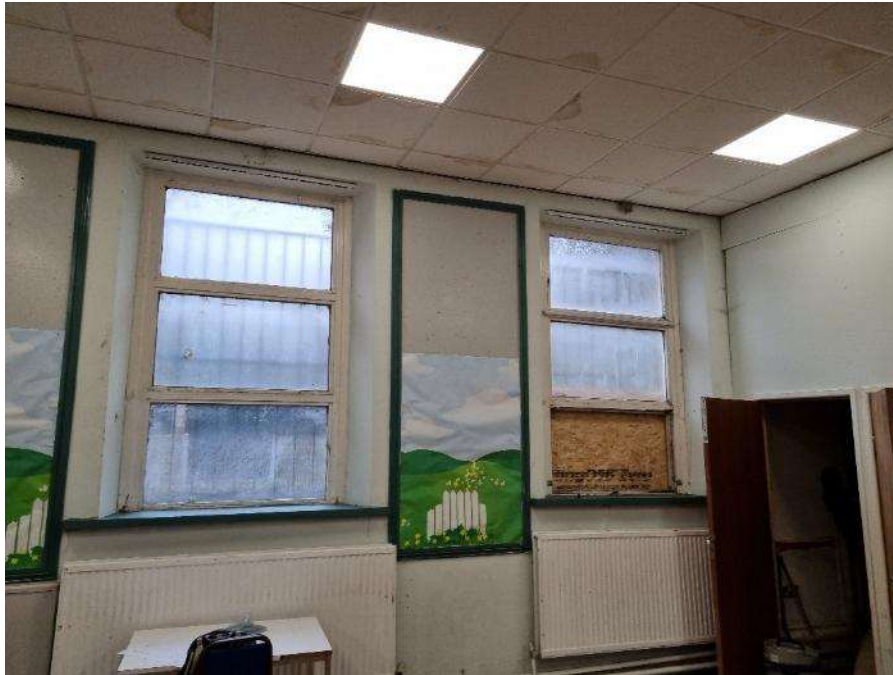
85. Windows are in poor condition

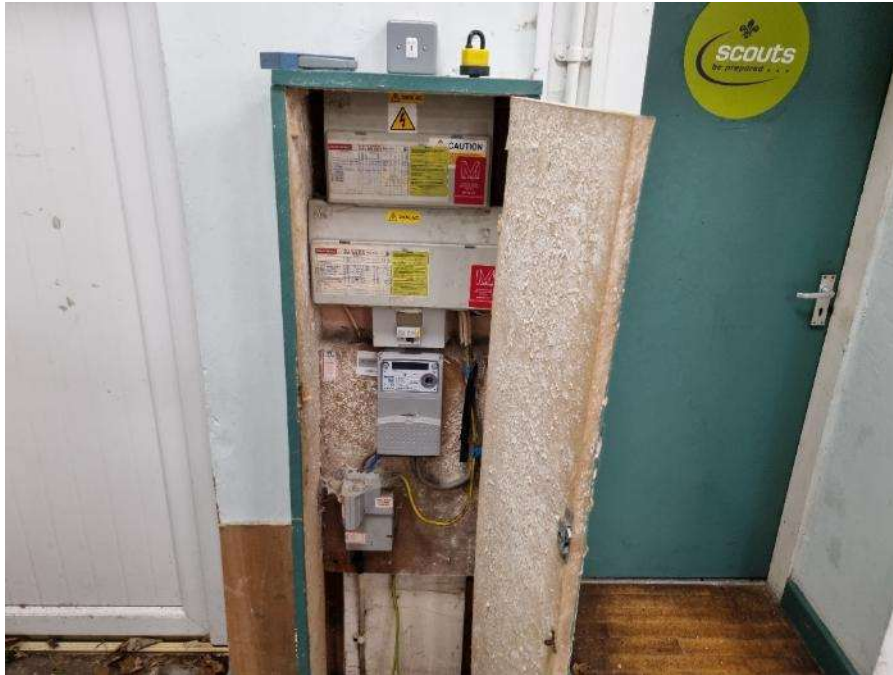
87. View of the main incoming electrics

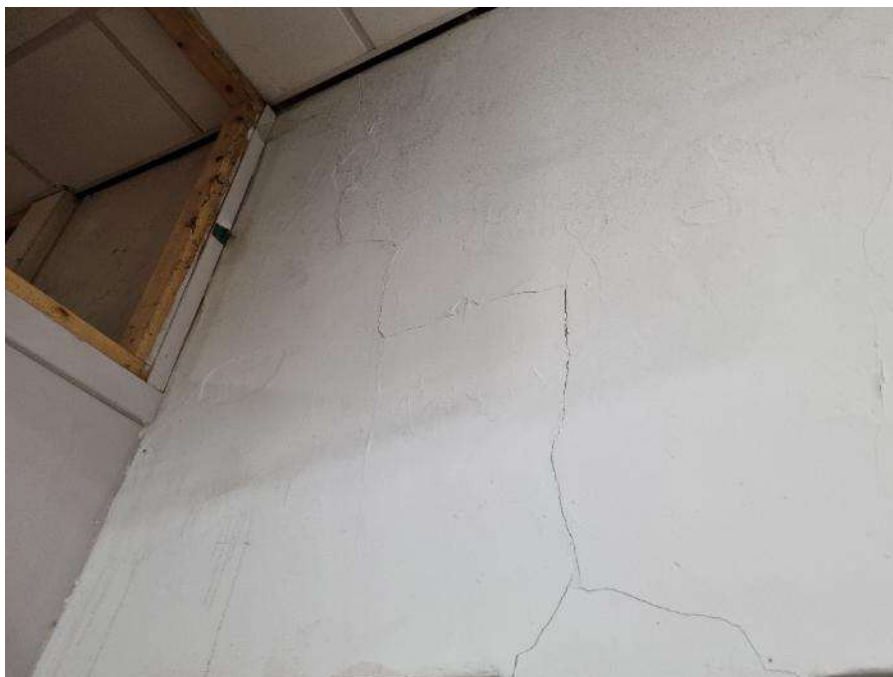
89. Sign of cracking noted to the wall

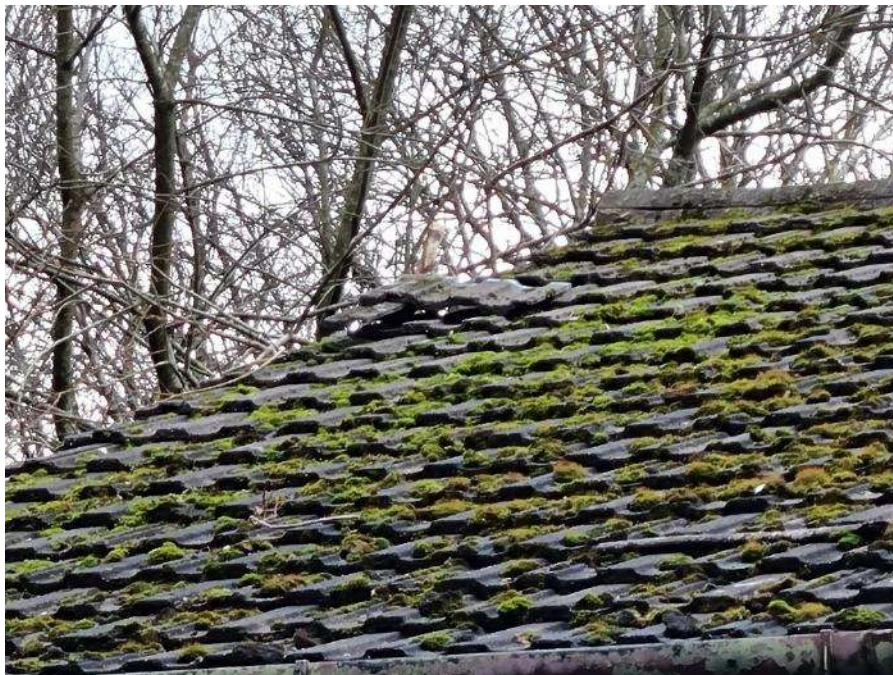
92. View of damaged Roof Tile

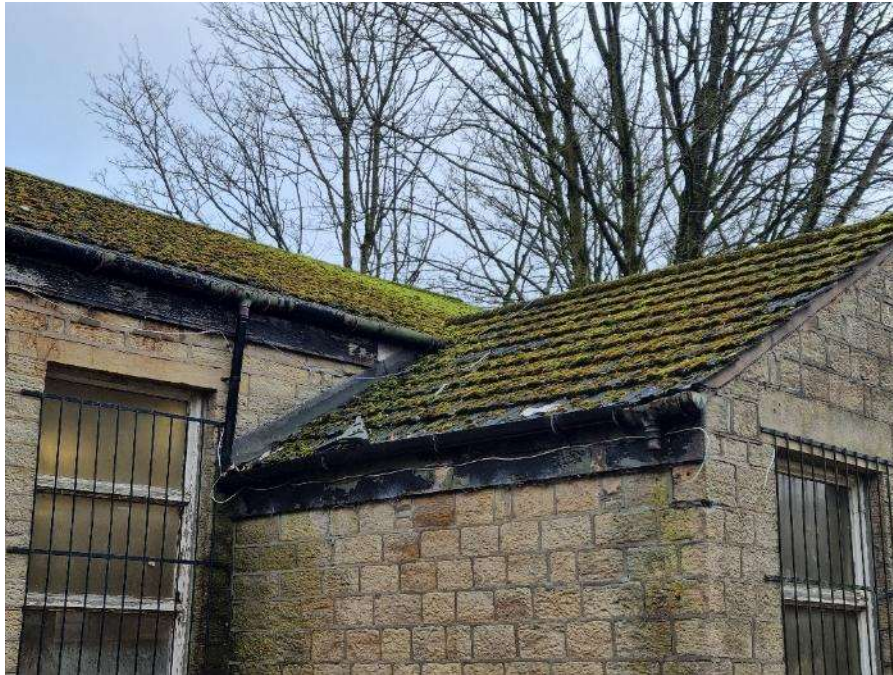
93. View of damaged roof
