CAT BACKGROUND AND PROCESS

The Council has recently conducted a condition survey of the property which has identified £136,023 of repair works. The full condition survey is found in Appendix 3.

STRUCTURAL INSPECTION REPORT
HOLLINGWORTH COMMUNITY CENTRE
5.5.26

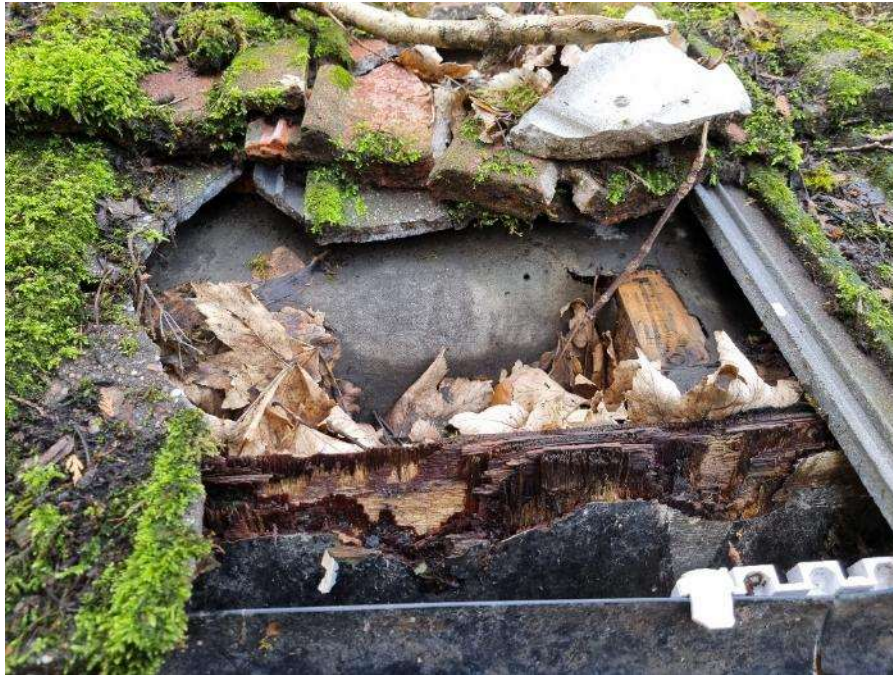
95. View of damaged roof

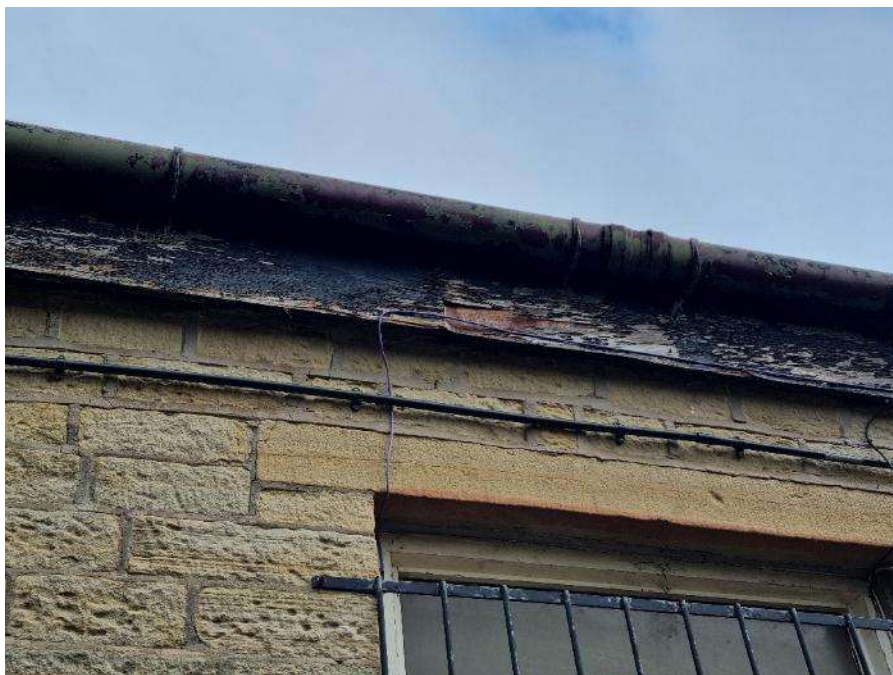
101. Fascias and guttering is in poor condition

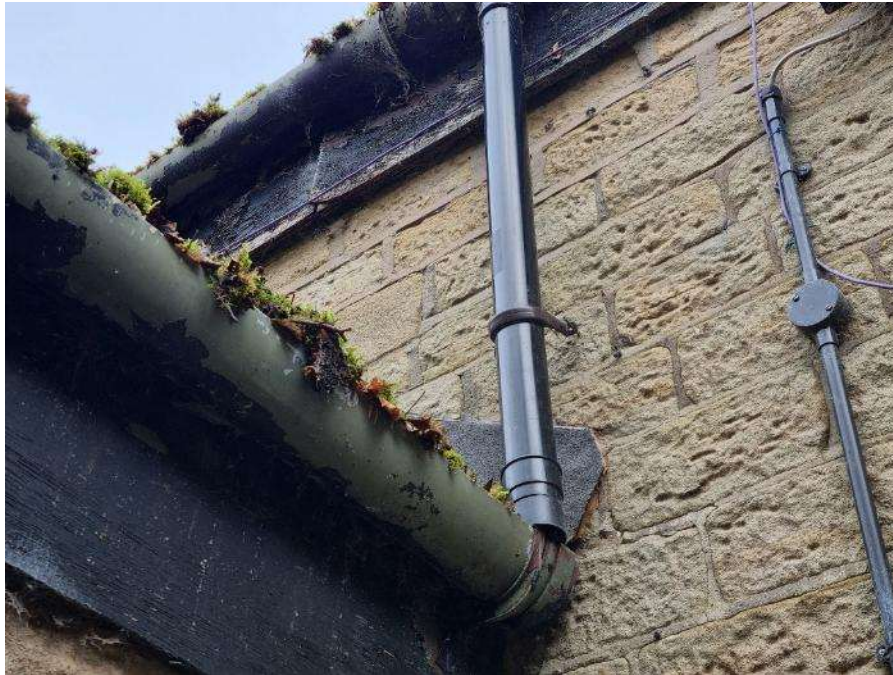
103. Fascias and guttering is in poor condition

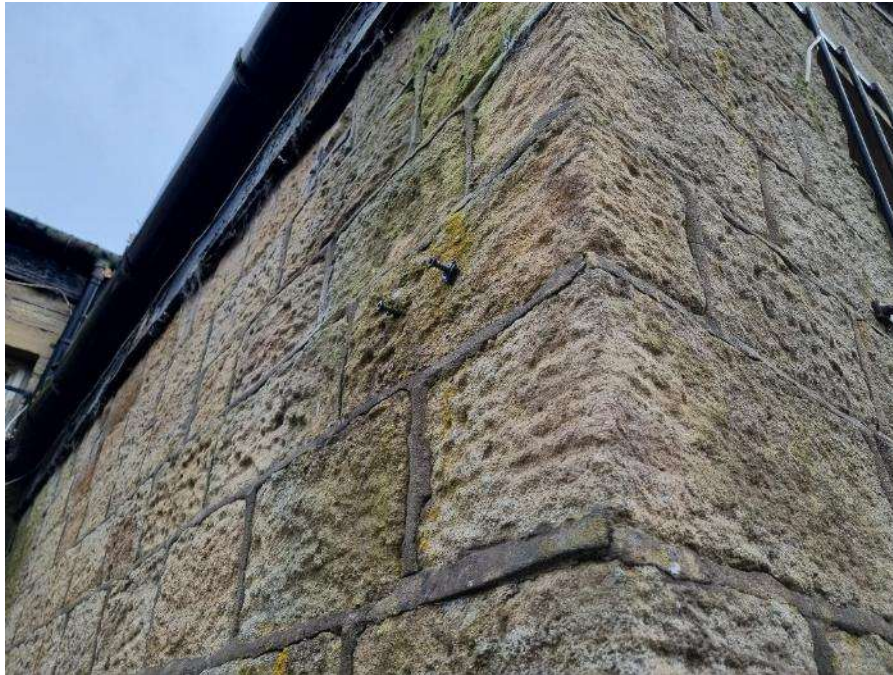
105. Missing downpipe and poor pointing.

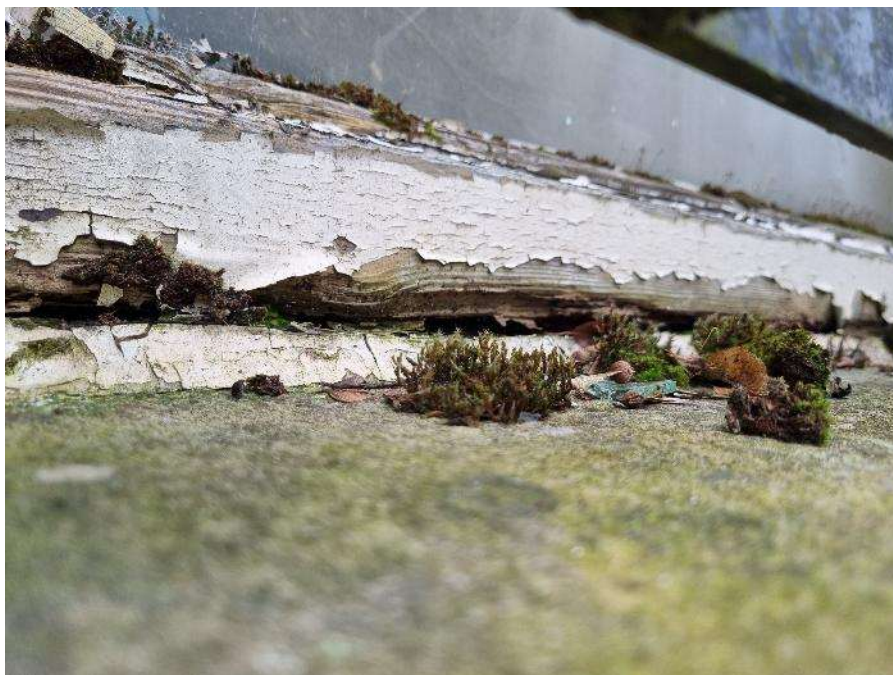
109. Window is in poor condition

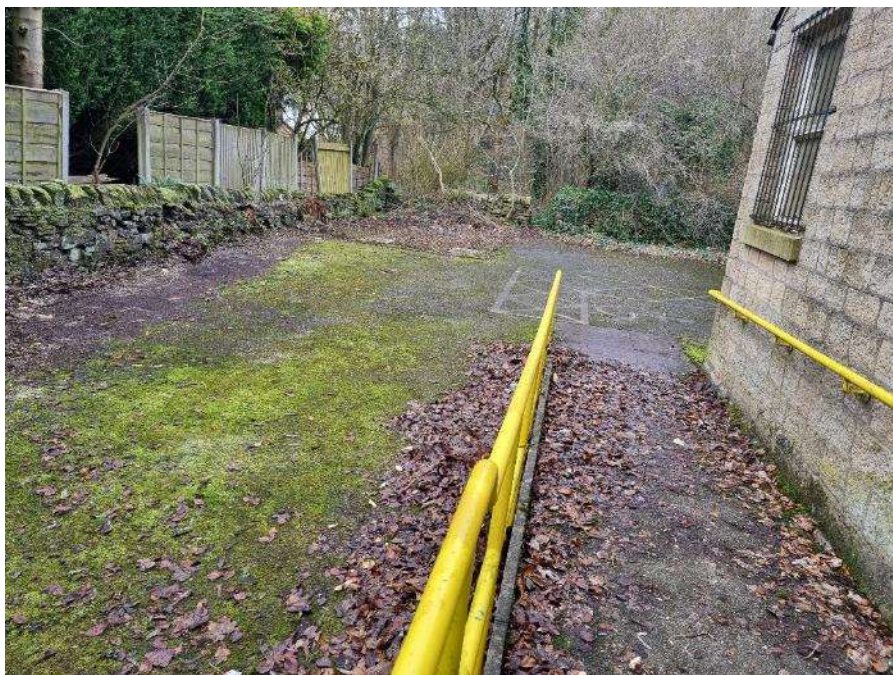
113. View of the ramp and surrounding areas.

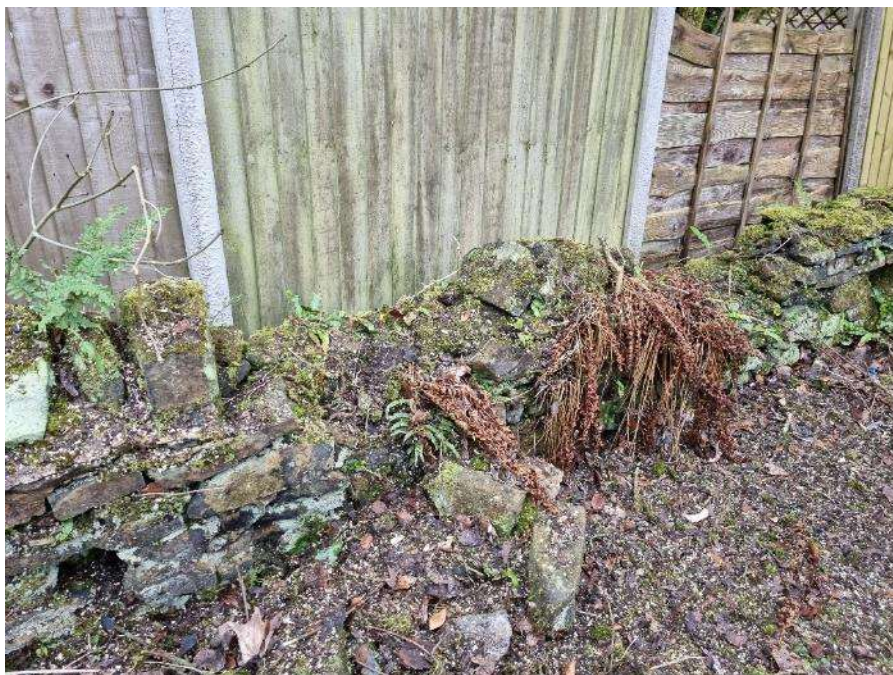
117. Boundary Wall is in poor condition

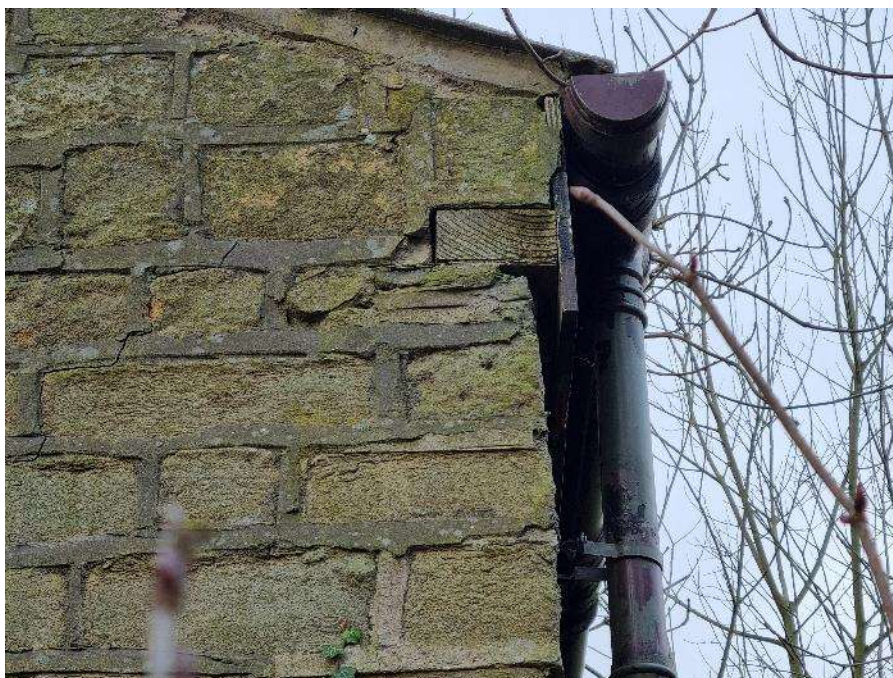
121. View of the stone work, showing signs of graffiti

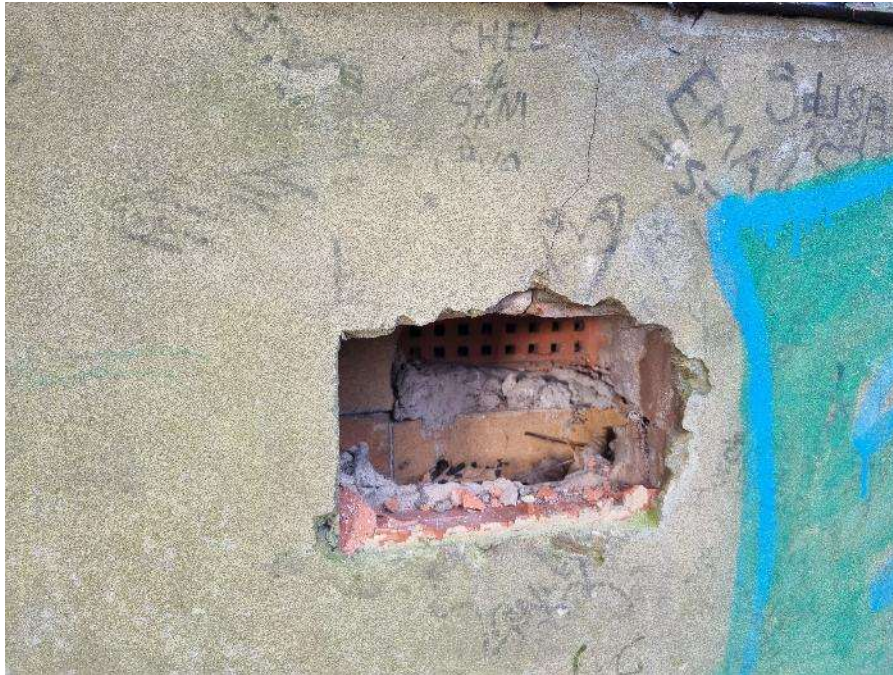
122. Exposed wall plate

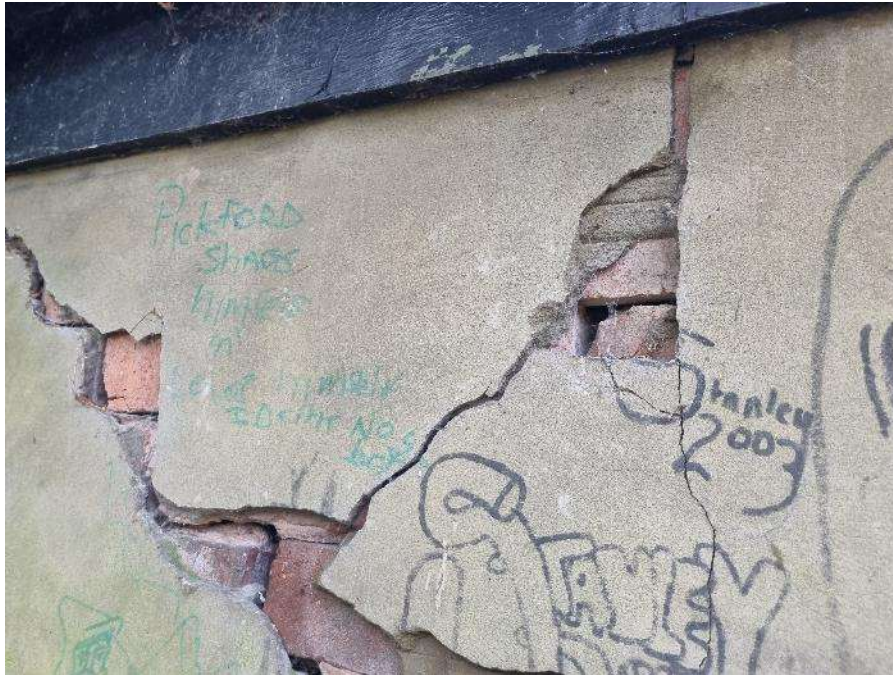
124. Damage to the render

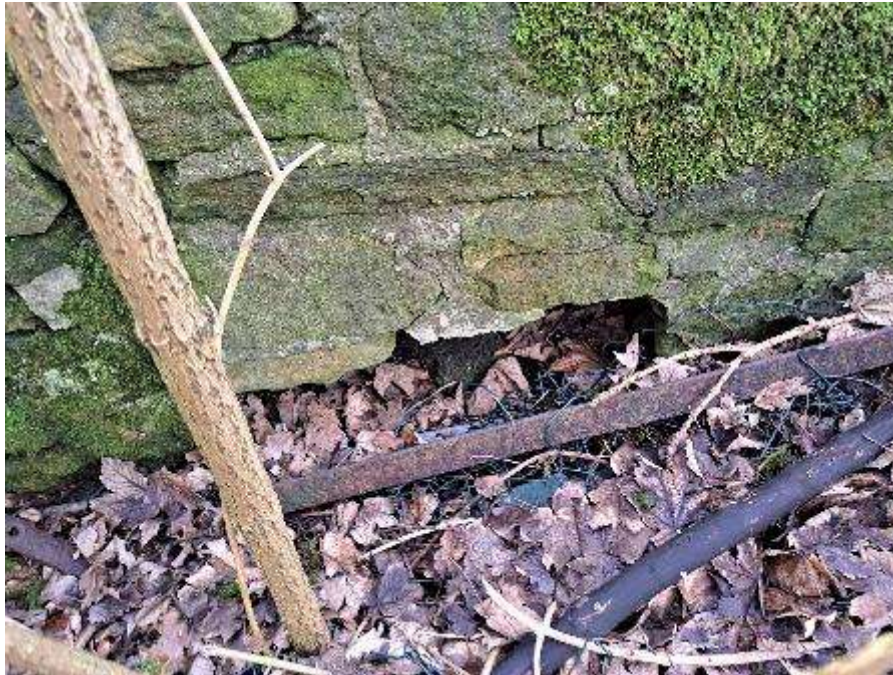
134. Damaged retaining wall

- **Retaining walls to rear supporting school playground. These walls are in serious danger of collapse and require rebuilding. It is recommended that an area within 1m of these walls on the playground side is cordoned off until works to rebuild these walls is completed.**

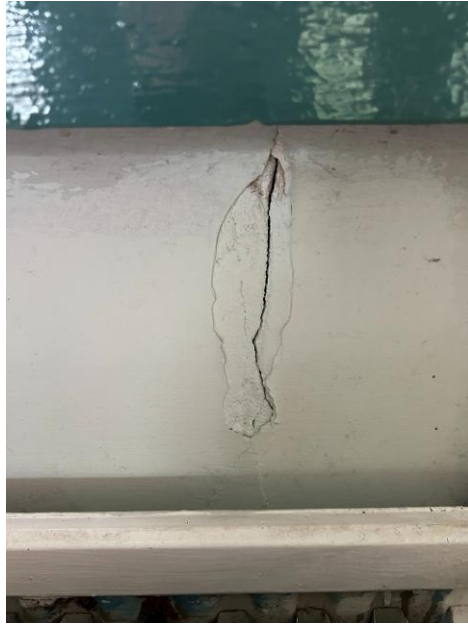
8) Small structural crack below sill (C)

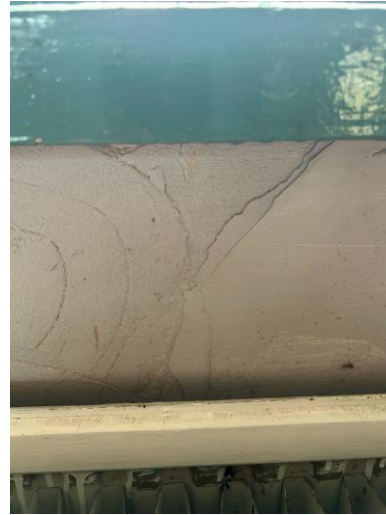
13) Crack under window sill (C)
