CAT BACKGROUND AND PROCESS

The Council has recently conducted a condition survey of the property which has identified £136,023 of repair works. The full condition survey is found in Appendix 3.

STRUCTURAL INSPECTION REPORT
HOLLINGWORTH COMMUNITY CENTRE
5.5.26

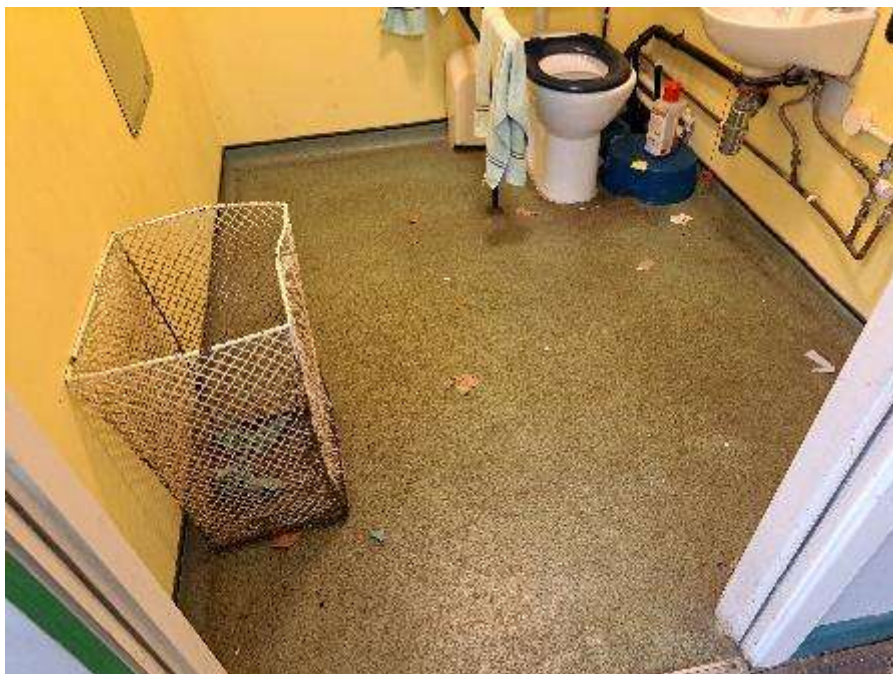
26. Aged vinyl to the Disabled WC

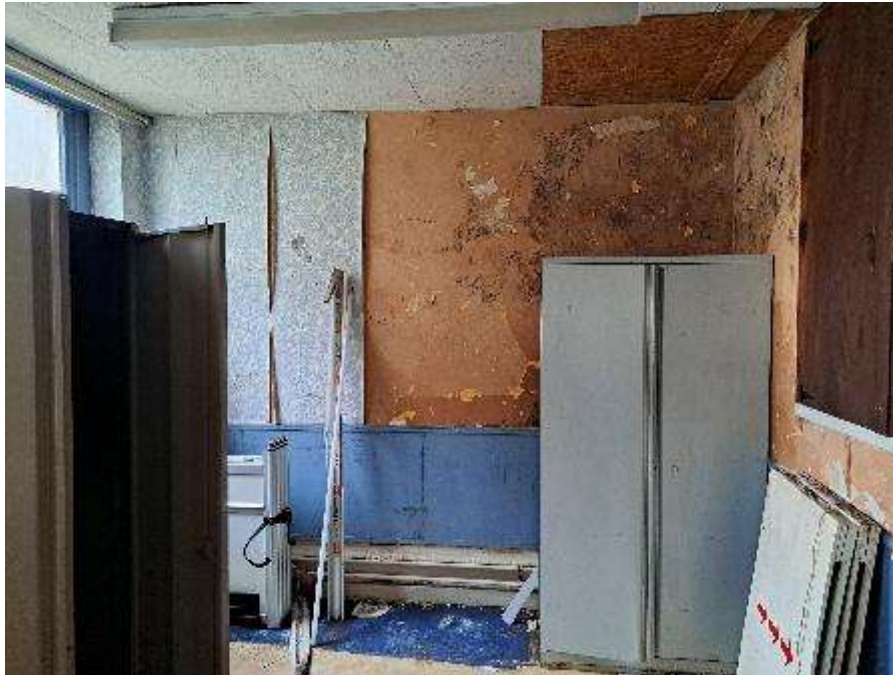
33. Damaged wallpaper

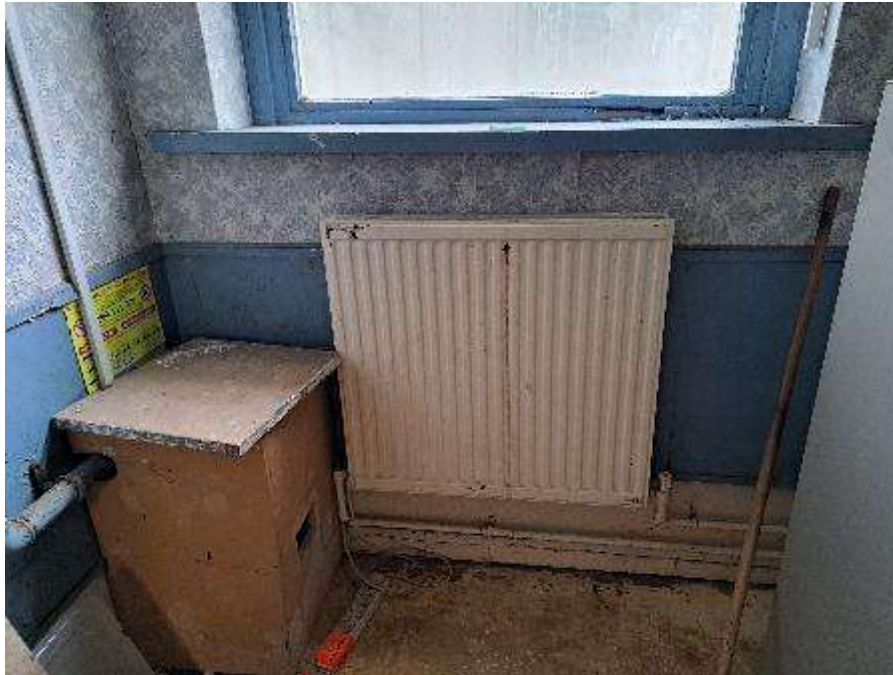
39. Damaged radiator

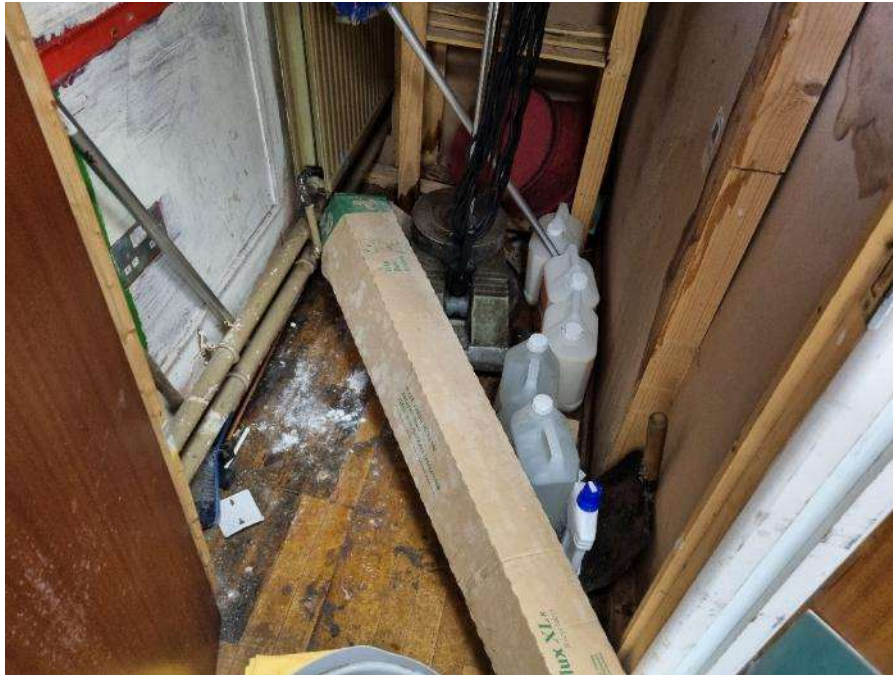
65. View of the storage areas within the main hall

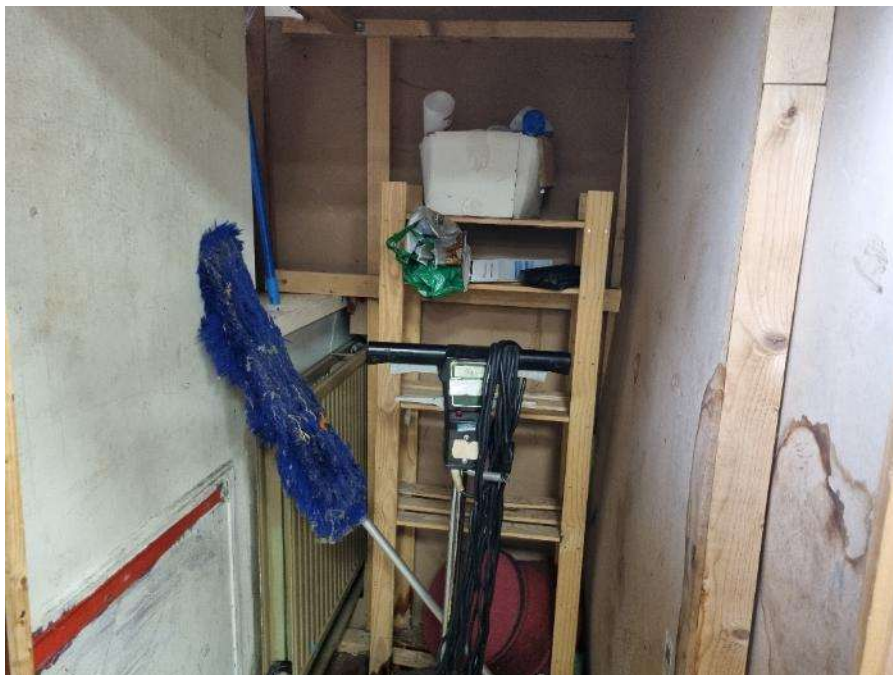
66. View of the storage areas within the main hall

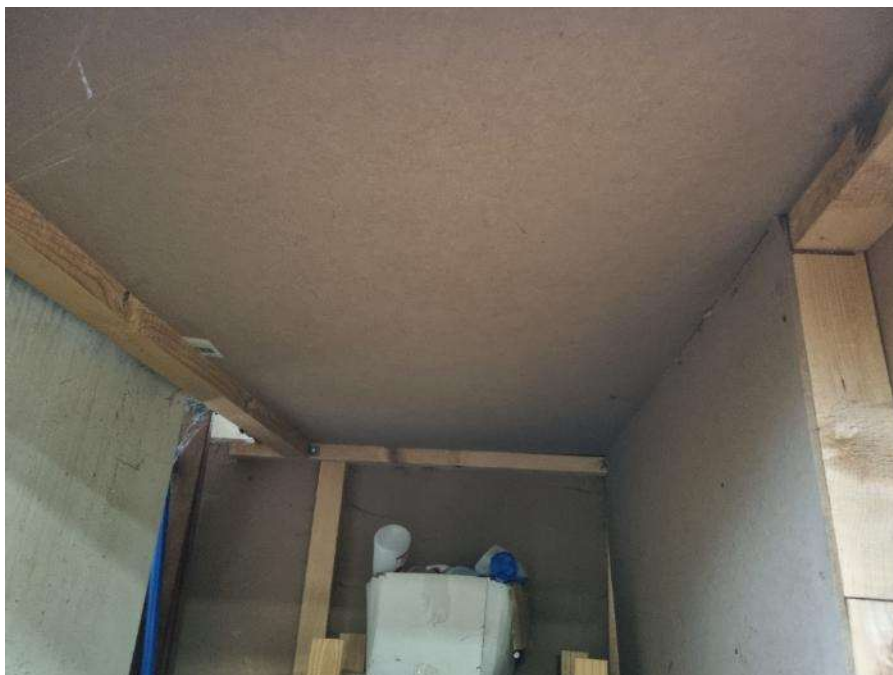
67. View of the storage areas within the main hall

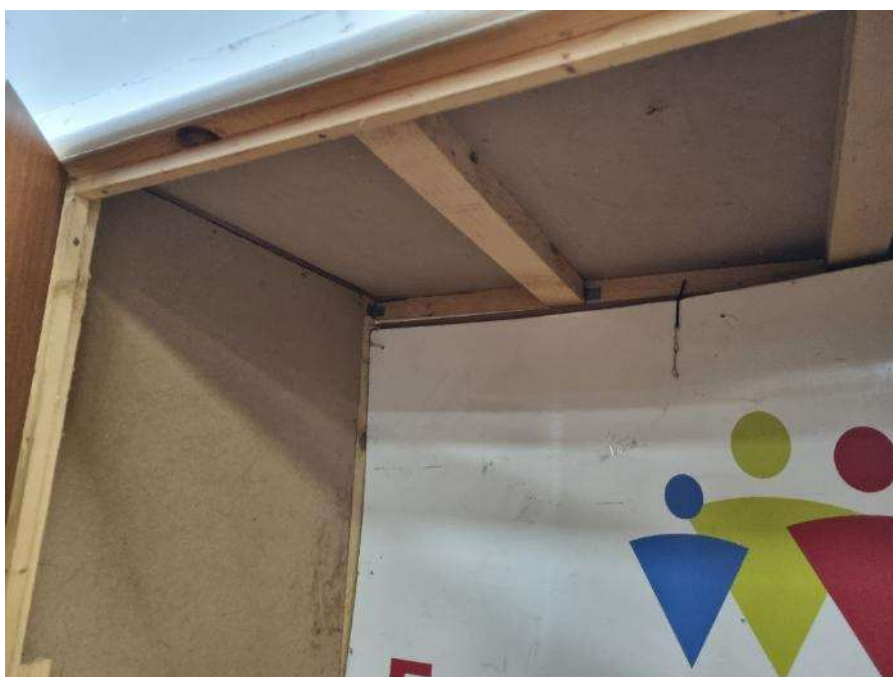
68. View of the storage areas within the main hall

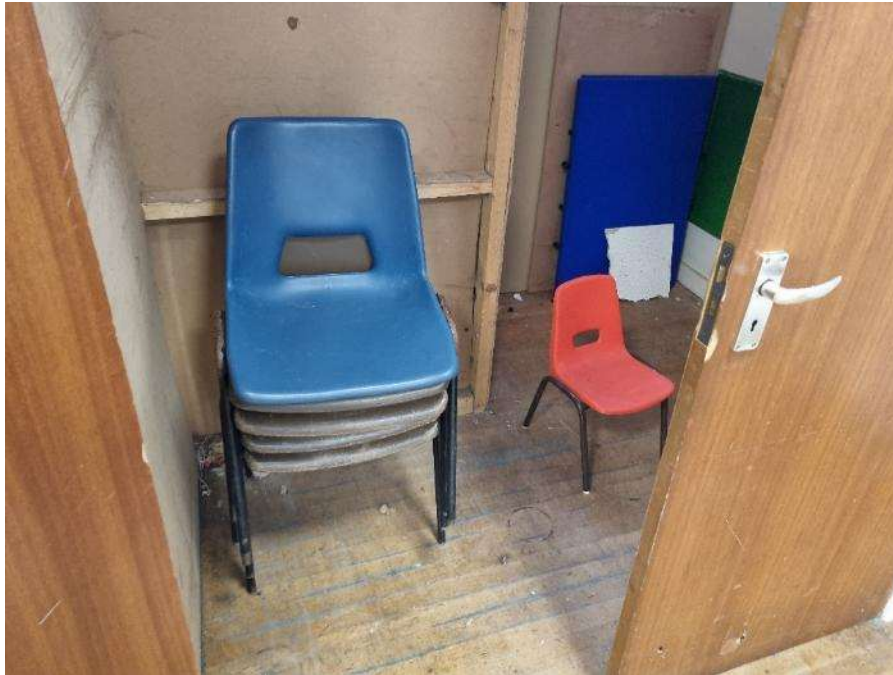
69. View of the storage areas within the main hall

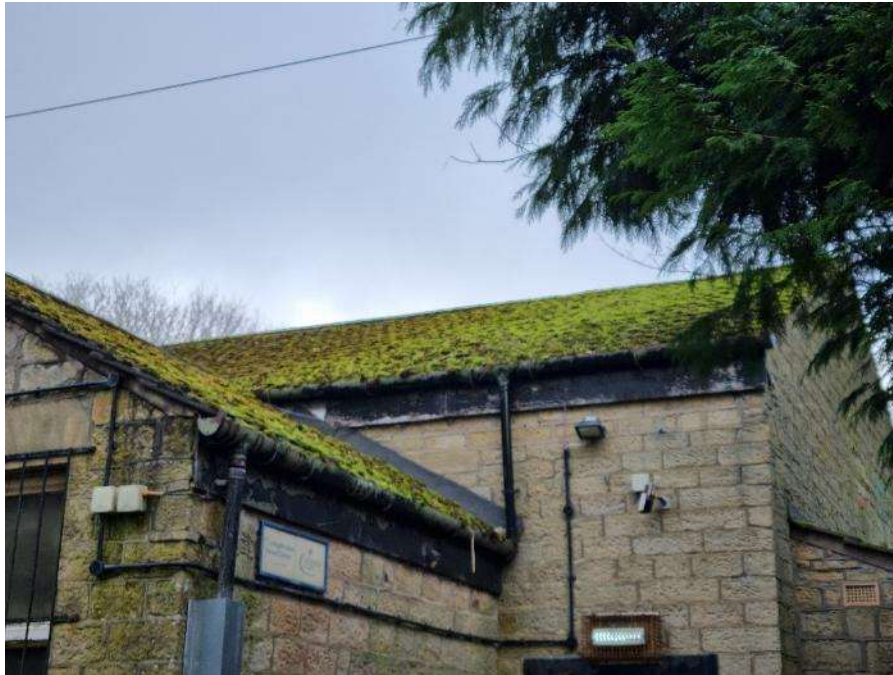
91. View of vegetated roof

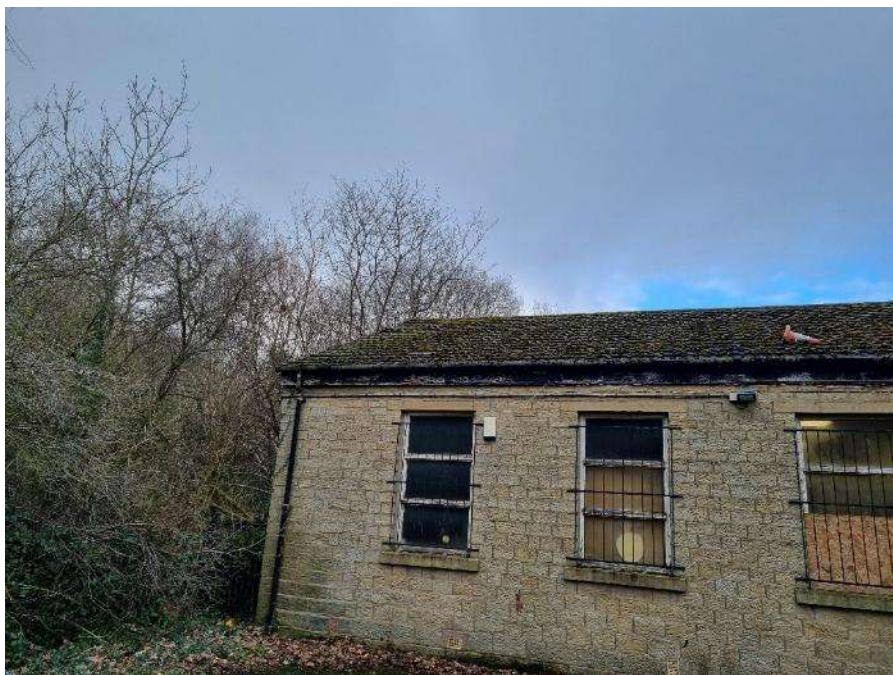
97. General view

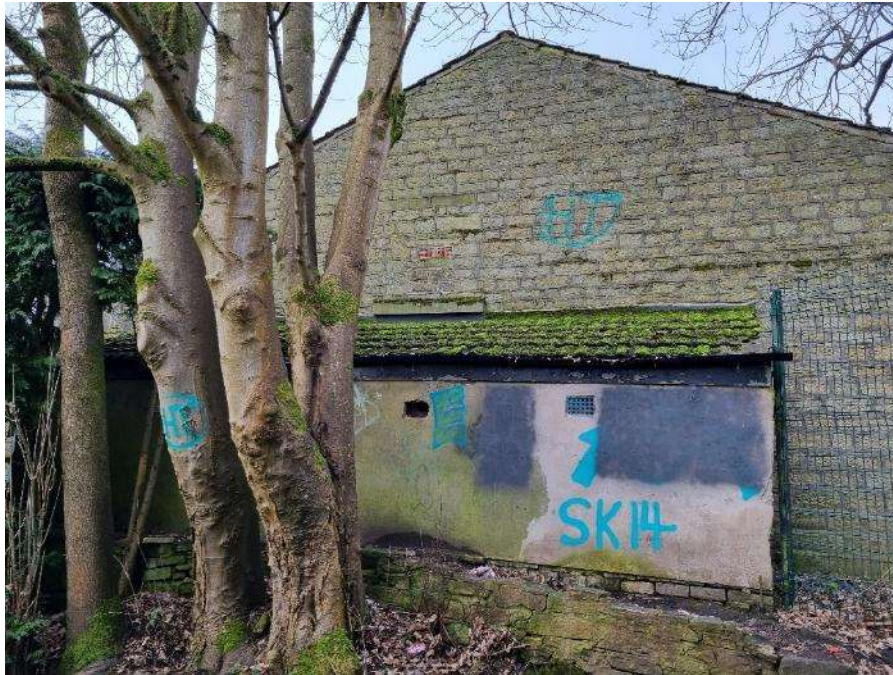
119. View of the south elevation

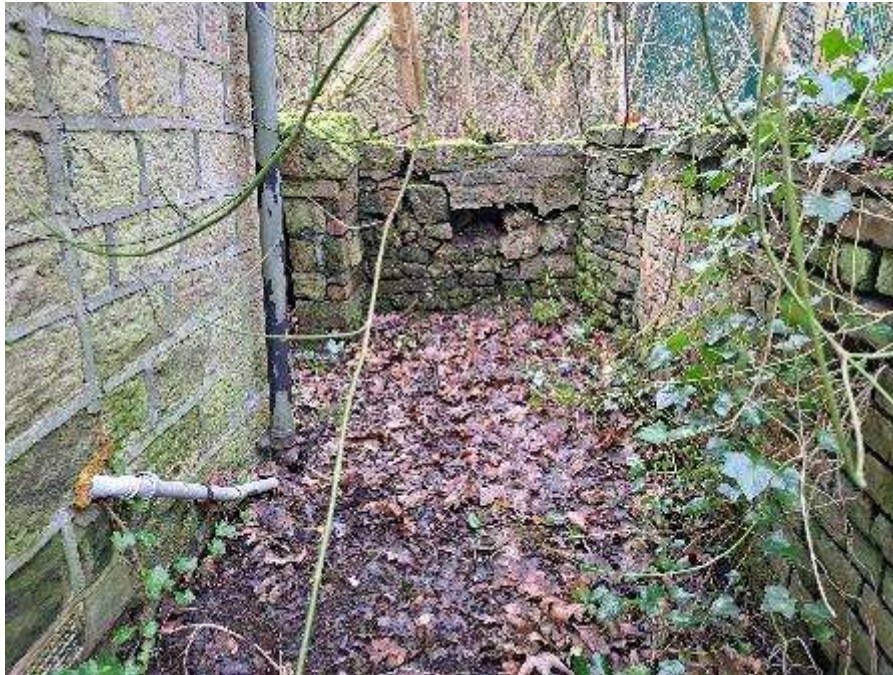
126. Damage to the render and guttering.

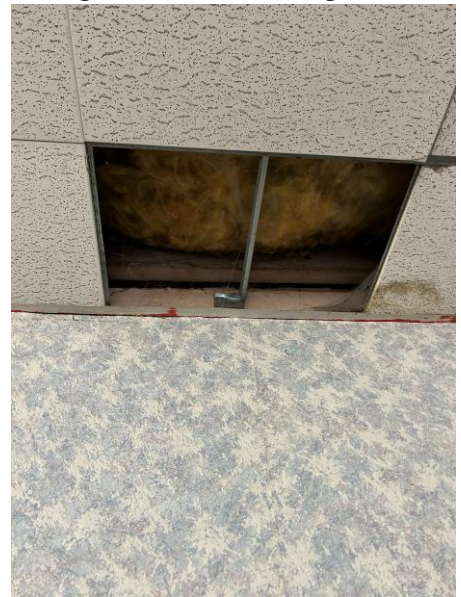
- 1) Front store area – damp patches to ceiling indicating roof leaks. Inspection of timber roof structure by specialist recommended and roof, gutter and flashing repairs recommended to prevent further water ingress (B)

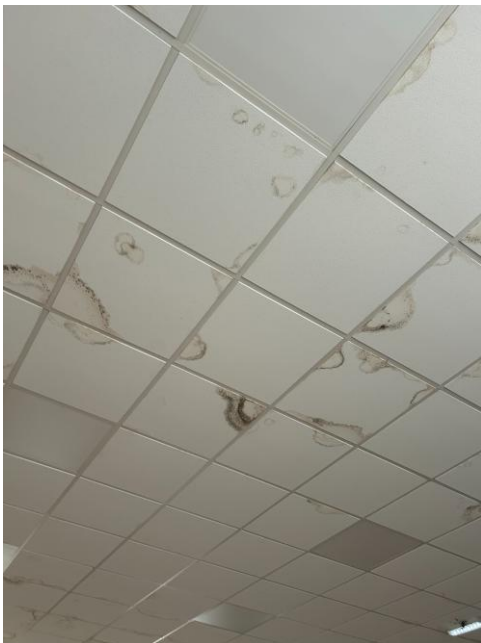
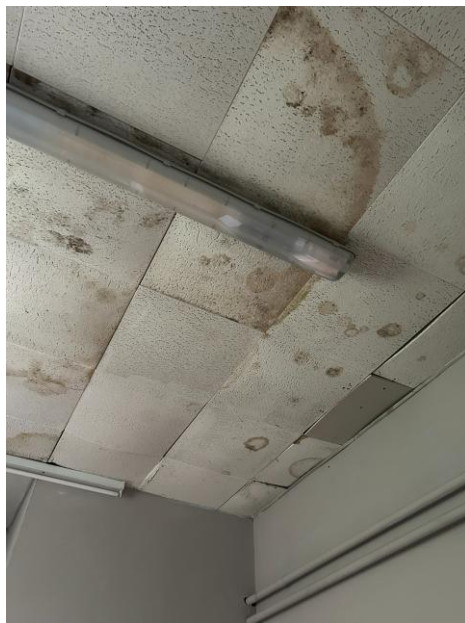
- 2) And 3) Kitchen ceiling – as item 1) (B)

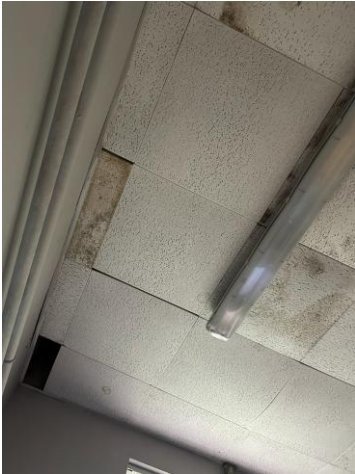
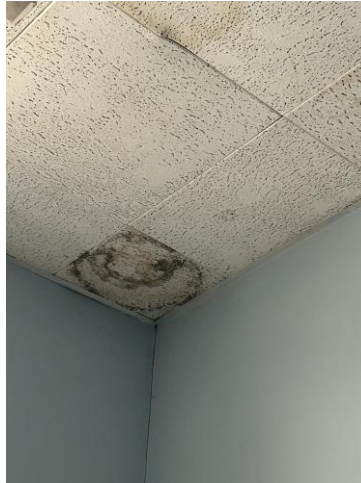
4) Office ceiling – water ingress as item 1) (B)

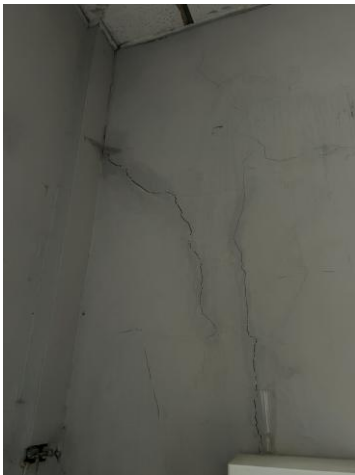
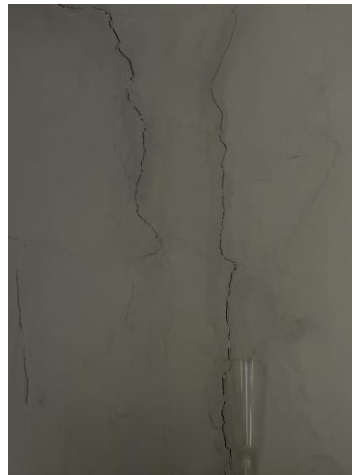
5) And 6) crack across corner of wall in kitchen reflecting external crack observed – refer item 34) (A)

- **Subsidence to the rear corner. This is a significant subsidence crack and will allow damp into the building and will progressively worsen if not dealt with. However, it does not affect the integrity or safety of the building. There are 3 possible causes of this subsidence and intrusive investigations will be required to determine cause and best solutions to prevent further movement: a) blocked / leaking drain in this vicinity causing damp and soft ground b) this area is naturally damp due to surrounding retaining walls (approx. 1m lower than ground to the side and rear) or c) nature of the underlying ground eg clays which may be affected by damp and drying actions. It is probable that the cause is a combination of all the above**

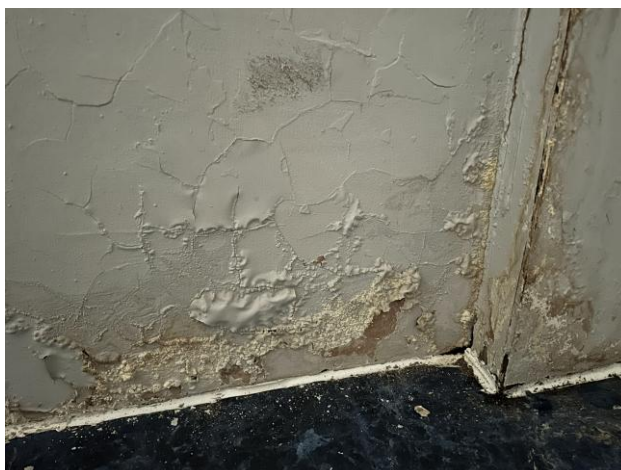
7) Damp on wall of kitchen – damp survey required to identify cause (B)

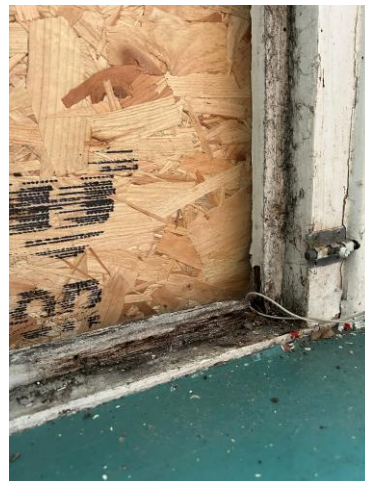
10) Rotten window frames – window fallen out

(B)

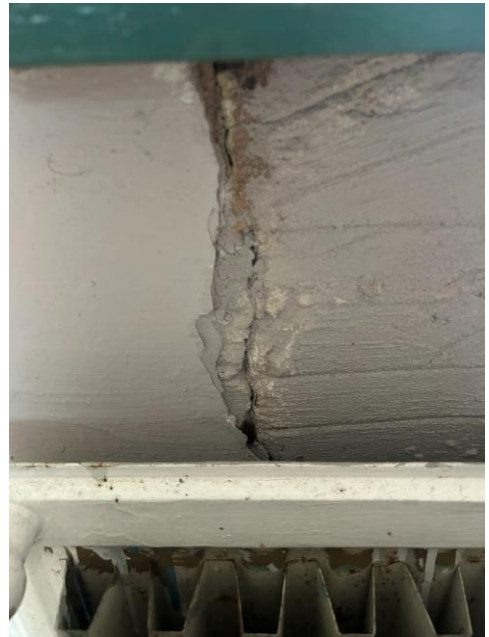
11) Crack under window sill (C)

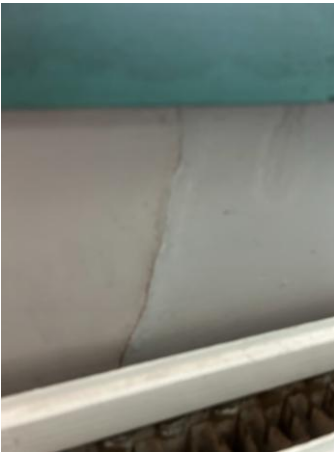
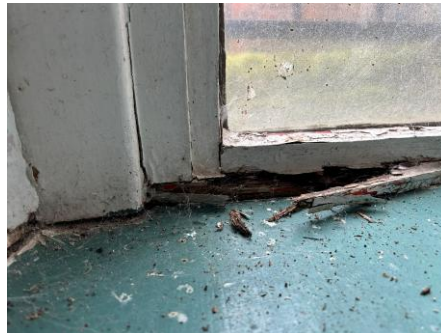
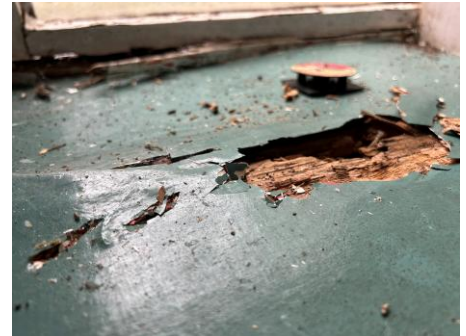
14) , 15) and 16) wall crack under sill and rotten sill and windows (B)

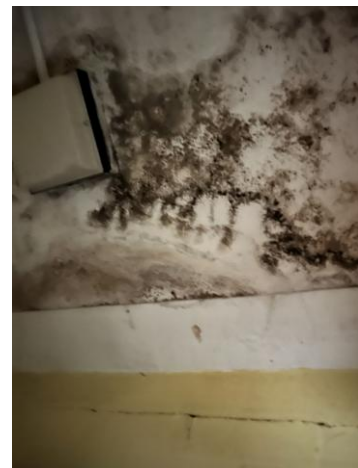
17) Damp on ceiling of ladies toilet. Leaking roof structure (B)

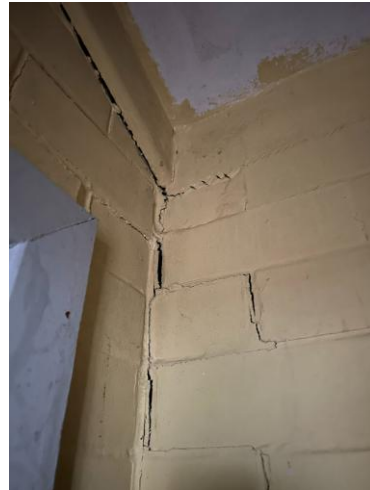
18) Crack in men's toilets side wall which reflects external cracking (see items 41. 42,) (A)

- **Subsidence cracks to the wall of the toilets (lean to structure) - significant cracks to the external wall skin but only minor cracking reflected internally. Most likely cause is the large (20m plus) sycamore tree within about 1m of this gable. It is recommended this tree is removed and the stump dug out or poisoned to prevent further damage. In addition, the Leylandi hedge is too close to the building and will cause future problems with building foundations**

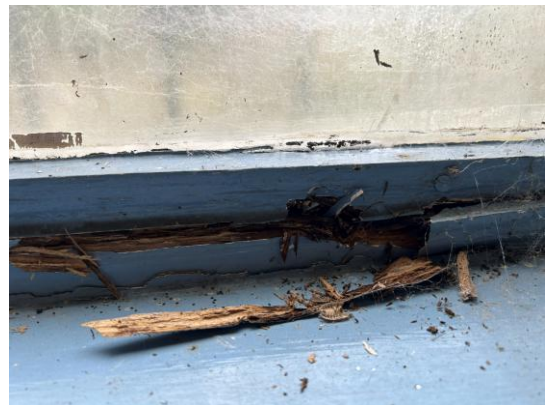
19) Rotten window and sills in front store area (B)

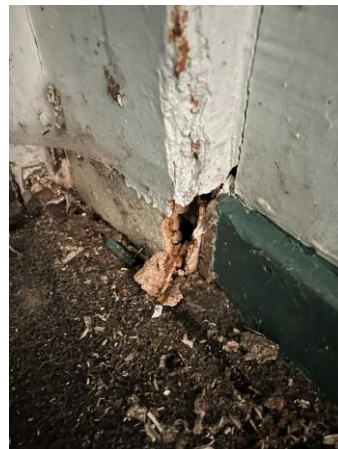
20) Base of escape door rotten (B)

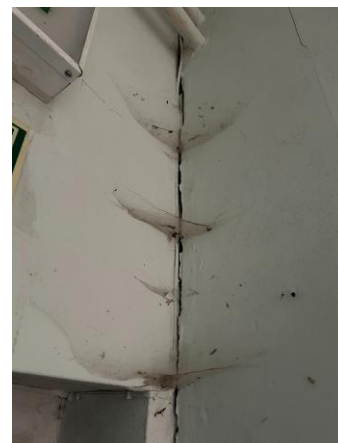
21) Small cracks and holes in corner of wall by door (C)

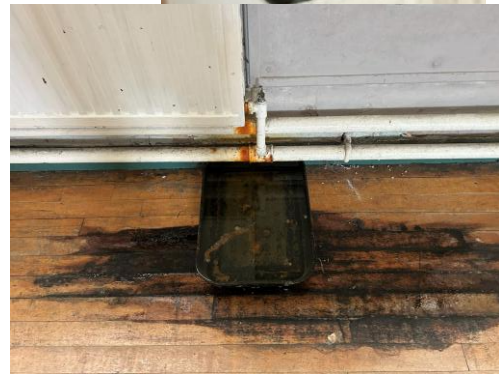
23) Leaking/ corroded radiator causing damp to floor and potential damage to timbers.

(C)

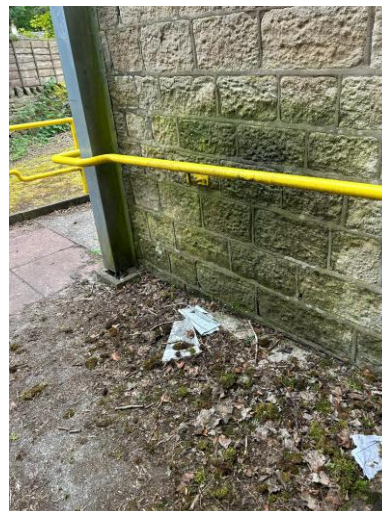
24) Damp on wall – most likely from blocked / damaged gutters and downpipes (B)

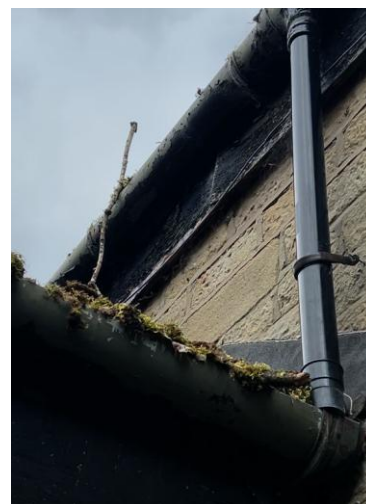
25) Rotten fascia boards in need of replacement (C)

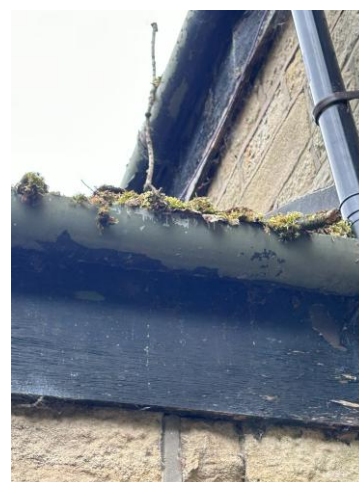
26) Illustration of blocked gutters (B)

- **Blocked drains, corroded and collapsing gutters, poor flashings, loose roof tiles – all these items are causing water / damp ingress into the building which will progressively cause damage to internal timbers**

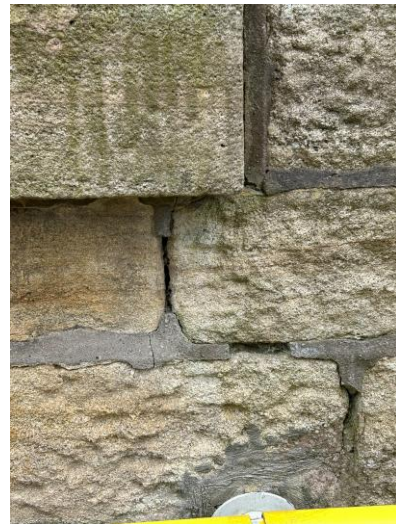
27) Minor cracks in external stonework requiring repointing (C)

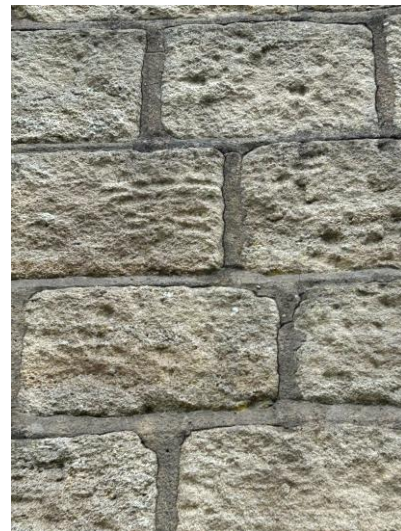
28) Hairline cracks in stonework (C)

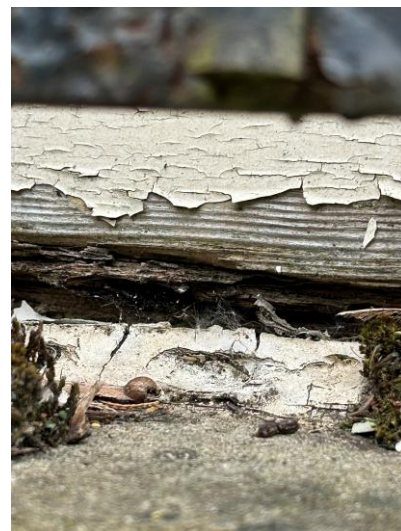
29) Rotten windows in need of replacement

(B)

- **Rotten windows and sill – resulting in water and damp ingress which will progressively cause further building fabric deterioration**

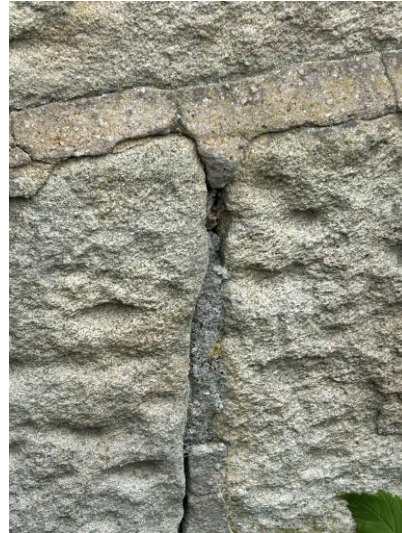
30) Minor cracking in stonework at base of wall

(C)

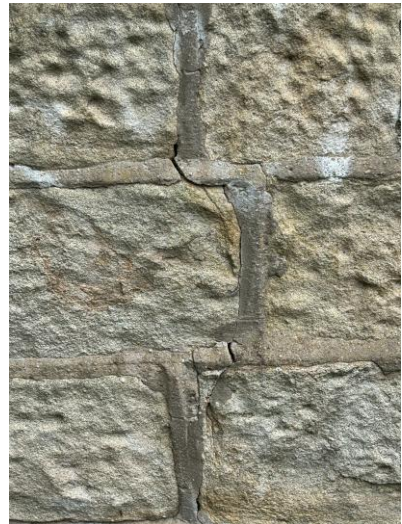
31) Minor cracking in stonework (C)

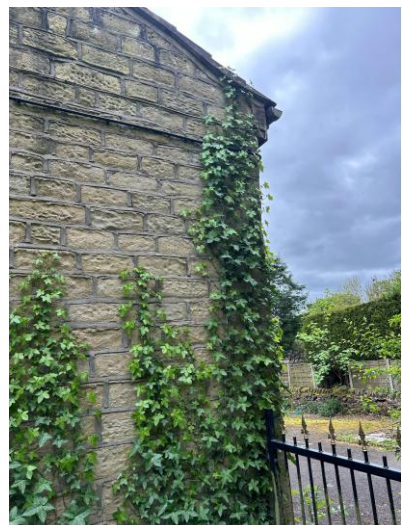
32) Ivy growing up wall which need removing to prevent damage to mortar joints

(C)

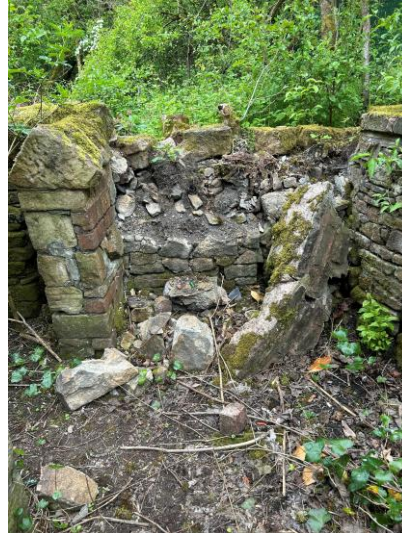
33 Collapsing garden retaining wall

(A)

- **Retaining walls to rear supporting school playground. These walls are in serious danger of collapse and require rebuilding. It is recommended that an area within 1m of these walls on the playground side is cordoned off until works to rebuild these walls is completed.**

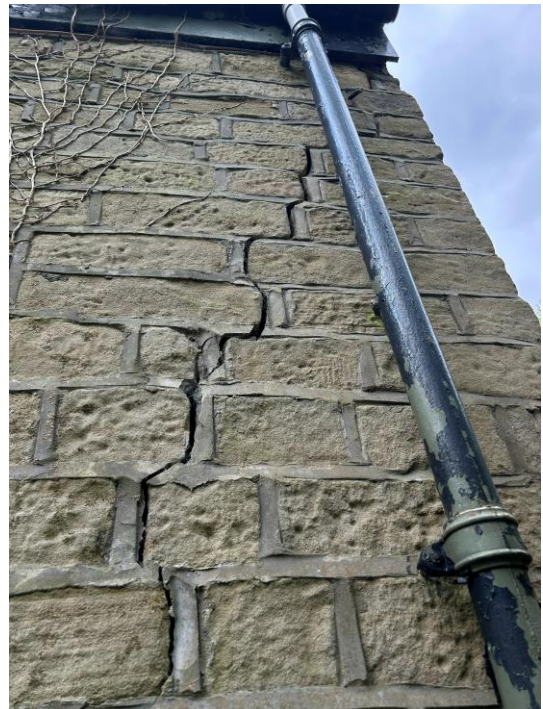
34) Subsidence crack at corner of building – cause needs investigating. Note drainage gully at this corner

(A)

- 3) Deleterious materials survey – it is assumed Tameside MBC already have a detailed deleterious materials survey for this site
- 4) Intrusive site investigation – to determine exact nature and cause of subsidence to rear and enable recommendations to be made on remedial works

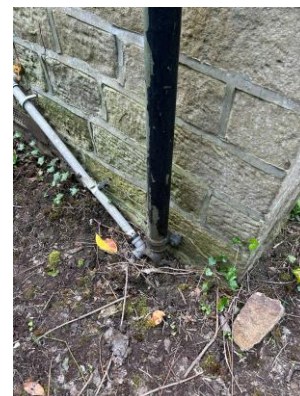
35) Downpipe and gully in vicinity of subsidence

(A)

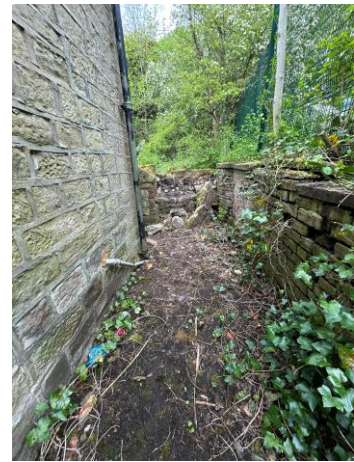
36) Damp ground in corner of subsidence due to level changes in area (B)

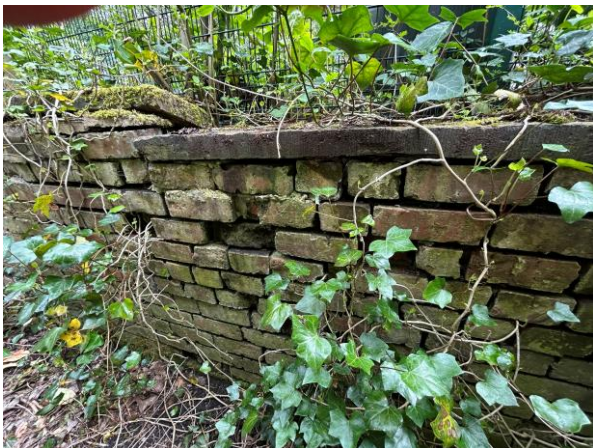
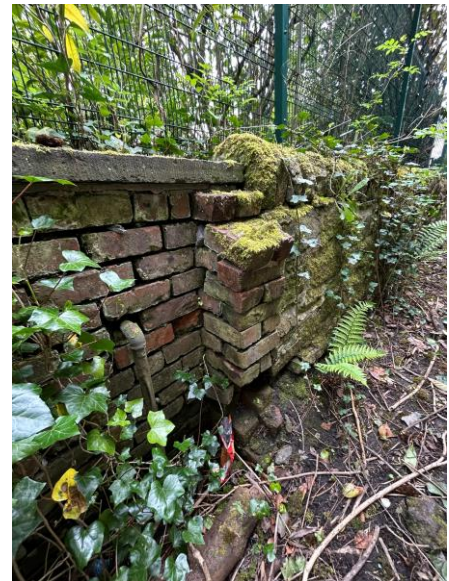
37) And 38) collapsing retaining wall supporting children's playground on high side (A)

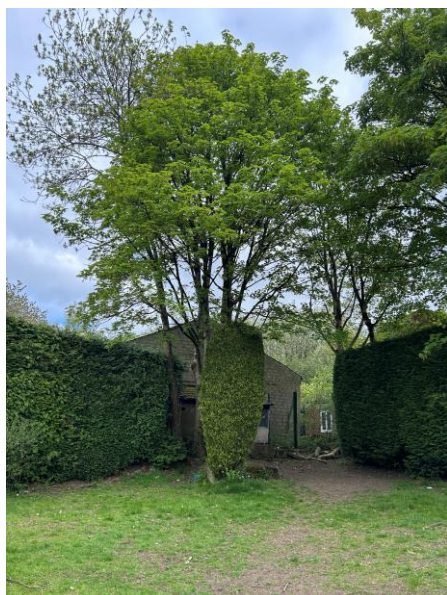
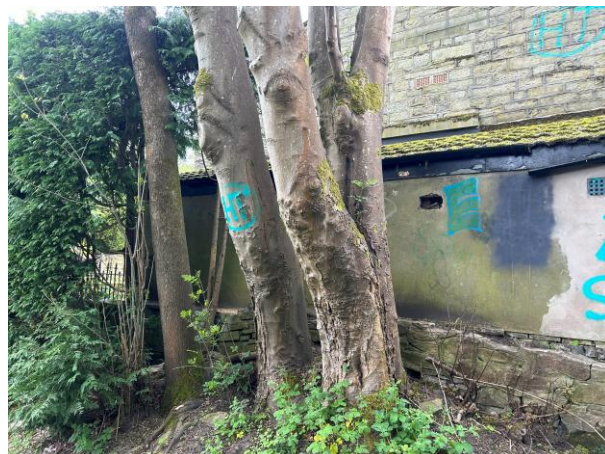
39)And 40) Large sycamore tree within 1m of end wall (A)

- 5) Arboriculture survey to determine nature and status of surrounding trees, determine which trees can be removed. (Currently a number are too close to the building resulting in damage

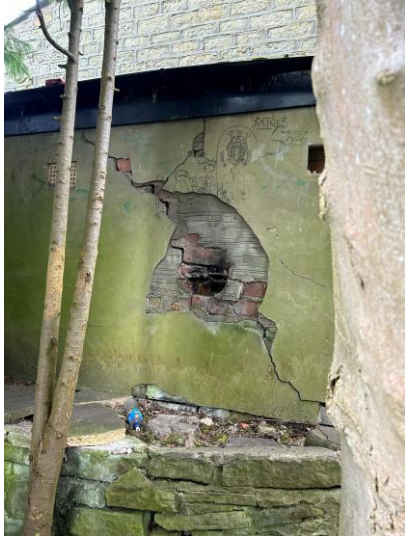
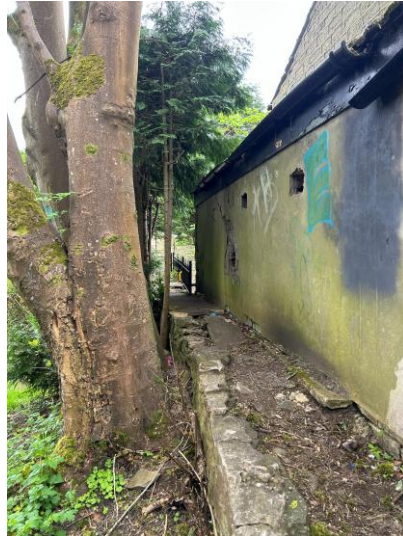
41 And 42) subsidence cracks and damage to toilet wall (lean to structure) (A)

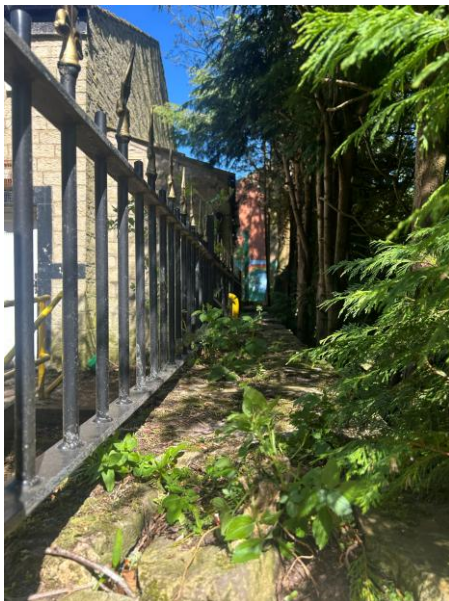
43 Leylandi hedge in close proximity to lean to wall (A)
